Retrofit of deteriorated structure due to rocket strikes

Abstract:

A building in Al-Samawa City was struck by three rockets on March 2003. This building is recommended to be rehabilitated for accommodation of Medicine College Deanship in Al.Muthanna University.

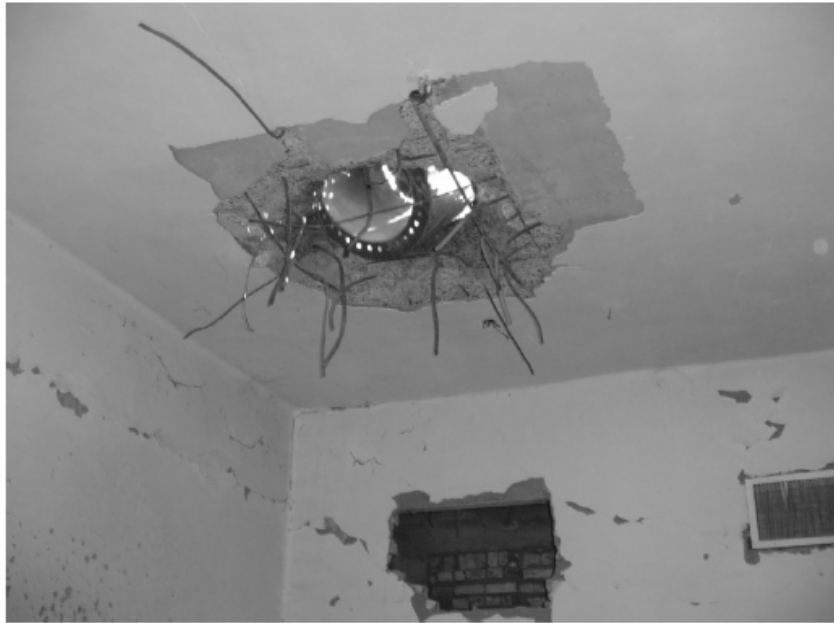
Fig. 1: Hole in the Reinforced Ceiling of the building

The stroked slabs shown in **Figs. 1 and 2** have holes due to the penetration of the rockets, it is obvious that these slab have cracks around the hole. This means that each slab firstly should have reconstructed its self and secondly supported by steel frame under each one. In addition to that the steel structure will has integrity point with the upper part of the walls (U.N.D.P, 1989 and Horii et.al, 1998). Therefore; to achieve the above scope, in this paper presented the patterns and arrangement of the steel structure and the details of connections between its parts and also the design of tiles that will accommodate to fill the holes in slab.

1. From the photos and the visual inspection for the building, it can be concluded that the bearing walls are affected highly due to this strike.
2. Due to the rocket hit the slabs experienced punching shear and they are drilled to form holes.
3. The structural solution that was proposed was the best way for rehabilitate of the structure and to gain a rigid one.

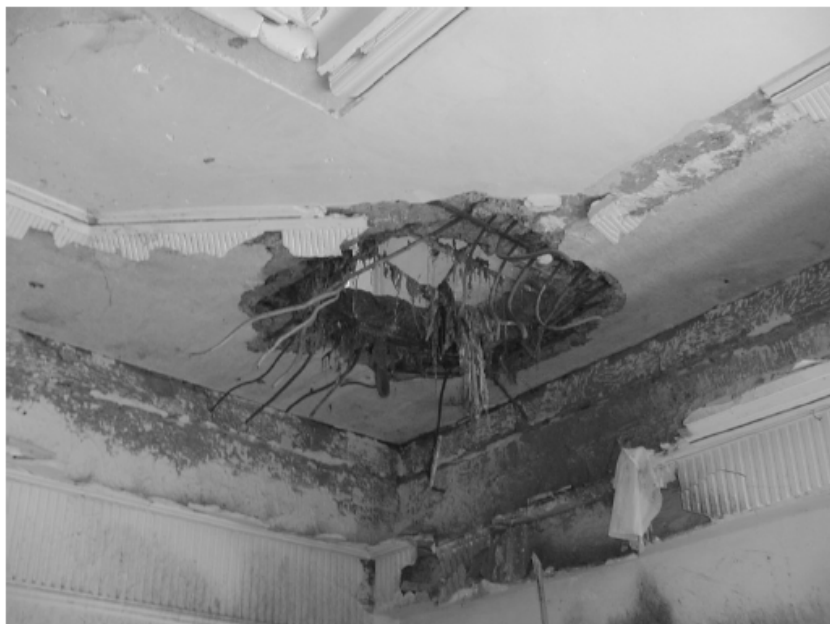
Fig. 2: Hole in the Reinforced Slab of the Main Hall in the building

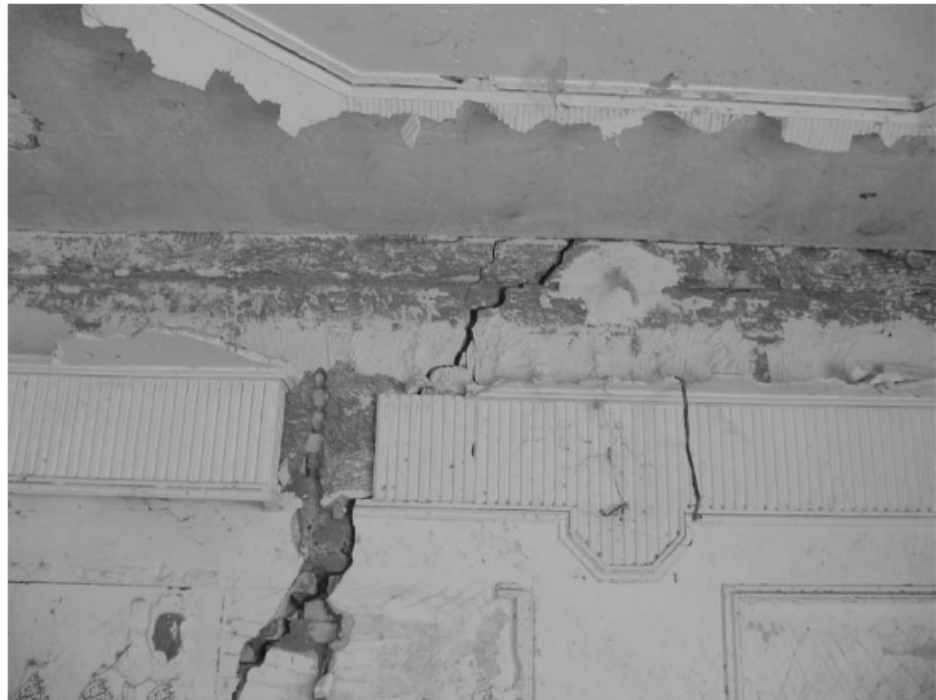
The building is of brick masonry bearing walls and reinforced concrete slab system. The walls experienced severely cracks and also the slabs due to the momentum loads by striking of rockets (see **Figs., 1, 2, 3**). As shown in **Fig. 3**, the walls are affected severely and it is required to be rigid enough.

Fig. 3: Cracks in the Wall of Main Hall

penetrated within the skeleton of the existed wall at spacing in transverse direction and these bars will connect with steel bars in the longitudinal direction in both sides of wall. The described mesh of steel reinforcement bars will erected and installed within thickness of 150 mm in each side. At the upper end of wall, where the slab seats, anchorage steel bars will be bent in elongation of the side concrete in order to insure the well connection between wall and slab (McCormack, 1984 and Wang and Salmon, 1985). The details are shown in **Fig. 5**.

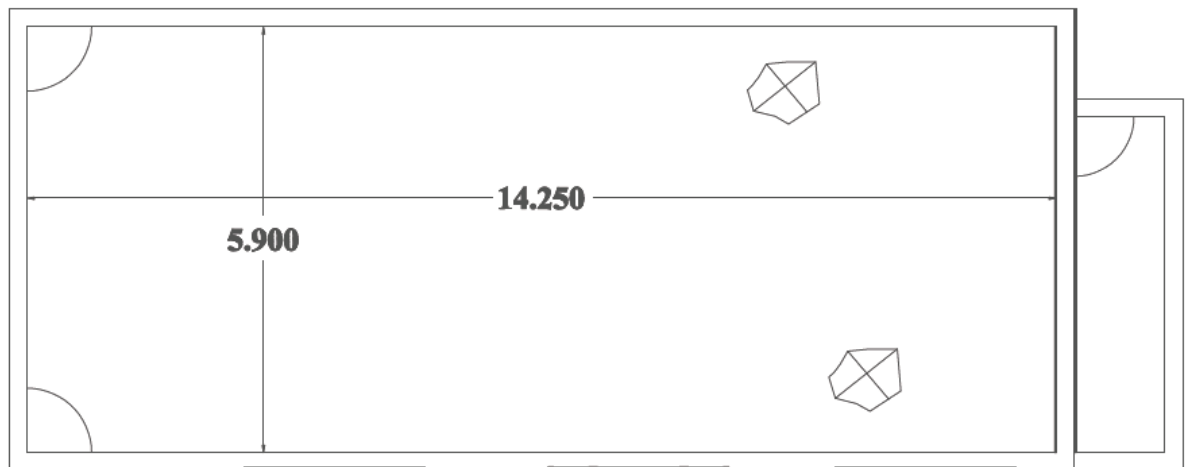
Fig. 4 illustrates the schematic diagram of the plan of the main hall of the building and the approximate location of the rocket hit.

Fig. 4: General Plan of the Main Hall Showing the Location of the Rocket Strike.

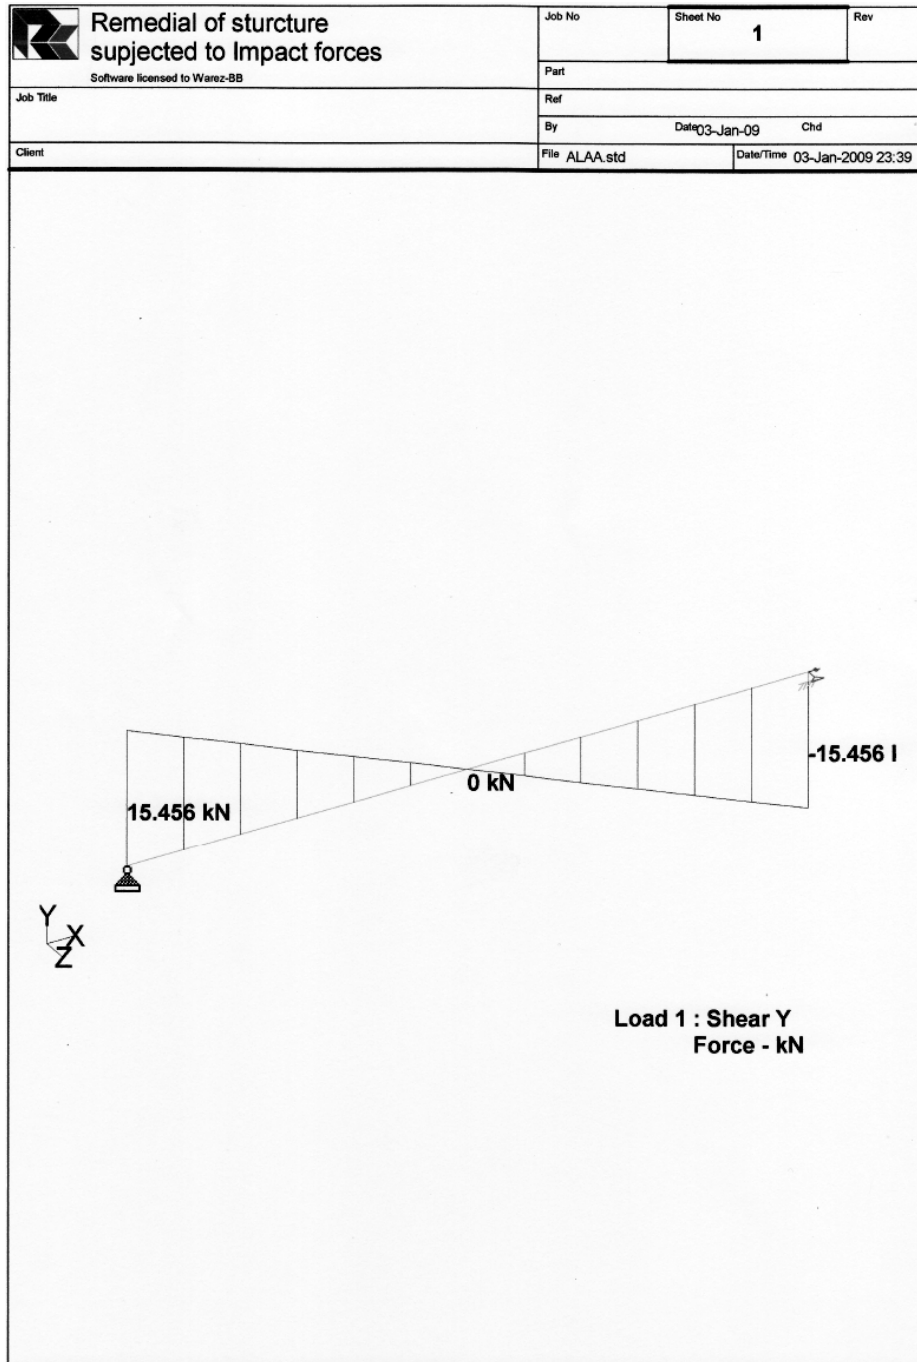
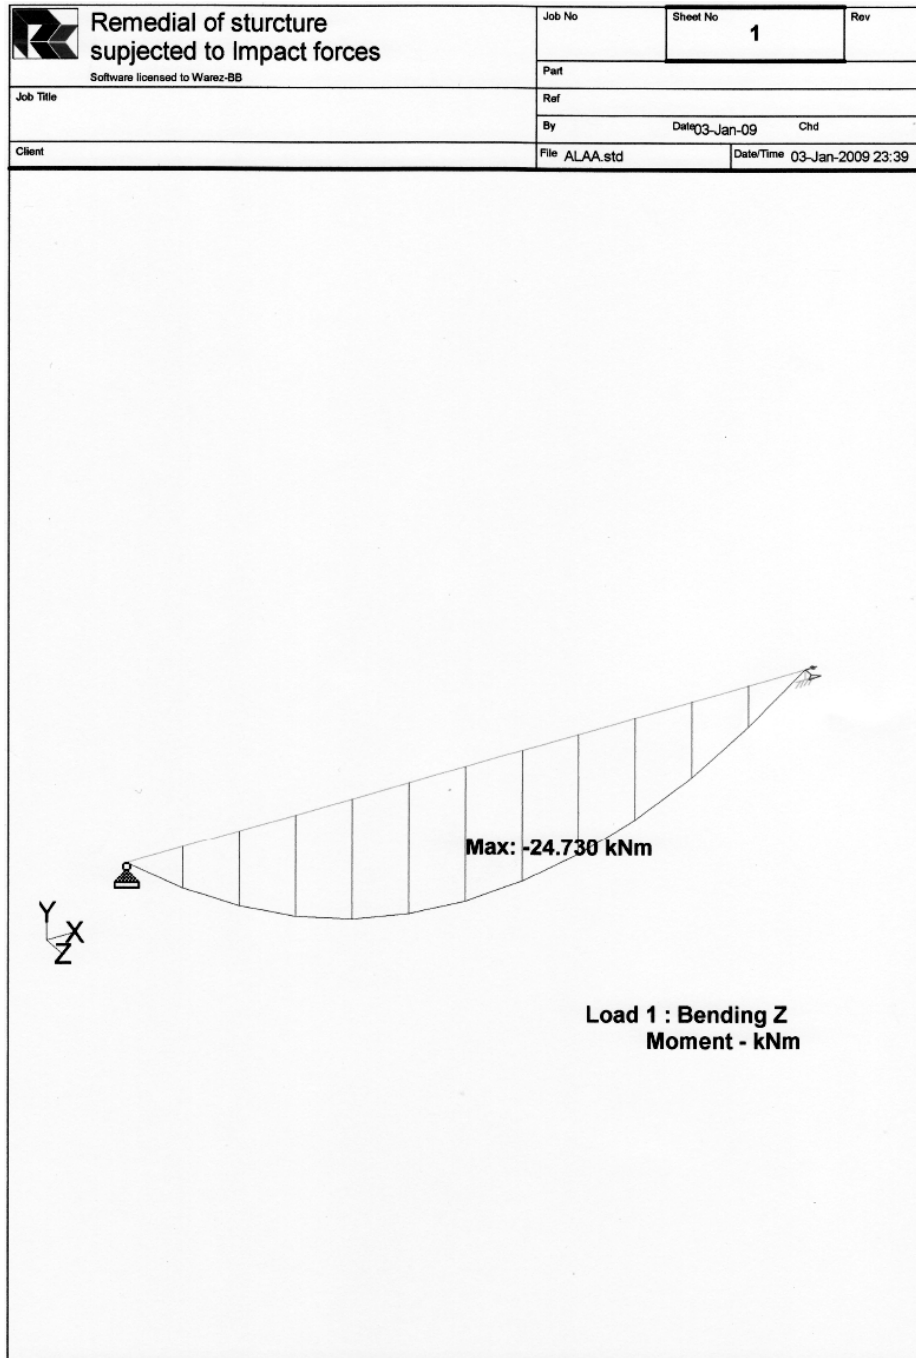
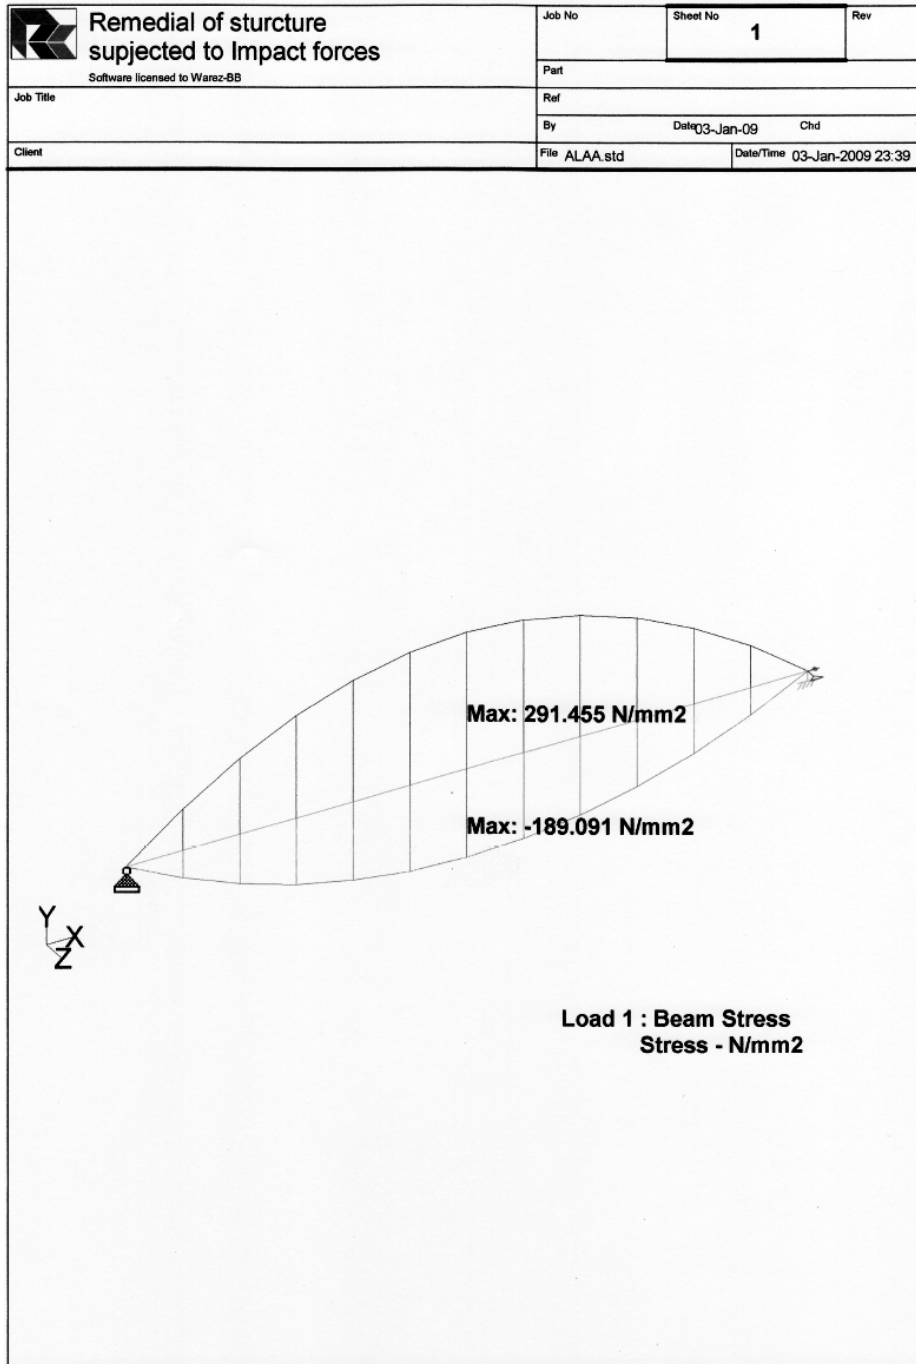
The analysis was conducted utilizing STAD Pro software, a typical analysis was shown in **Fig. 8**, and these calculations were expressed the safe suggested way for remedy. The details of analysis and design can be found in the technical report prepared by the authors which was financed by the department of engineering of the University.

Fig. 8 a: The shear diagram for the beam under the slab

Fig. 8 b: The moment diagram for beams under slab

Fig. 8 c: The stress in steel beam under the slab
