# Failure Characteristics Of Boiler Pipes In Al-Emsaeb Electric Power Plants

Sami Ibrahim Jafar

*Department of production eng. & metallurgy, University of technology, Baghdad*

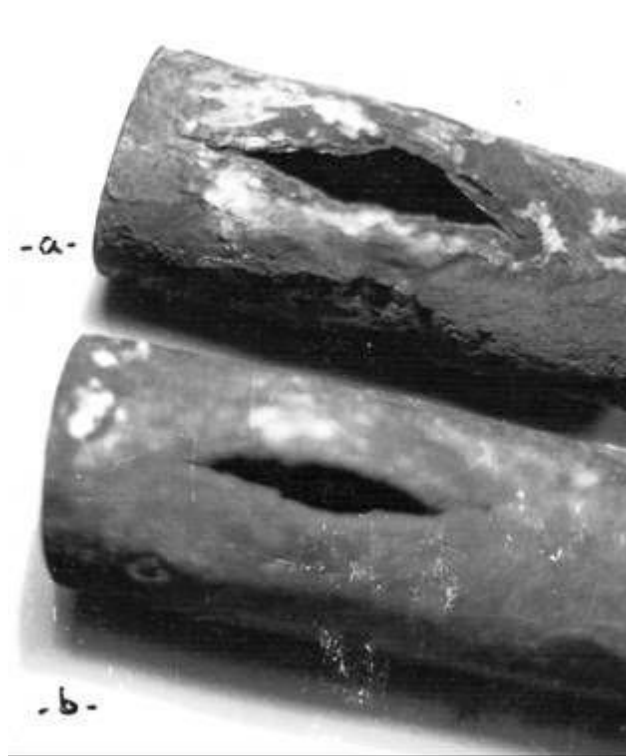
Thick lip rupture occur mainly by stress rupture as a result of prolonged overheating at a temperature slightly above the maximum working temperature for tube material {Islam & Riad, 1989}. Fracture surfaces of such failures are rough {crystalline} in macroscopic appearance and are oxidized or hot gas corroded because of exposure to a high temperature corrosive environment following the rupture.

The macroscopic examination reveals that the direction of fractures is normally to the tube surface(flat – face fracture) and parallel to the tube axis as shown in Fig. 2.

**Fig.2.** Over – all view of rupture. Atypical Fish Mouth rupture.

- a- Thin Lip Fracture.
- b- Thick Lip Fracture.

Thin lip fracture (Fig.2) usually are Tran granular tensile fracture , occurring at metal temperature from  $650-870\text{ C}^0$  (  $1200-1600\text{ F}^0$  ) { Islam & Riad, 1989} . A tensile fracture results from rapid overheating to a temperature considerably a above the working temperature . This fracture is accompanied by considerable swelling of the tube in the region adjacent to the rupture that, have been exposed to the highest temperature.

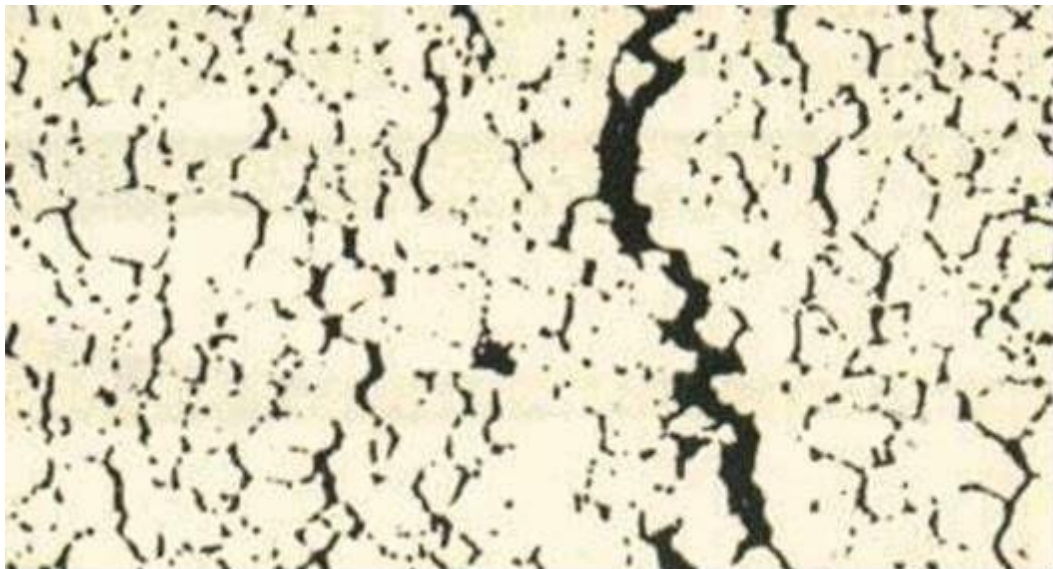
Examination of a polished transverse section through the tube at the center of the fracture usually reveals extensive secondary transverse cracking adjacent the main fracture (Fig.3) and when etched , the section will exhibit intern granular separation as show in micrograph in Fig.4.

**Fig.4** Intergranular nature of cracking for etched specimen electrolytically in 60%  $\text{HNO}_3$ .

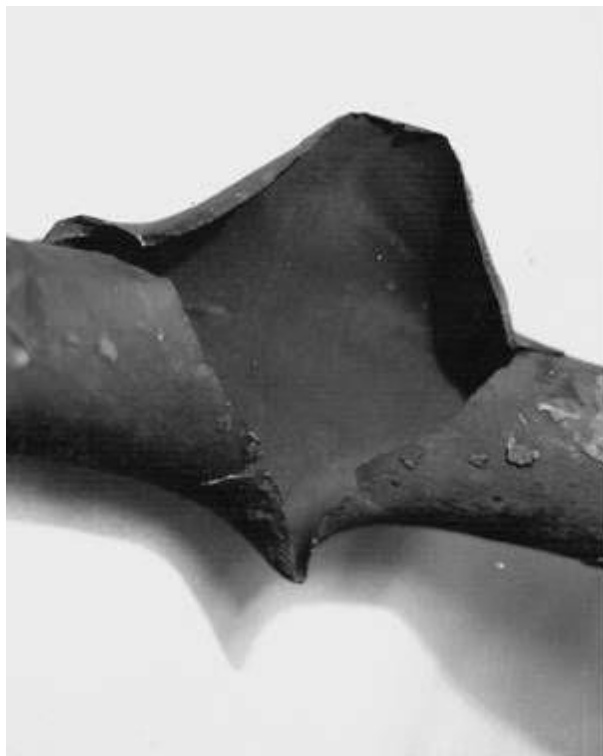
Some times steam escaping at high velocity through the rupture will impose a reaction force in the tube sufficient to bend it laterally { Jackson,1980}. As a result of later bending , the tube- wall is thinning adjacent to the failure and appear as a knife-edge. This rupture exhibits as a (cobra) appearance ( Fig.5).

Thinning also occurs in areas of swelling adjacent to rupture. The tube wall was 67% as thick as it was opposite the rupture, where the tube was shielded from exposure to hot gas.

**Fig. 5** The fracture exhibits {Cobra } appearance

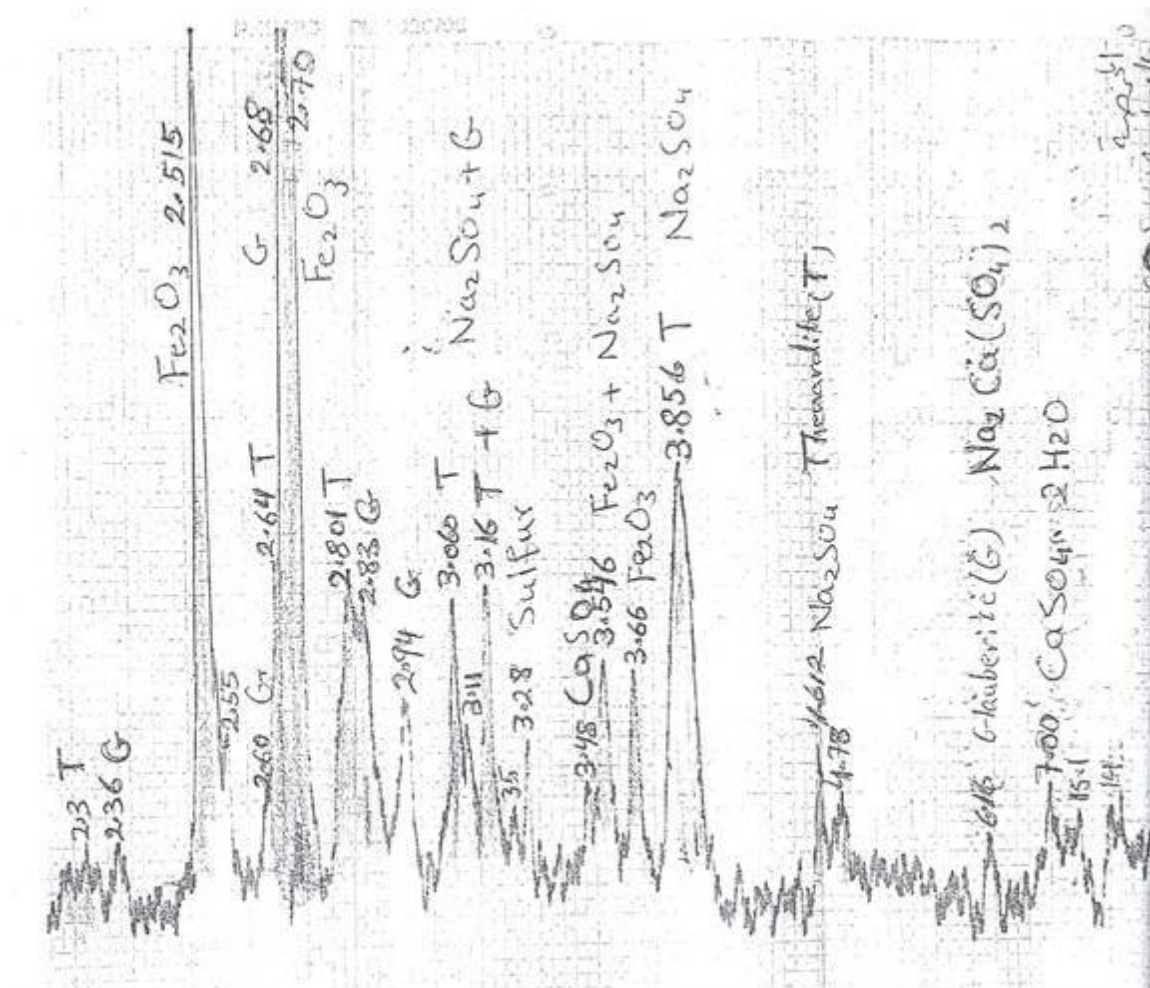
Visual examination revealed noticeable swelling and high oxidation was visible. Thick black oxide scales deposited on the steam- side surface face of the tube and brown oxide scale formed on the fire-side surface. Analyses by X-ray diffraction ( Fig. 6 ) identified that the oxide scales deposited on the steam side surface is composed of iron oxide (  $\text{Fe}_3\text{O}_4$  ) while the scales on fire-side surface contains haemetite and wustite. The major constituent in the black deposits was mixed with complex structure of thenardite ( $\text{Na}_2\text{SO}_4$ , Glauberite {  $\text{Na}_2\text{Ca}(\text{SO}_4)_3$  and Gypsum (  $\text{CaSO}_4 \cdot 2\text{H}_2\text{O}$  ) .

**Fig. 6** X-ray diffraction of surface deposits.

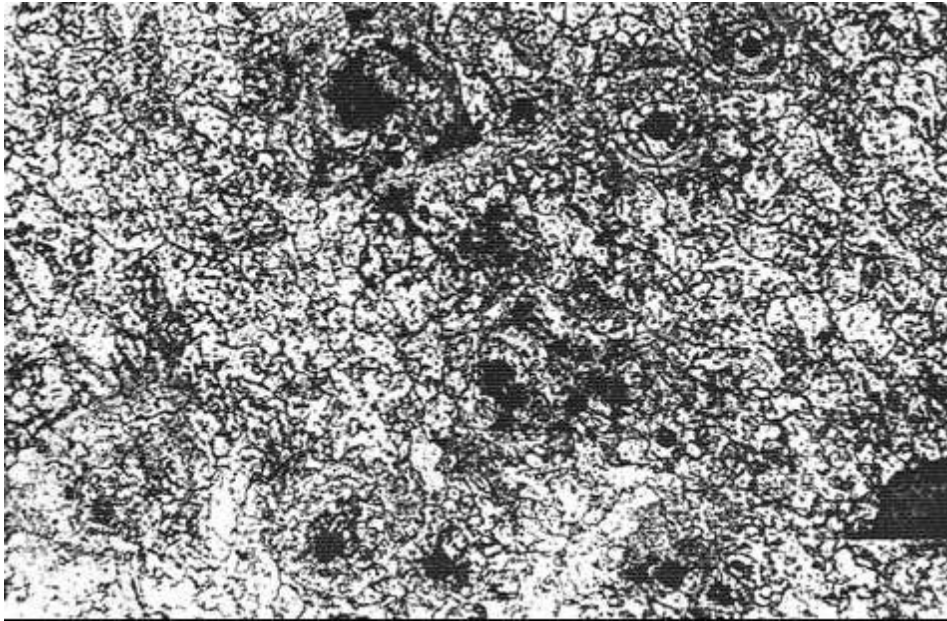
Polished & nital – etched specimens of the metal in the both rupture and unruptured tubes were examined metallographically . The microstructure near the failure edge consisted of a considerable amount of martensite or bainite in a ferrite matrix as shown in Fig.8. There were no indications of a cold worked structure in this area but there were good appearances of localized corrosion . Hardness of the metal in this area was 187-197 Hv.. The microstructure and the presence of corrosion indicated that a temperature had been reached in some areas to localized overheating (above the transformation temperature of  $727\text{ }^{\circ}\text{C}$  ). When carbon steels were exposed to temperatures above  $482\text{ }^{\circ}\text{C}$  but less than the lower critical temperature  $723\text{ }^{\circ}\text{C}$  this steel is subjected to spheroidization. The carbides present in the steel in annealed condition are not in their lower energy state and exposure to higher temperature results in the coalescence of these carbides into spheroidal form.

**Fig.8** The microstructure of the metal near the rupture edge.

Microscopic studies of cross- section of failure zone of boiler tube show quenched microstructure with small amount of carbides present at the grainboundaries. Other microstructure of failure zone of tube shows coalescence of the carbides into a spheroidal form and elongation of the grains at the end of the knife edge failure opening. wWhen comparing the two microstructures of failed area with unfailed area of tube , the former appears as quenched overheated microstructures. This shows that the exposure temperatures of the above failed areas have exceeded the lower critical temperature and were exposed to this temperature for quite long time.

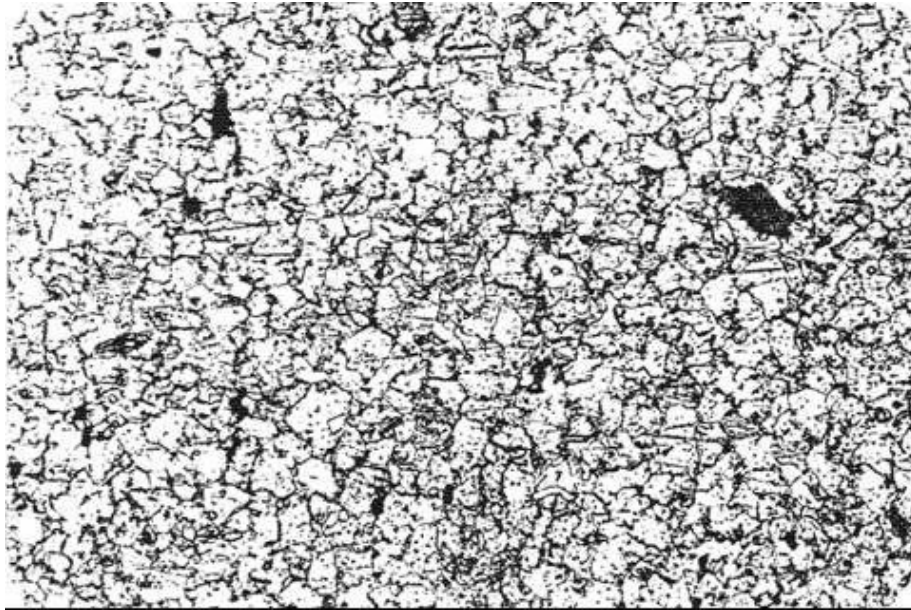
Examination of the microstructure opposite the rupture revealed a lesser amount of lower transformation products an indication that, the max. temperature was lower in this area of the tube than the rupture area , but still was higher than  $727^{\circ}\text{C}$  . The microstructure of the metal about (25-40) mm from the rupture edge revealed some , randomly located areas of acicular cementite in a ferrite matrix and some of corrosion areas (Fig.9). Hardness of the metal in this area was 165-170 Hv.

**Fig.9** The microstructure of the metal a bout 25 mm from the rupture edge.

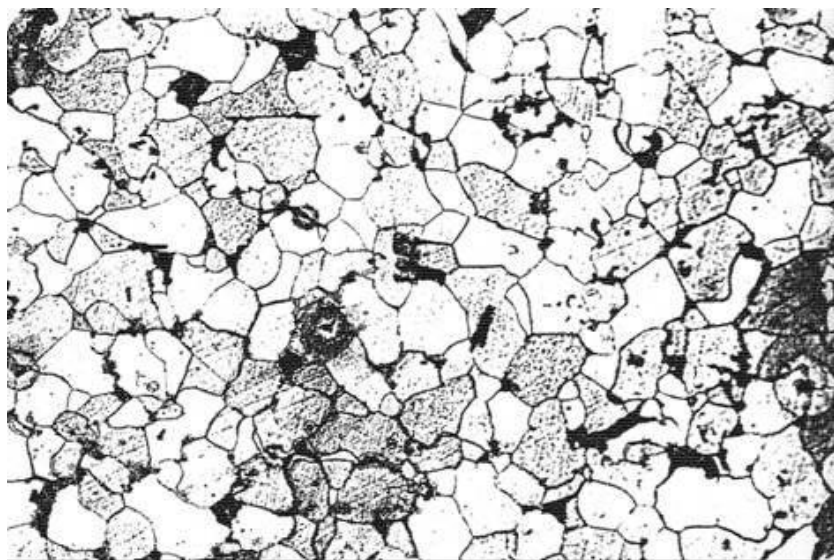
The microstructure of the metal about (40-60) mm from the rupture edge revealed the same microstructure of one of the unruptured tubes ( Fig.10) which revealed a considerable amount of cementite in a ferrite- pearlite matrix. Hardness of the metal in this area was 160-165 Hv. But the other unruptured tube had a structure of spheroidized carbide in a ferrite matrix with 160 hardness of Vickers.

**Fig. 10** The microstructure of the metal of unruptured tube.

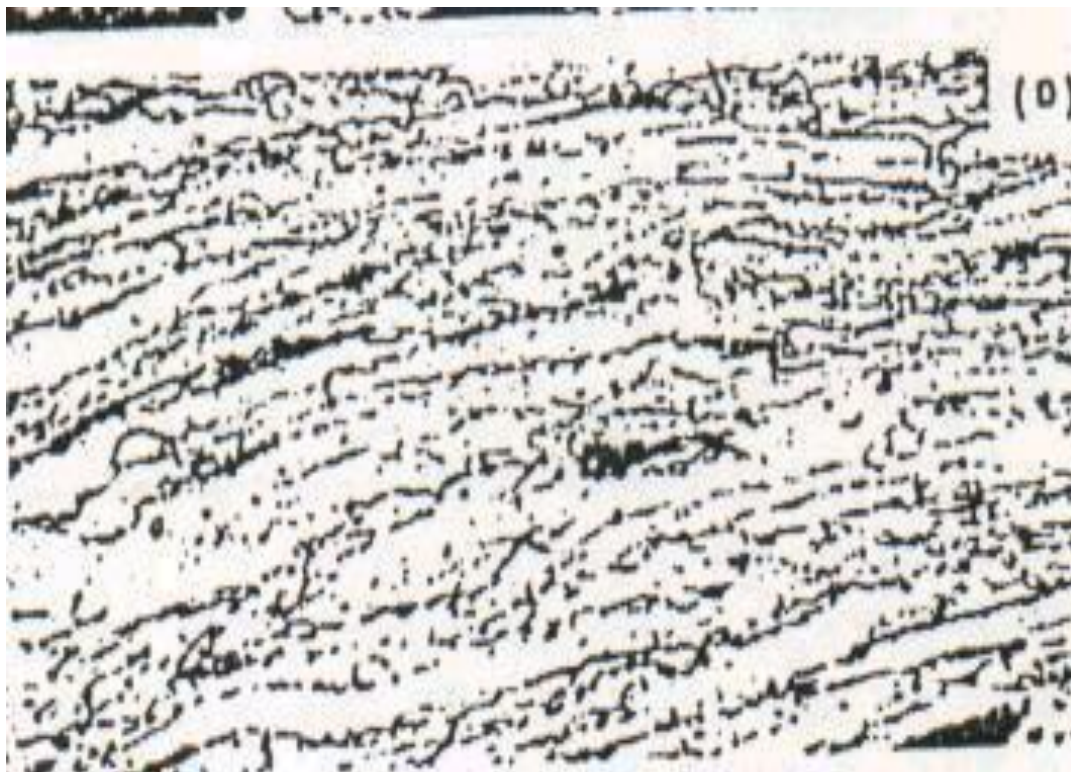
Rapid overheating of boiler tubes usually results in failure because of a decrease in yield strength . If rupture occurs at a temperature below the crystallization temperature ,microstructure will exhibit severely elongated grains (as shown in Fig.11).

**Fig.11** Elongated structure near tensile rupture resulting from rapid overheating below the crystallization temperature.
