دراسة لأنواع الفشل في الطابوق الحراري المبطن لأفران الاسمنت

Fig. 1 : The cement kiln zones and temperature distribution (Operational Parameters:(Kufa Cement Factory) , Wet Production Method , Six Stages ,Radius (5.25-5.75)m , Length (175)m, (1.5-2.25) rpm.).[Kufa Cement Plant/Kilns Department)

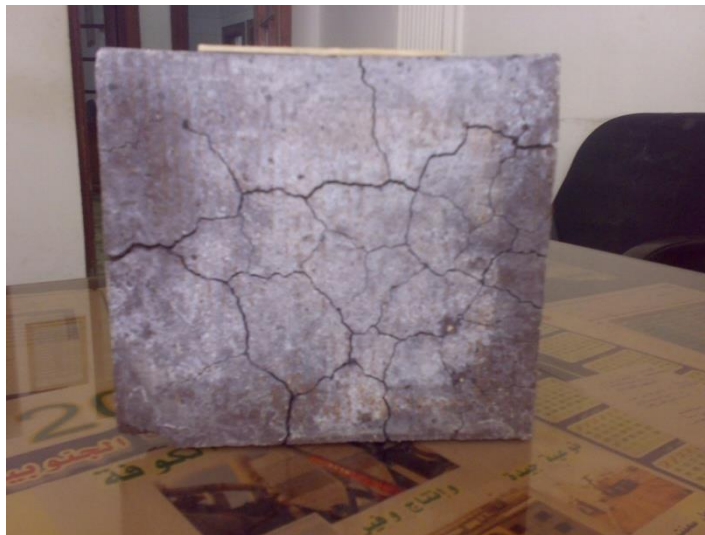
The X-Ray diffraction results for magnesia bricks (MTC1) which were not used but damaged during storage showed a formation of Brucite phase ($\text{Mg}(\text{OH})_2$). This means that MgO reacted with water found in air or direct water during storage period according to the following hydration equation:

This reaction accompanied with a volume expansion leading to the spider cracks (Fig.4). To avoid hydration problem in Magnesite bricks, a dry storage or using double plastic cover may be useful, the recommended time of storage must not exceeds 4 months.

Fig 4: Spider cracks due to bad storage

- 1- Failure of Magnesia brick (**Failure during storage case Fig .4**) is occur due to presence of water which leads to formation of Brucite phase. This type of failure was accompanied with spider cracks.

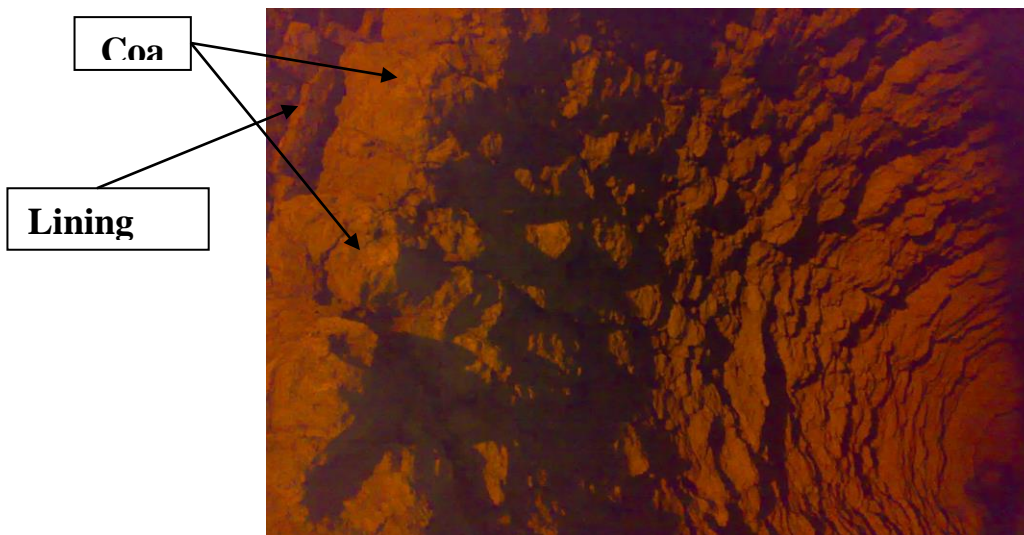
**Fig. 5: Coating formation on Magnesite bricks**

Coating is formed due to the high thermal conductivity of magnesite brick and its location in the burning zone. The clinker mass adhered on the Magnesite brick as clinker transforms from a liquid

- 3- It was shown that cement clinker infiltrated into the hot faces of magnesia bricks (**Coelex 80R and MTC1**) resulting in a formation of a coat layer which protect the brick from spalling. When the kiln operate under equilibrium conditions, the coating maintain itself , but with increased temperature coating will start to come off causing brick corrosion. Corrosion is the main type of failure of magnesia bricks lining cement kilns.

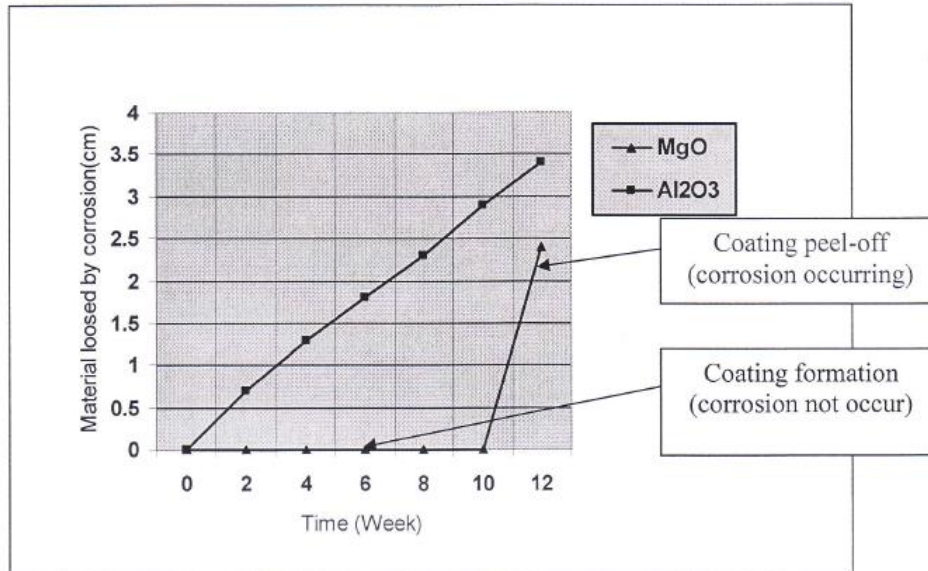
to a solid state in this zone. When the kiln operate under equilibrium conditions, the coating maintain itself , any change in operation temperature lead the coating to come off, when the kiln temperature is cooled the denser portion of bricks will peel off easily (Figure 6) causing brick corrosion.

Fig. 6: Material loosed from the hot face for Magnesite and Alumina bricks.

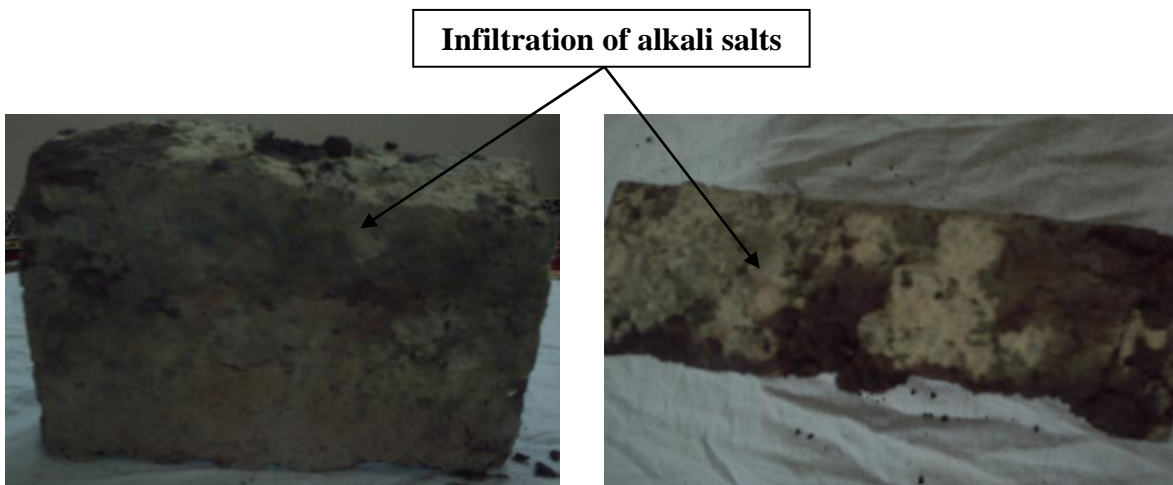
- 2- It is also shown that for both **Coelex 80-R** and **MTC1** there is a very small amount of alkalis (Na_2O , K_2O) infiltrated into bricks, this may be due to the basic properties of Magnesia brick that make it unaffected by alkalis.
- 3- It can be seen also that for both **Coelex 80-R** and **MTC1** there is a large amount of SO_3 infiltrated into the brick after using. Infiltration of SO_3 salts weakens the bond inside the brick material resulting in another type of failure and cracking as shown in Fig. 7. To improve kiln lining against infiltration of alkali salts a reduction in alkali content of raw materials seems to be useful.

Fig. 7: Infiltration of alkali salts

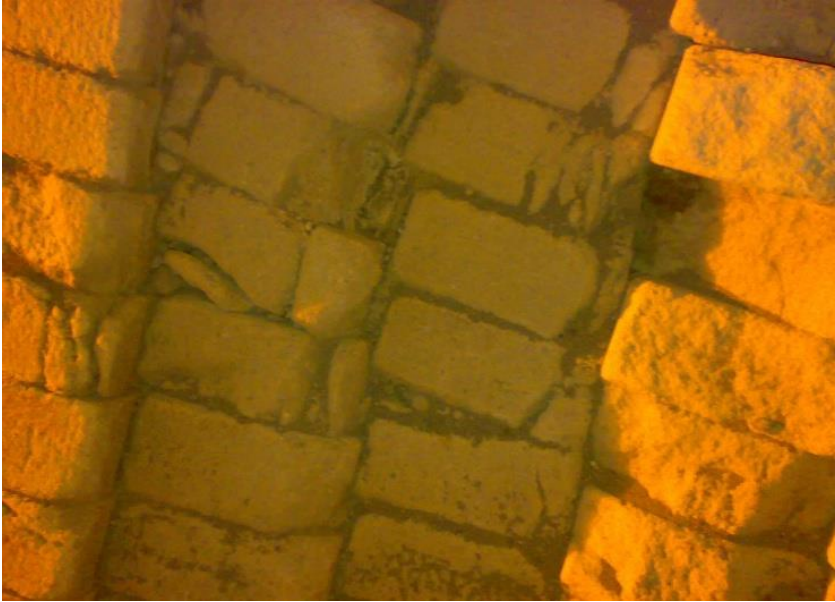
The spiraling problem (Fig. 9) occurred in **Hasle D39A** at Pre-heat zone is the result of loose installation, increased in kiln shell Ovality and the deformation in the kiln shell caused a relative movement between bricks, and in high axial stresses more than brick strength this will lead to cracks along the width of brick.

10- A spiraling failure **was noted in Hasle D39A** bricks at Pre-heat zone as a result of loose installation and kiln Ovality.

2- Improve the strength of the rings of bricks inside the kiln by good installation and using suitable mortar to bond bricks.

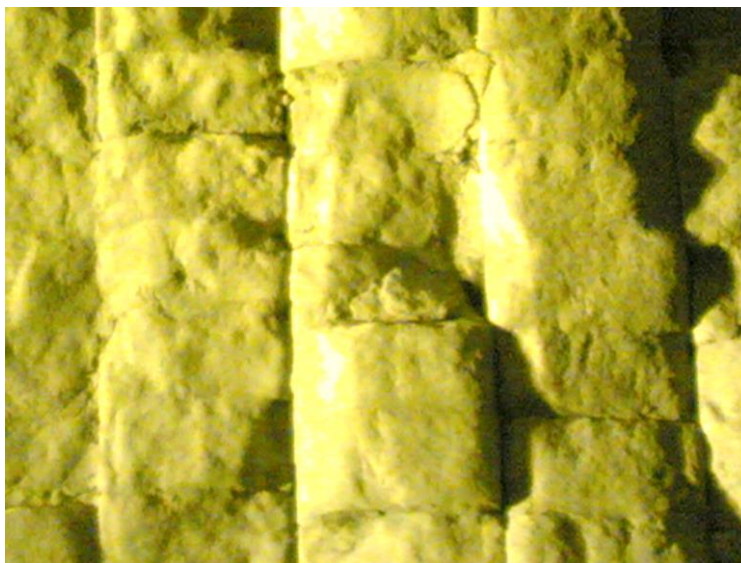
This Phenomenon occurs in Alumina brick type **Alumax 75 A** in upper transition zone. It occurs only in case of too fast heating up rate (overheating) which develops a compression forces near the brick hot face and when no time to expand, these pressure forces may exceed the strength of brick. As a final result the curved spalling with convex surface will appear (Fig10).

Fig. 10: Convex spalling of Alumina brick at upper transition zone.

11- Because of overheating a convex spalling failure was noted in Alumina brick type (**Alumax 75 A**) in upper transition zone.

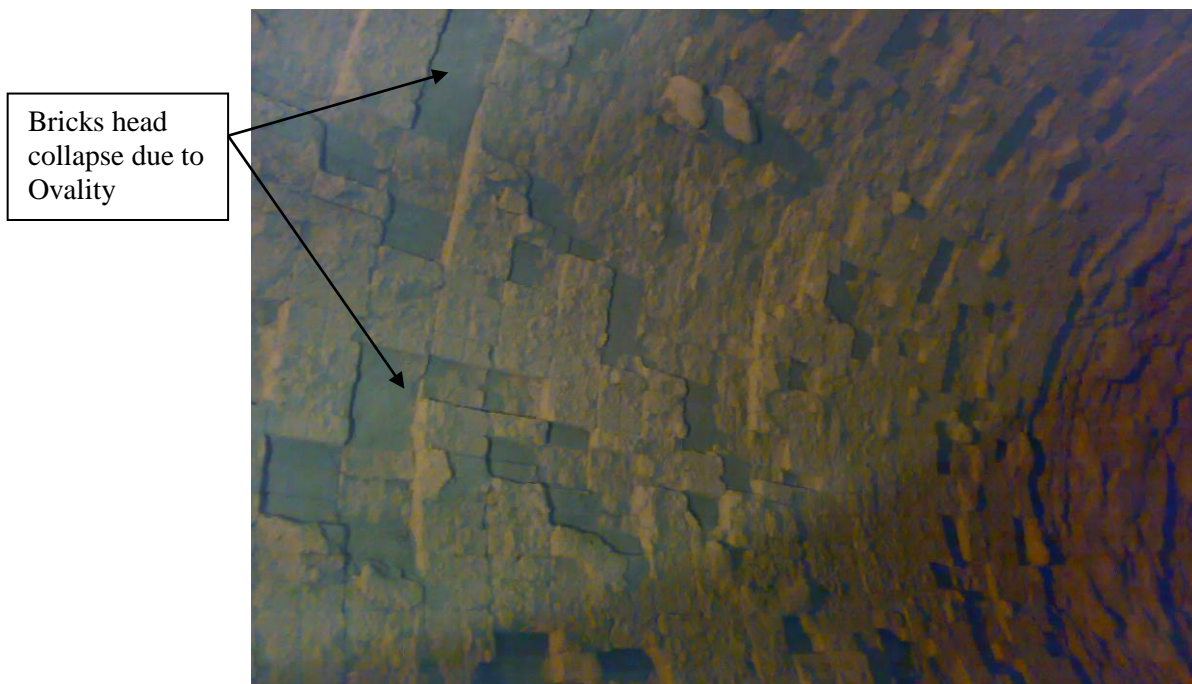
Ovality, as it applies to an operating kiln shell, is the change of curvature or flexing of the shell during the course of each revolution. This effect causes a shear stresses on the brick heads at the tire sections of the kiln (mechanical failure) as shown in Fig.11. However, Ovality is a complicated mechanical phenomenon in rotary kilns and so it may needs a special separate research.

Fig. 11: Brick failure due to Ovality

13- Mechanical failure due to Ovality was noted at the tire sections of the kiln. Ovality causes shear stresses at the brick heads.

3- It is recommended to investigate deeply the effect of Ovality of the kiln shell on the refractory brick life.
