Environmental Pollution in five floors (5th to 9th) Resulting From the use of Depleted Uranium Weaponry in the AL-Tahreer Tower Building

Nabeel hashim Ameen, Mazen Abbas Al-ghirrawy, Hamza Hadi Kadhim

Ministry of science and Technology

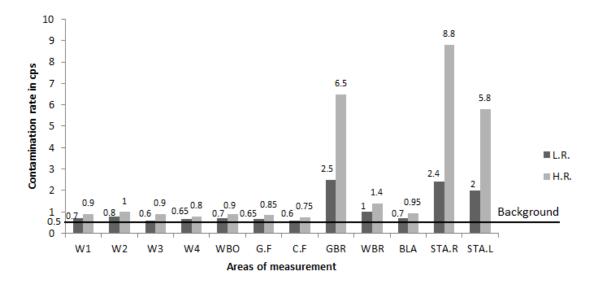
Figure (1) contamination rate in floor 5 before processes decontamination

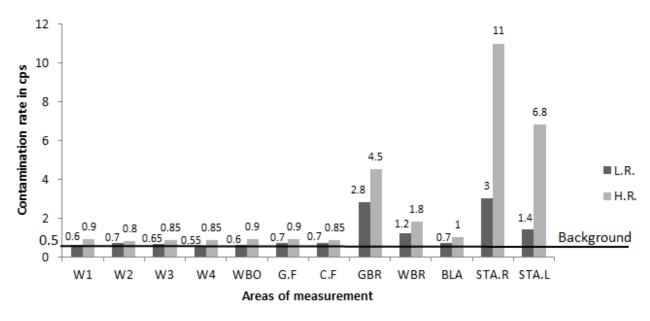
Figure (2) contamination rate in floor 6 before processes decontamination

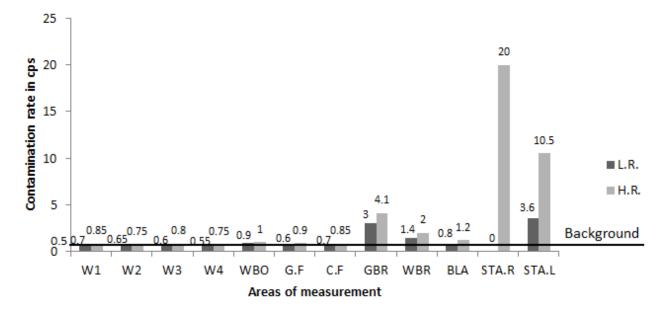
Figure (3) contamination rate in floor 7 before processes decontamination

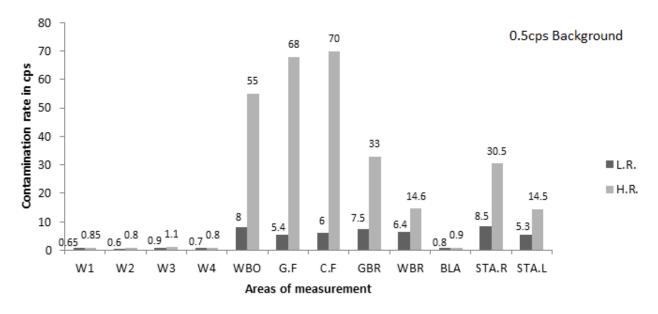
Figure (4) contamination rate in floor 8 before processes decontamination

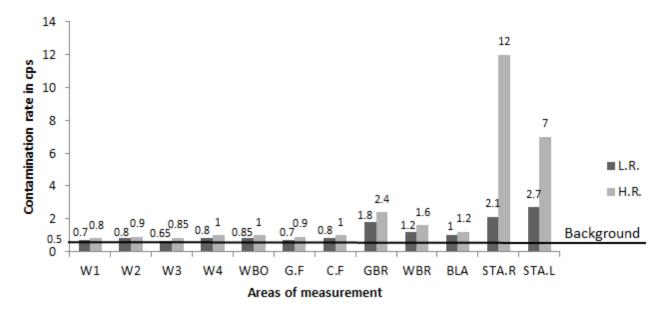
Figure (5) contamination rate in floor 9 before processes decontamination

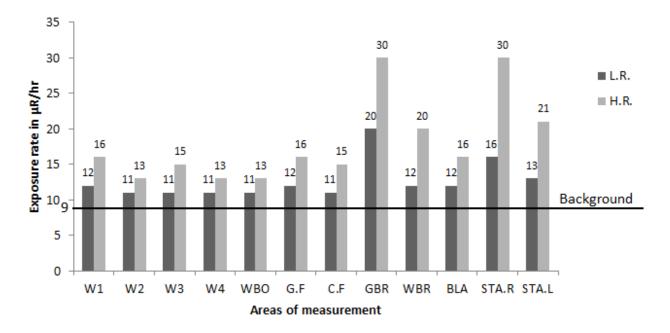
Exposure rate measurements were performed before the decontamination processes. Figures (6, 7, 8, 9 and 10) show that.

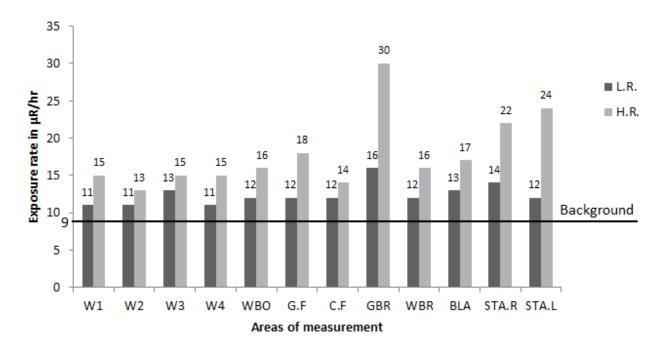
Figure (7) Exposure rate in floor 6 before the decontamination processes

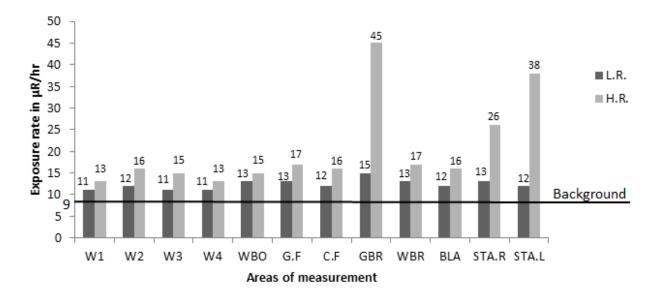
Figure (8) Exposure rate in floor 7 before the decontamination processes

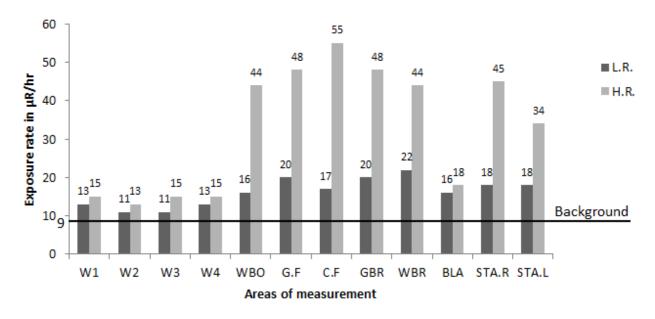
Figure (9) Exposure rate in floor 8 before the decontamination processes

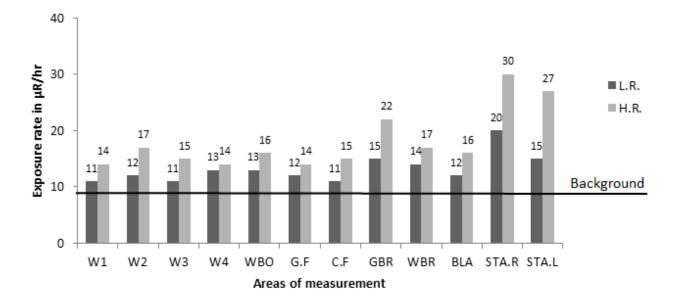
Figure (10) Exposure rate in floor 9 before the decontamination processes

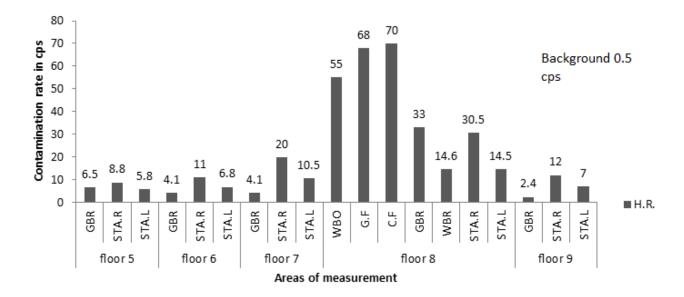
Figures (11, 12) show the results of radiological survey in all floors which indicates the higher doses and contamination rates in eighth floor because the floor exposed to direct hits by depleted uranium bullets. The above figures indicate there were no significant levels of radioactivity detected in walls, and the spread of contamination in the bathrooms because the eighth floor was exposed to direct hit by depleted uranium bullets in the wall of bathroom from right side and that made a hole and contaminated large areas in floor in addition to contamination in internal walls of bathroom,

Figure (11) high value for contamination rate in all floors

The figures indicate the large spread of contamination in the bathrooms and stairs because some materials have been transported from the building to other areas without taking any environmental consideration, in addition to the building subject to movement of the winds. Therefore, the work has been focused on decontamination processes and lifted the contaminated soil which is considered more than two times higher than the natural levels when were using the portable radiation detection equipments, and sometimes were used mechanical decontamination techniques involved the removal of some thickness of the material of construction of walls, and the pipes waters especially in the eighth floor. The contaminated soil and waste collected in a special barrels intended for this purpose.

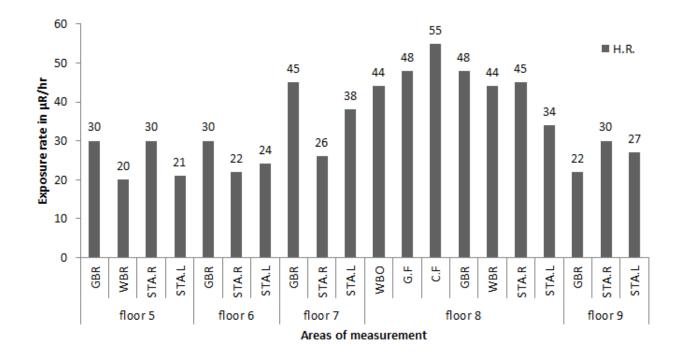
Figure (12) high value for exposure rate in all floors

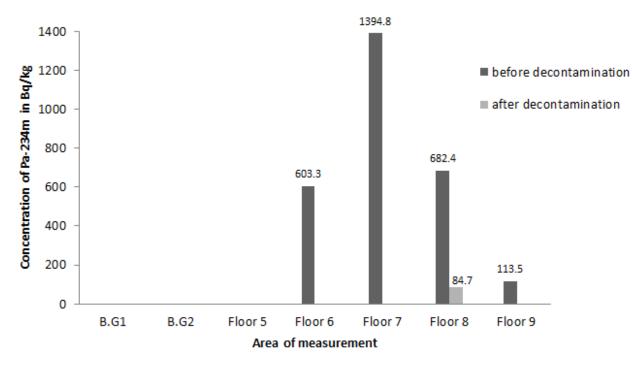
After the decontamination processes, soil samples were taken according to IAEA. The laboratory results indicated the presence of high concentrations of Th-234, and Pa-234m (an indicated nuclides for the presence of Uranium) of the soil samples in the floors (7th,8th and 9th) therefore we repeated the decontamination processes by putting detector (CAB) on distance 0.5 cm and with speed less than 10cm/sec on the soils in the floors [6] .Than the contaminated soil Collected in a special barrels intended for this purpose .Soil samples were taken and the results are shown in figures (13,14).

Figure (13) concentration of Pa-234m in soil sample before and after decontamination processes

This laboratory results can be consider normal and slightly higher in comparison with natural background level, and these concentrations of the radioactive isotopes can be considered within the regulations limits of the environment.

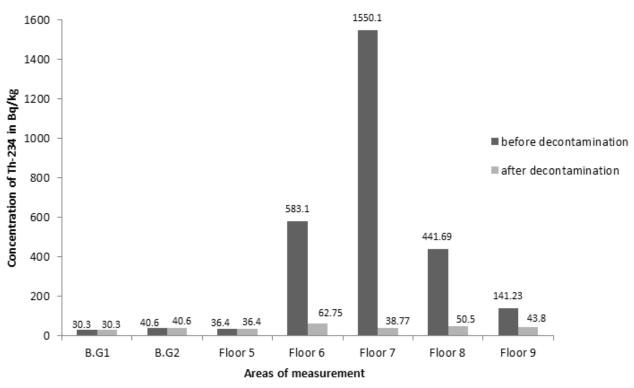
Figure (14) concentration of Th-234 in soil sample before and after decontamination processes
