## Corrosion Behavior of Bottom Plates of A potable Water Storage Tank

Dr. Mohammed Hliyil Hafiz\*

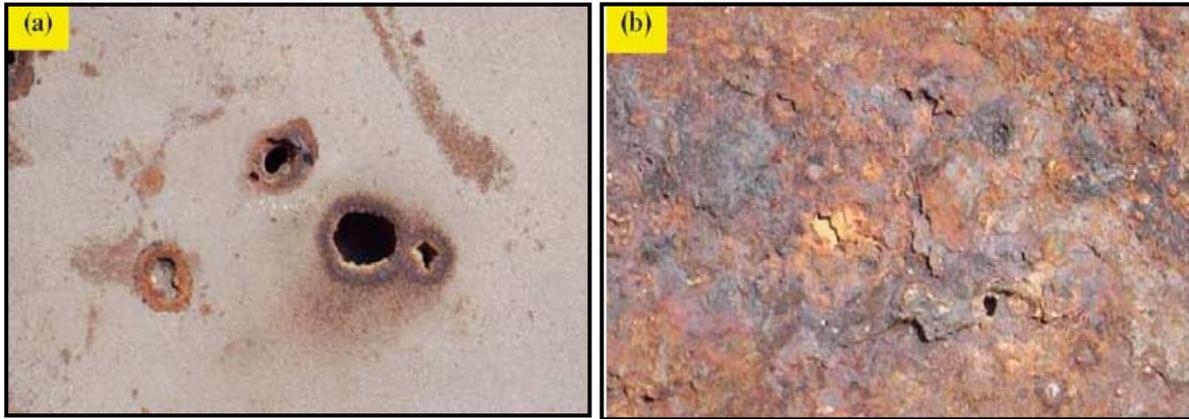
The samples of the bottom plate obtained from two different locations are shown in the as-received condition in Figures. 1 and 2. A visual examination of the topside of the plate, cut from a location near the annular plate, showed holes and deep pits of varying depth (Fig. 1a). The underside of the plate was found to be heavily corroded (Fig. 1b). Figure 2 shows the bottom plate sample cut from a location far away from the annular plate. Initiation and propagation of pits from

A detailed inspection of the bottom plate revealed that pits and holes were confined within a 1 m area of the junction of the annular and bottom plate and mainly concentrated over and/or near the weld junction of two sections of bottom plates. A gap between backfill and the bottom plates was also visualized around the same area along the periphery of the tank.

The observed holes and heavy wall loss along the tank periphery are due to underside corrosion as a result of water ingress under the tank bottom. The type of construction favored the ingress of rainwater or cleaning water through the gaps under the tank bottom and ring wall. The water accumulated near the periphery inside the ring wall, and with time the backfill settled down creating voids between the tank bottom and the backfill. Once the accumulated water settled down, the underside of the bottom plate in this area remained wet and started corroding due to local corrosion cell formation [11].

The heat-affected zone (HAZ) near the weld area provided the ideal site for the initiation of corrosion [12 ] . The CP system in this area remained ineffective due to the non-availability of the electrolyte. Further, some of the pits initiating and propagating from the water side along the periphery resulted in through holes due to considerable loss of wall thickness in the corresponding areas as a result of underside corrosion. The holes in the bottom plate led the high conductivity water to come in contact with the underside of the plate, thus causing heavy damage over a period of time.

**Fig. 1 (a) Topside of the bottom plate sample, cut from a location near the annular plate, in the as-received condition showing pit and holes. 1X. (b) Underside of the same bottom plate sample in the as-received condition showing heavy corrosion. 1X.**

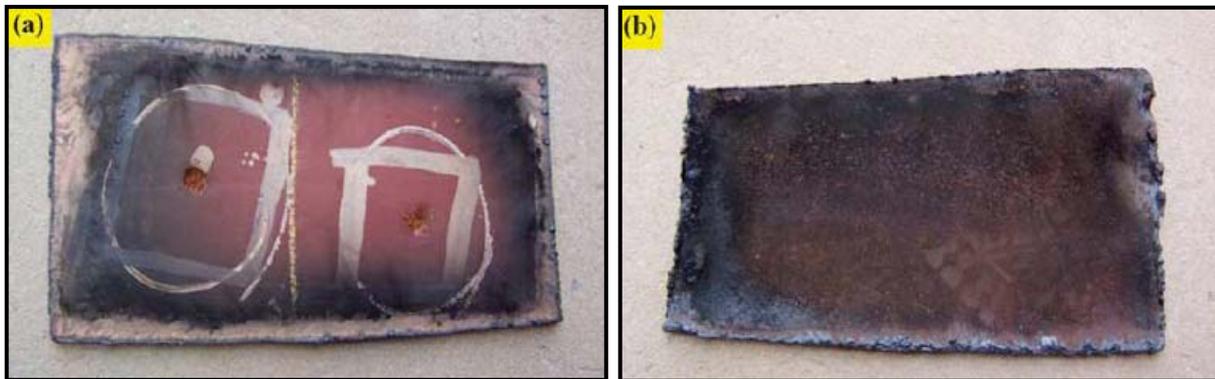
water side can be seen. However, the underside of the bottom plate sample does not show any corrosion.

Considering the corrosion on the topside of the plates, it was determined that the holes and deep pits were caused due to the failure of epoxy coating applied over the topside of the bottom plates of the water tank. In the absence of a detailed examination of the failed coating and analysis of the cathodic deposits in the pits and blisters, it is difficult to ascertain the actual cause of the coating failure at this stage of the investigation. However, the probable causes of the coating failure can be predicted.

This caused the formation of pits. The coating surrounding the anode and the activating property of corrosion products within the pits accounted for the tendency of corrosion to penetrate the metal rather than spread along the surface; this finally led to the formation of pits of varying depths. Some of the pits near the periphery resulted in through holes as a result of considerable wall thickness loss due to severe underside corrosion.

**Fig. 2 (a) Topside of the bottom plate sample, cut from a location far away from annular plate, in as-received condition showing only pits 0.35X. (b) Underside of the same bottom plate sample in the as received condition showing no corrosion 0.35X.**
