## SLOPE STABILITY ASSESSMENT WITHIN AND AROUND THE RESERVOIR OF THE PROPOSED BASARA DAM, SULAIMANIYAH, NE IRAQ

Ghafor A. Hamasur<sup>1</sup>

Received: 08/ 12/ 2011, Accepted: 28/ 04/ 2013

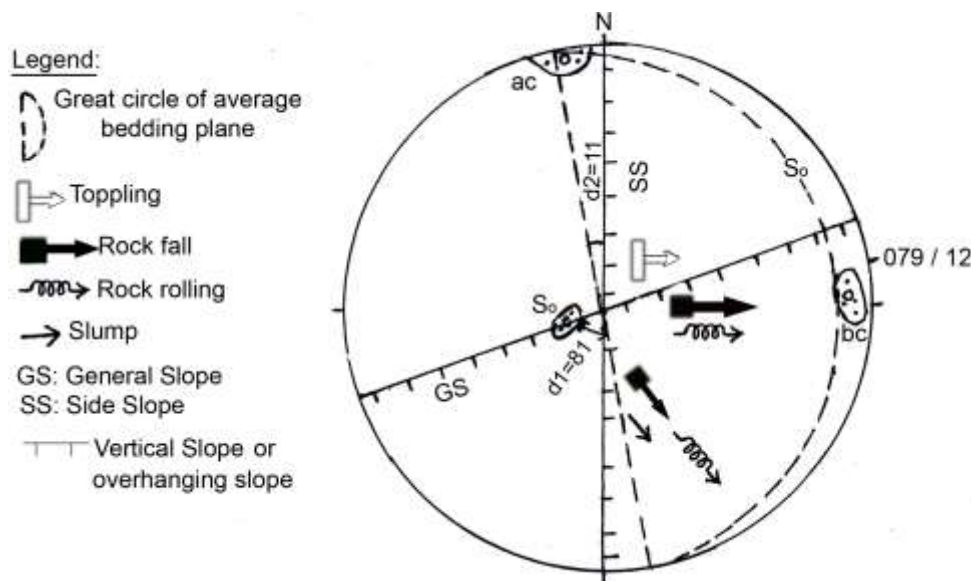
Fig.3: Stereographic projection shows the relationship between the slope, discontinuities and type of failure, in the Station No. 1

The side slope ( $090^{\circ}/90^{\circ}$ ) is unstable, wherein rock fall and toppling have occurred. Because the bedding planes below the upper part of the vertical slope are well cemented (having high cohesion), therefore, the effective spacing, which depends on the length of discontinuities and the size of the intact rock within a block that actually influences the height (h) or width (b) of the block of the bedding plane. Accordingly, leads to form high blocks up to 20 m in height and (2 – 3) m in width (Fig.4). The blocks are resting at an angle of  $12^{\circ}$  on the basal plane (bedding plane here), the ratio of  $b/h = 2.5 \text{ m} / 20 \text{ m} < \tan 12^{\circ}$  ( $0.125 < 0.212$ ). This leads to the weight vector of rock blocks to fall outside their base (Fig.5), then they are liable for toppling; when the cohesion on all discontinuities becomes zero, even blocks of less than 20 m in height may be subjected to secondary toppling by mechanism of failure by horizontal stress in  $\sigma_3$  direction (perpendicular to free face) as mentioned by Evans (1981).

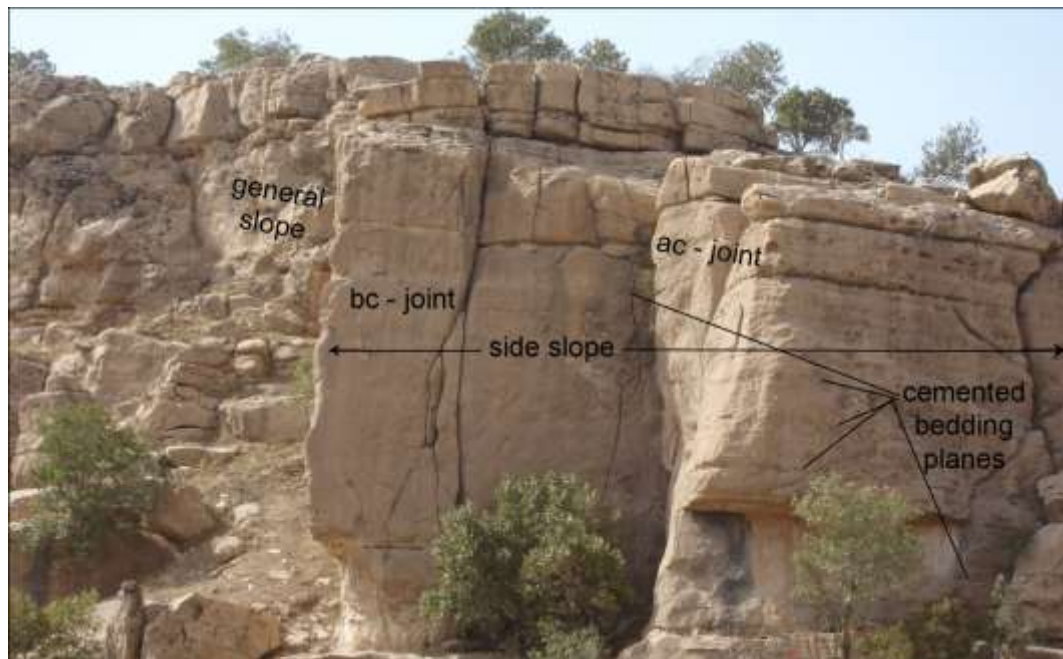
— **Station No. 1:** It is located at the right bank near the proposed dam (Fig.2), at elevation of 940 m (a.s.l.), and at a height of 210 m above the water level; when the reservoir is filled. There are two slopes in this station, the general slope inclination is  $160^{\circ}/90^{\circ}$  and that of the side slope is  $090^{\circ}/90^{\circ}$ . The bedding planes are dipping with an average value of  $079^{\circ}/12^{\circ}$ . Therefore, the general slope is orthogonal (divergence angle  $d1 = 81^{\circ}$ ), left emergent and discordant slope, while the side slope is a daylight, parallel ( $d2 = 11^{\circ}$ ), left emergent and concordant (Figs.3 and 4). The rocks of the the Station No. 1 are composed of dolomitic limestone of Pila Spi Formation. The bedding thickness ranges from (0.4 – > 2) m, they are dissected by two sets of joints, they are ac-joint set and bc-joint set (Figs.3 and 4), their spacing ranges from (0.5 – > 3) m, and their persistence is more than 20 m.

Fig.4: Unstable vertical slopes in the Station No. 1 within the Pila Spi Formation  
(The trees are about 4 – 6 m in height) (Photo direction is westwards)

The general slope ( $160^\circ/90^\circ$ ) is also unstable, wherein the rock falls and secondary toppling (due to mechanism of failure by undercutting of dolomitic limestone beds below basal plane) have occurred, also due to the steepness of the slope further blocks fall and topple and they may be roll on the slope, then some blocks may reach the Basara stream.

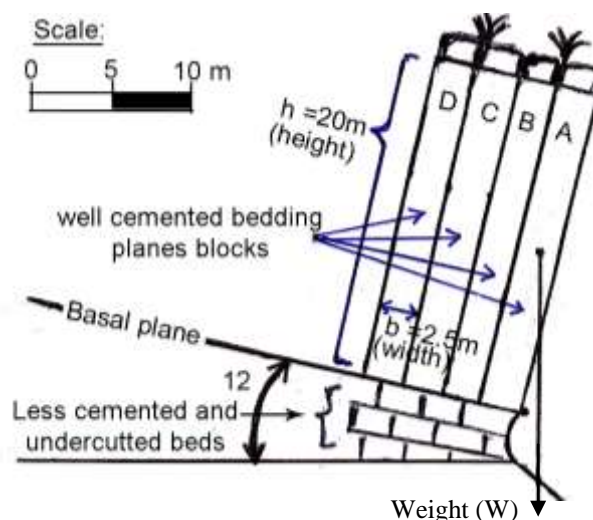
Fig.5: Geometry of rock blocks on inclined bedding plane (basal plane)  
at an angle  $12^{\circ}$  at the side slope in the Station No. 1

During toppling, the bedding planes act as basal plane, bc-joint acts as back release surface and the ac-joint acts as lateral release surface. Plane sliding does not occur because the friction angle of the bedding plane is greater than the bedding plane angle ( $12^\circ$ ).

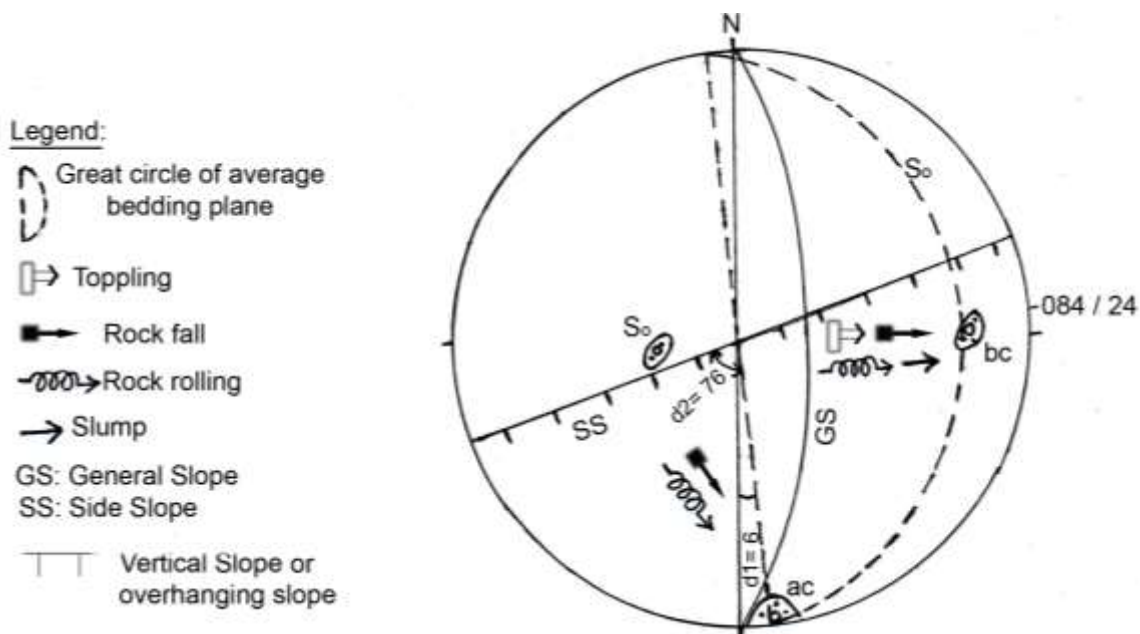
— **Station No.2:** It is located at a distance of 100 m to the east of the Station No. 1 (Fig.2), it has elevation of 895 m (a.s.l.), and a height of 165 m above the water level, when the reservoir is filled. There are two slopes in this station, inclination of the general slope is  $090^\circ/70^\circ$ , and of the side slope is  $160^\circ/90^\circ$ . The bedding planes are dipping with an average of  $084^\circ/24^\circ$ . Therefore, the general slope is parallel ( $d1 = 6^\circ$ ), left emergent and concordant, while the side slope is orthogonal ( $d2 = 76^\circ$ ), left emergent and discordant (Fig.6).

Fig.6: Stereographic projection shows the relation between the slopes, Discontinuities and type of failure in the Station No. 2

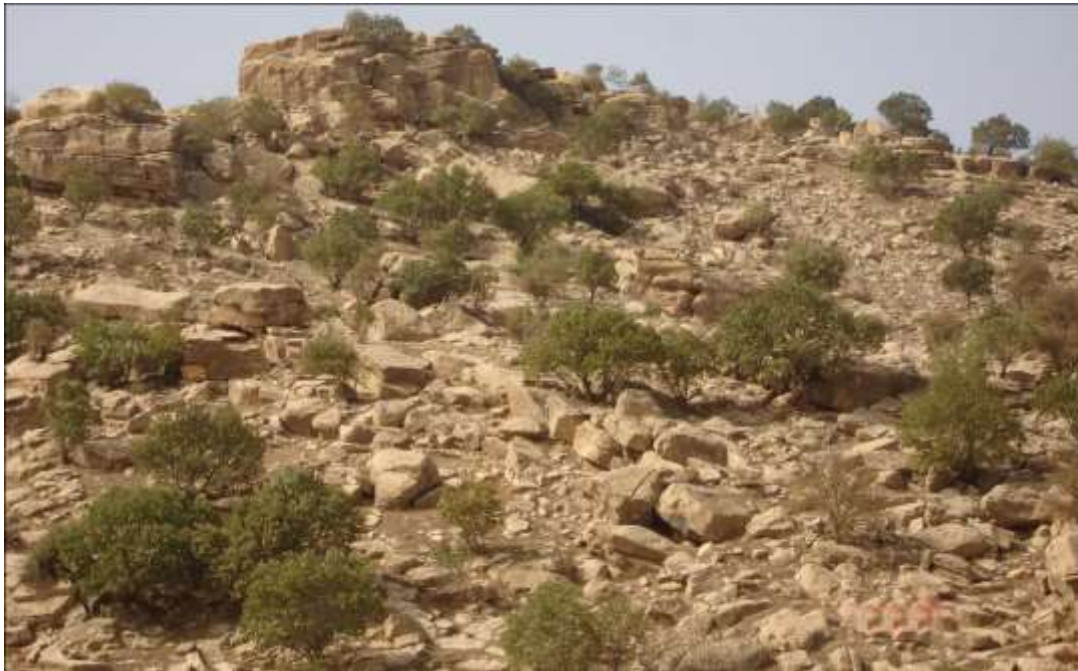
The two slopes in the Station No. 2 are unstable, many previous failures (toppling, rock fall, rock rolling and slumping) have occurred (Fig.7). The height of the upper steep part of the general slope ( $090^{\circ}/70^{\circ}$ ) is about 10 m, and the lower part is inclined at angle ranges from ( $35^{\circ} - 40^{\circ}$ ). The height of the upper part of the vertical side slope is more than 20 m (Fig.8). Some of the bedding planes are very tight (having high cohesion), this leads the effective spacing of the bedding to form blocks of about (5 – 7) m height and (0.5 – 2.5) m width (Fig.9), and they are resting on the basal plane (bedding plane) at an angle of  $24^{\circ}$  (Fig.10).

Fig.7: Fallen blocks on the general (main) slope at the Station No. 2 (the trees are about 2.5 – 4 m in height) (Photo direction is west wards)

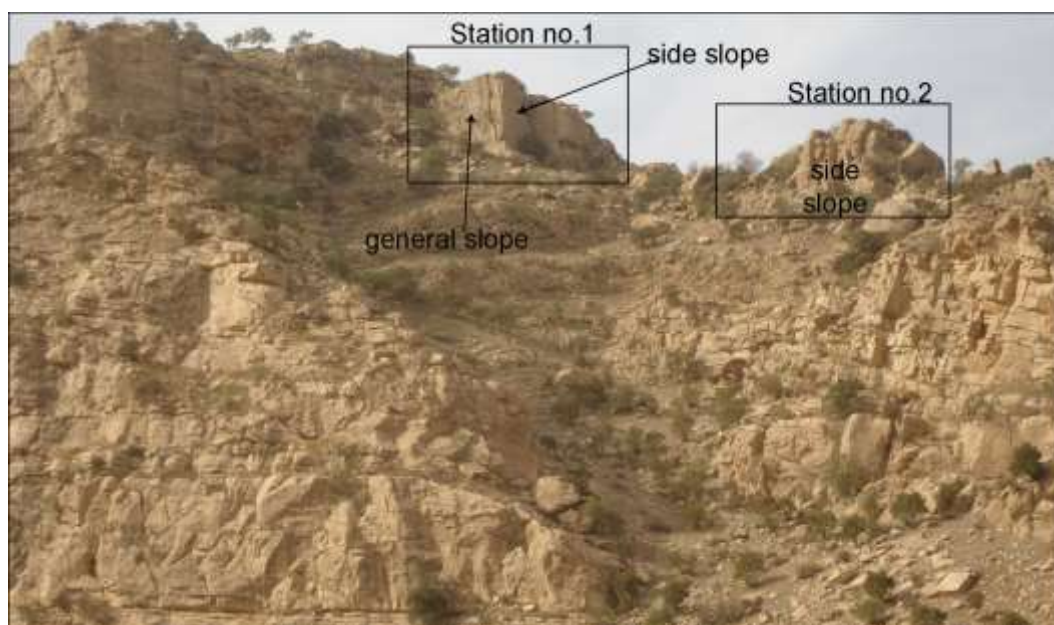
Fig.8: The side slope of the Station No. 2, also the Station No. 1 appears in this photo (Photo direction is  $340^{\circ}$ )

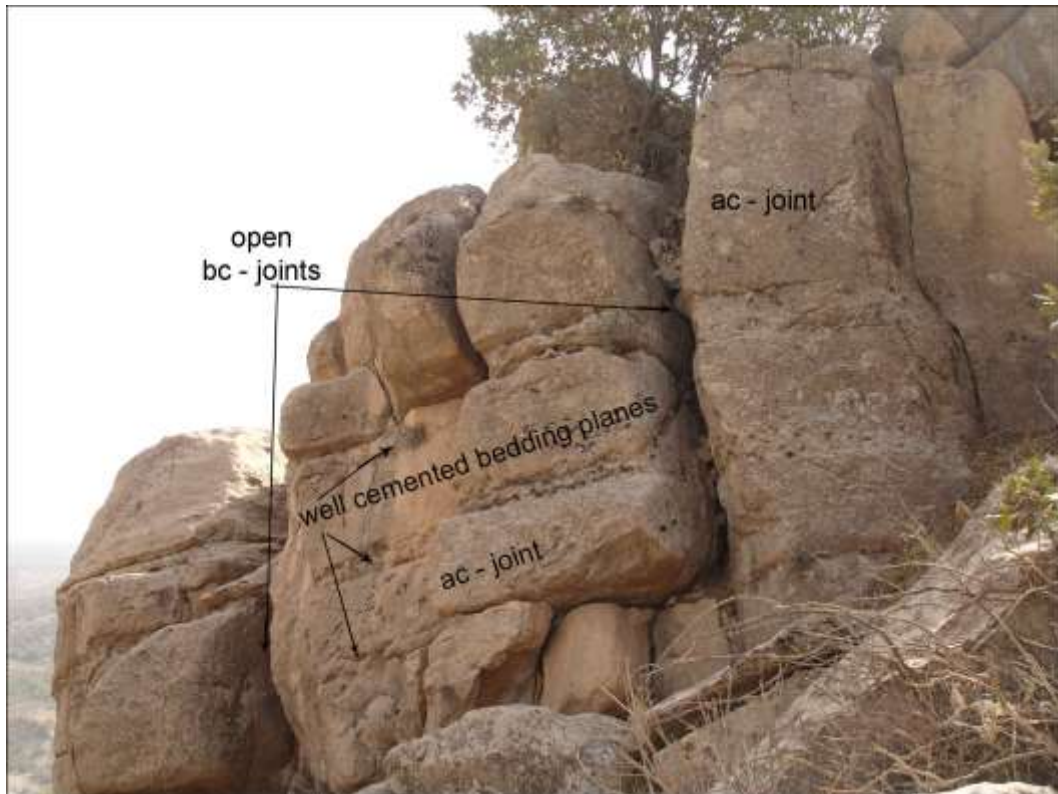
Fig.9: Very tight bedding planes, forming blocks of about (5 – 7) m in height in the Station No. 2 (the trees are about 3 – 4 m in height) (side view photo of the general slope in direction of 150°)

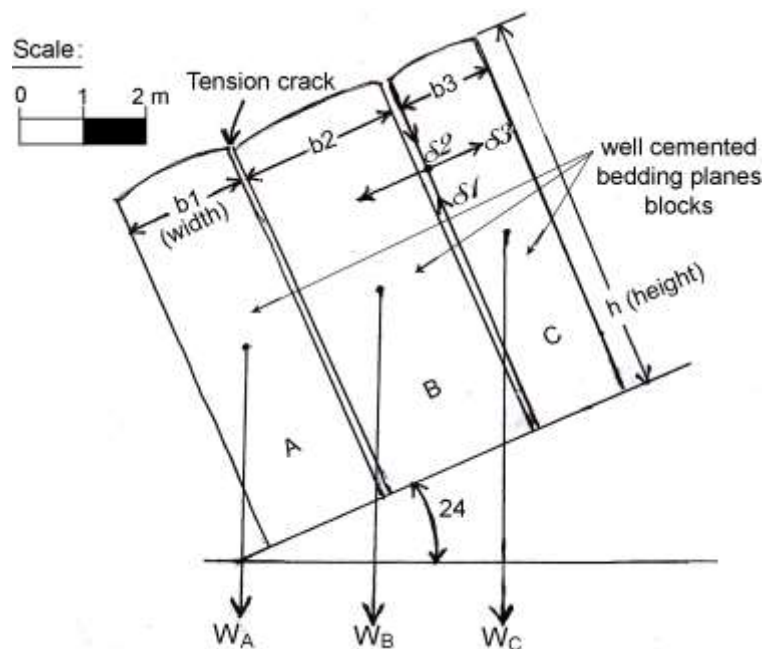
Fig.10: Geometry of rock blocks on inclined bedding plane (basal plane) at an angle 24° at the general slope in the Station No. 2

The weight vector of some rock blocks falls outside their base ( $b/h$  of rock blocks  $< \tan 24^\circ$ ) or at critical state (Fig.10), then toppling or secondary toppling (tension crack toppling and slumping) as mentioned by some authors (Goodman and Bray, 1976) may occur in the general slope. The mechanisms involved in such toppling failure are the toppling induced by tension crack water pressure, when filled with water, and failure by horizontal stress in  $\sigma_3$  direction (perpendicular to the free face) plays a great role (Figs.10 and 11). The joints in the  $\sigma_3$  direction are invariably (always) open, indicating a fully stress relieved environment in this direction (Evans, 1981). This case is seen for bc-joint set as in Figs. (11 and 12). These states could act with some other primary failure mechanism to initiate toppling. Furthermore, rock fall may occur in the upper part of the slope. After the rock blocks are toppled and the fallen blocks may roll on the lower part of the slope (Fig.7). Rock fall followed by rock rolling is the dominant mode of failure in the side slope due to the steepness of the slope, and toppling failure may occur, but in small number because the basal plane is not inclined in the direction of the side slope. However, plane sliding does not occur in the general slope, because the average bedding plane angle ( $24^\circ$ ) is less than the friction angle of hard dolomitic limestone, which is more than  $35^\circ$  (Hoek and bray, 1981).

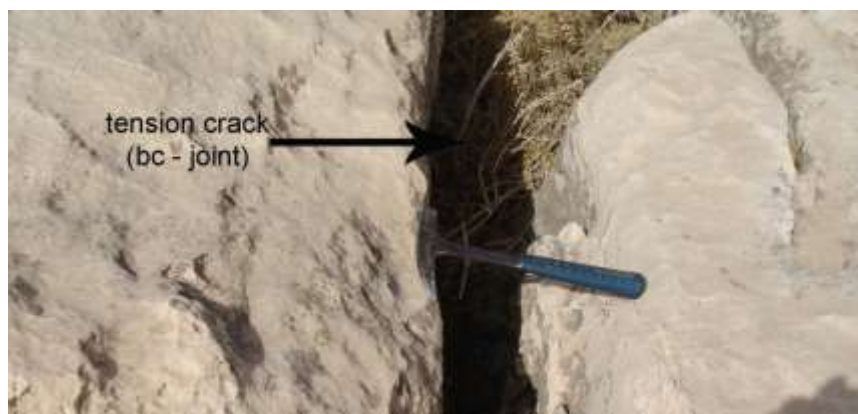
Fig.11: Tension crack represents bc-joint, is an indication of instability in the Station No. 2 (Photo was taken above the bedding plane)

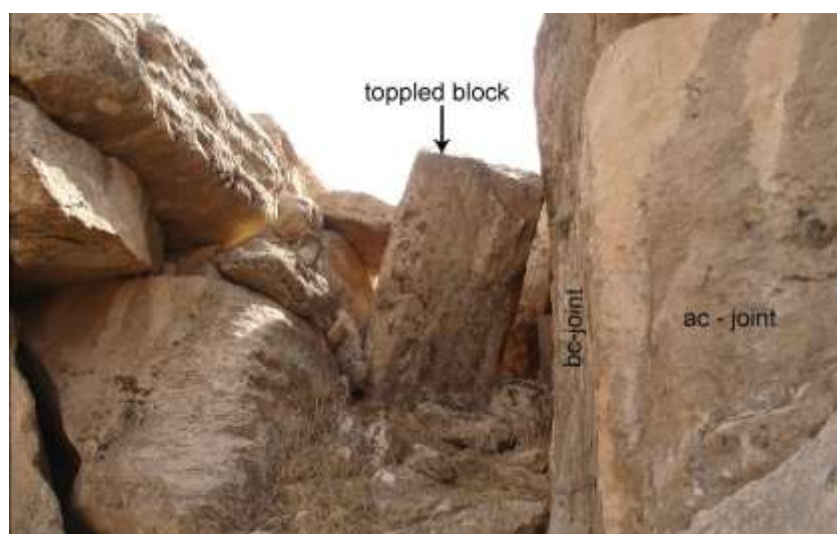
Fig.12: Large tension crack shows opening of bc-joint, ac-joint and toppled block in the Station No. 2 (Photo direction is  $170^\circ$ , parallel to the bc-joint)

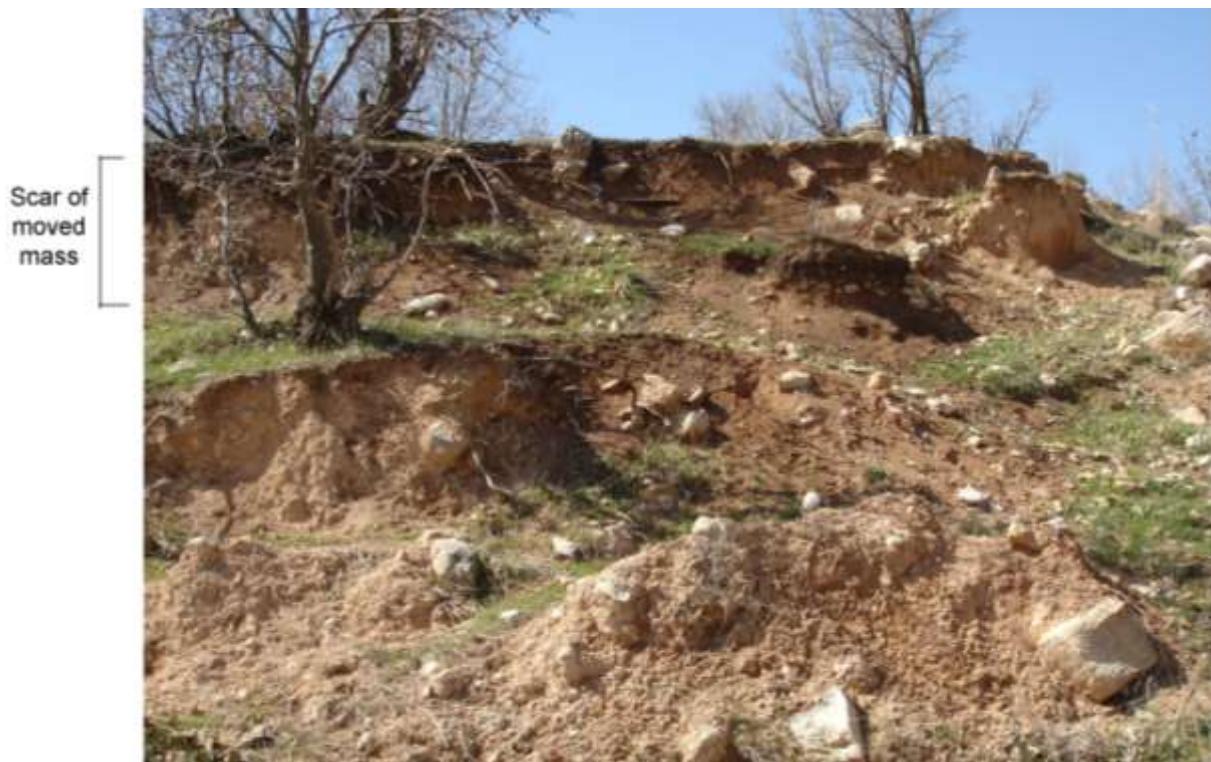
It is located nearby the left bank of Tele stream, to the east of Delaizha village, and at elevation of 715 m (a.s.l.) (Fig.2). The slope is at height of 20 m above Tele stream, and the inclination of the slope is  $045^{\circ}/(25 - 30)^{\circ}$ . The slope is covered by brown clayey soil with some cobbles and small blocks of limestone. The slope is unstable and was subjected to shallow creep that left a scar in the slope (Fig.13). Such failure, most probably had occurred after heavy rainfall, because normally water causes reduction in the soil friction angle and cohesion and then reduction in the soil shear strength. More creep may occur in the future if torrential rainfall occurs again.

After filling the reservoir of the proposed dam, the Station No. 14 will be inundated, then more creep or slide may occur, and large amount of slope materials will be carried by the water, this will give increase in the rate of sedimentation in the reservoir (siltation).

Fig.13: Soil slump shows the scar of moved mass in the Station No. 14  
(Photo direction is  $230^{\circ}$ )

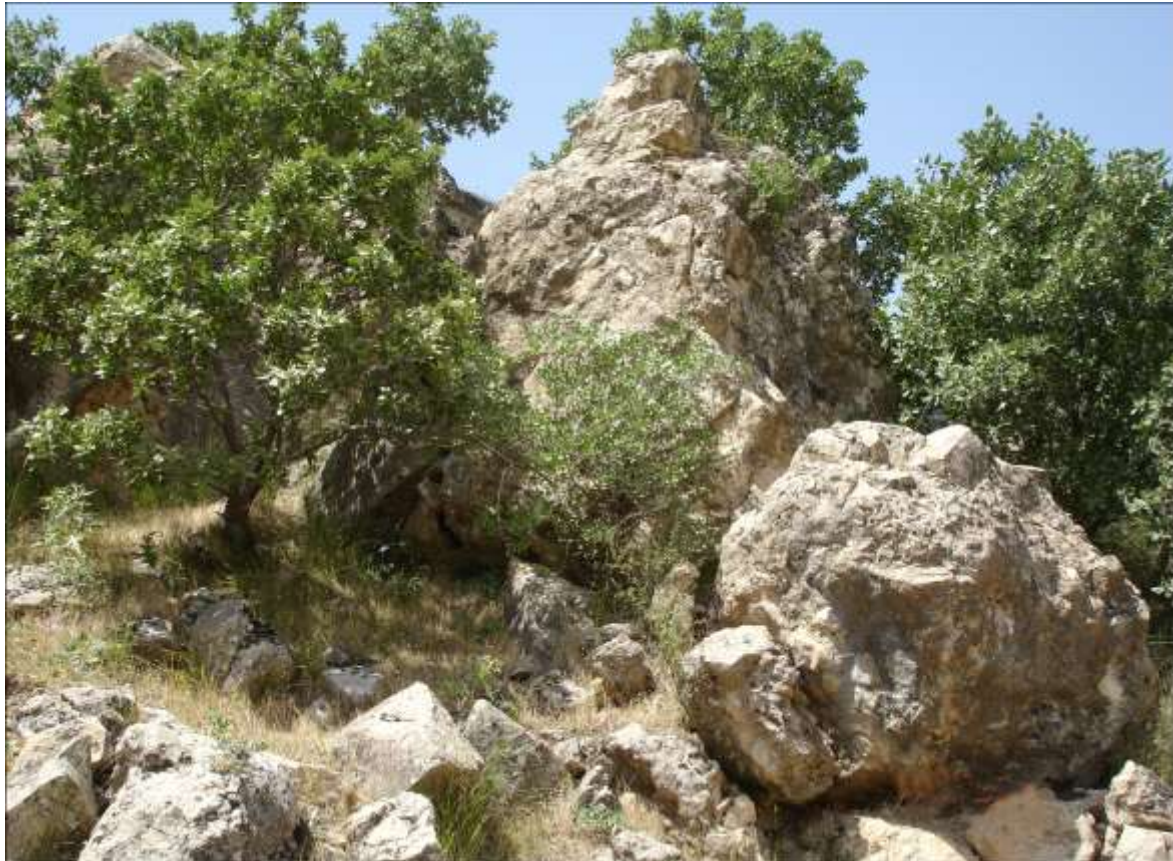
It is located near the converging of Tainal and Tele streams (near the inlet to Darband Basara), on the left bank of Basara stream, and at elevation of 690 m (a.s.l.) (Fig.2). The slope is covered by a mixture of large limestone blocks and clayey soil, silt and sand (Fig.14), fallen from the left cliff of the Pila Spi Formation, and mixed with the weathering products of the underlying Gercus Formation. The slope is unstable, because the toe of the slope has a direct contact with the valley floor and being continuously undercut by water currents during floods, thus the water currents wash out fine materials between the large blocks, and then rolling them to Basara stream valley. Further rolling may take place after filling of the reservoir.

Fig.14: Unstable large blocks of former failures from limestone cliff of the Pila Spi Formation at the Station No. 16 (Photo direction south wards)
