IRAQI BULLETIN OF GEOLOGY AND MINING (IBGM)\ IRAQ GEOLOGICAL SURVEY (GEOSURV-IRAQ)

Vol.18, No.2, 2022

AN APPLICATION OF THE RISK-CONSEQUENCE ROCKFALL HAZARD RATING SYSTEM FOR THE "MIRAWA" MAIN ROAD ROCK CUTS, KURDISTAN REGION, NORTH IRAQ

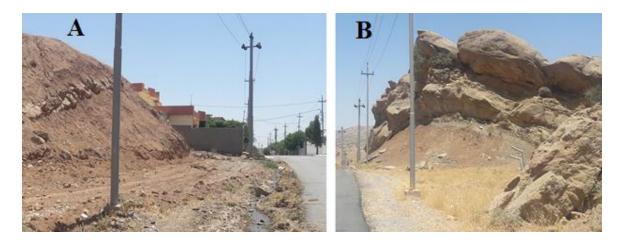
This site is a road cut through the right side of the road and consists of siltstone and claystone beds of the Injana Formation. The blocks of the relatively harder siltstone beds form the potential rockfall after the differential erosion of the underlying weaker claystone beds. The fallen rock blocks are about 0.5 m in size. The shoulder in this site is relatively wider (Fig.3A), which may reach 2.5 m, compared to the other sites, and not ditch. This rock cut has previously been subjected to rockfall and potential subsequent rockfalls.

Fig.3: Side and front views for the rock cuts in (S-6 A) and (S-10 B), respectively

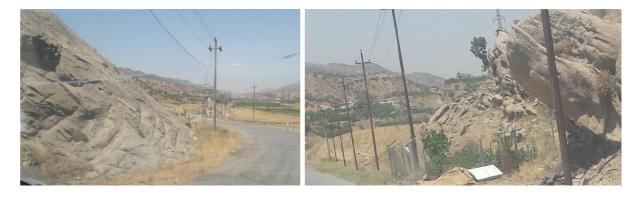
It is located on the left side of the main road and totally consists of a relatively hard sandstone bed of dip slope toward the road (Fig.4A). It has a limited sight distance due to the curved road and relatively high slope height. This site is vulnerable to later plain sliding with different block sizes.

Fig.4: Side views for the rock cuts for (S-11A) and (S-14B)

This site is on the right side of the road, it consists of a relatively thick and hard sandstone bed that overlies the softer claystone bed (1.5-2 m) thick). Although the sandstone bed dipped against the slope (rock cut), it forms an overhanging slope due to the deferential erosion of the underlying soft claystone and potentially failed by wedge sliding and/or toppling (Fig.4B).

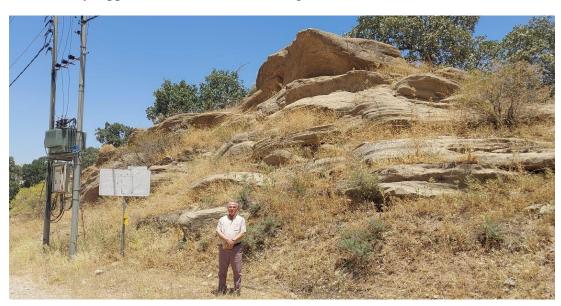
This road cut is located at the northeastern limb of the syncline and the left side of the road. It is totally consisting of hard and massive and thinly bedded sandstone succession. Although, the sandstone bedding dip against the road cut, some large masses potentially fall by toppling or wedge sliding along the discontinuity intersection lines (Shakir, 2006), which have unfavorably dipped towards the road cut (Fig.6).

Fig.6: Side view for the rock cut in (S-22)

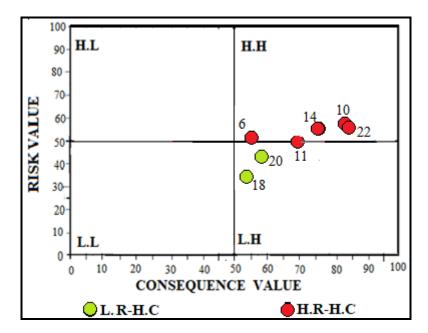
high risk-high consequence (H.R-H.C) rockfall ratings and tow rock cuts (S-18 and S-20) have a low risk-high consequence (L.R-H.C), but only one rock cut (S-11) is at the contact between the (H.R-H.C) and the (L.R-H.C), and for more safety, it considered within the (H.R-H.C) rockfall rating (Fig.7).

- According to the "risk consequence" diagram (Fig.7), the rock cuts (S-18 and S-20) have a low risk- high consequence (L.R H.C) rockfall rating due to the low rating of the; Expected rockfall quantities (ERFQ), relatively wide road Shoulder (SW) and adequate decision sight distance (D.S.D).
- (ERFQ) were rated as low (3), which means few areas on the rock cut face are loose and the expected volume of falling rocks will be 10 ft³/ft.
- The relatively wide road shoulder was rated as (2) because the shoulder width is about 10ft in length, in which the chance of fallen rocks reaching the road will be low.
- The adequate decision sight distance (0.0 rating), makes the driver able to recognize the hazard of falling rocks and maneuver his vehicle to safety.

Fig. 7: The results of the Risk – Consequence diagram for the rock cuts along Mirawa main road (After Maerz and Youssef, 2004)

On the other hand, the high risk- high consequence (H.R-H.C) rating is due to the following;

- 1- The high slope angle (SA) on the rock cuts (S-6, S-10, S-11, S-14, and S-22)
- 2- No ditch or nearly flat ditch made the ditch shape rating high on the rock cuts (S-6, S-10, S-11, S-14, and S-22) cannot contain all the fallen rocks.
- 3- Massive blocks have greater kinetic energy and travel further down the inclined slope and cause more damage to the road and vehicles.
- 4- The relatively narrow road shoulders on rock cuts (S-10, S-14, and S-22)
- 5- The limited decision sight distance (D.S.D) on the rock cuts (S-11 and S-22), does not allow the driver to avoid the fallen rocks, because there are some curves and obstacles on the road not giving the driver enough time to perceive that there are falling rocks on the road.

Note that, the risk-consequence rating of the rock cuts (S-6 and S-11) is located at the contact between the (H.R-H.C) and the (L.R-H.C), due to its relatively low-risk rating (51.8% and 50.3%, respectively).

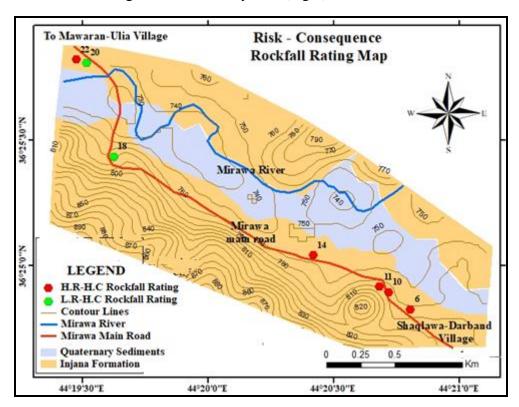
These results were used to develop the risk-consequence rockfall rating map for the "Mirawa" main road, using the GIS 10.8.1 system (Fig.8).

Fig.8: Risk-Consequence rockfall rating map for the studied rock cuts

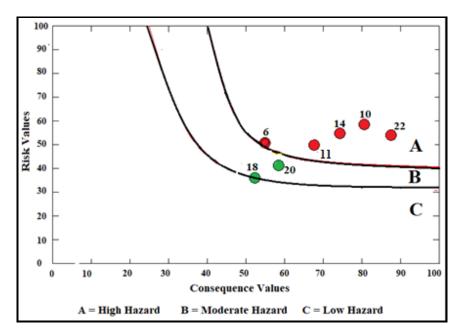
In order to produce the "Risk-Consequence" rockfall hazard map for the studied rock cuts, the total risk-consequence rating values were plotted on the rockfall Risk-Consequence Hazard Zones diagram (Maerz *et al.*, 2004), which shows that five-rock cuts (S-6, S-110, S-11, S-14, and S-22) are within the "High Hazard Zone" (Zone A), and two rock cuts (S-18 and S-20) are within the "Moderate Hazard Zone" (Zone B), as shown in Fig. (9). Note, that the rating of the rock cuts (S-18) is located at the contact line between the "Moderate Hazard" and "Low Hazard" zones, and considered within the "Moderate Hazard Zone" for the most safety.

The "High Hazards" of the rock cuts (S-6, S-10, S-11, S14, and S-22) are due to the high consequence ratings (54.2%, 82.5%, 66.7%, 74.2%, 53.3%, and 87.5%, respectively), although the relatively low total risk ratings (37.3% and 42.0%) for the rock cuts S-18 and S-20.

The "Moderate Hazards" of the rock cuts (S-18 and S-20) are due to; the low-risk ratings (less than 50%) and the relatively low values of the consequence ratings (53.3% and 56.3%, respectively), as shown in Tables (25A and 25B) and Fig. (9).

Fig.9: Risk – Consequence hazard diagram for the rock cuts along Mirawa main road (after Maerz and Youssef, 2004)

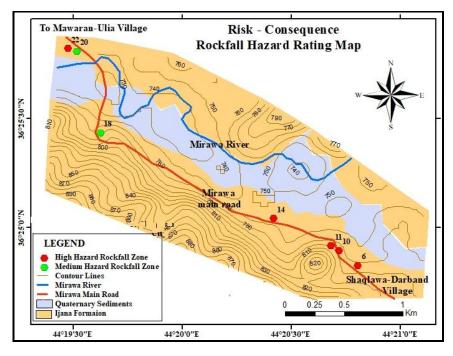
Accordingly, the aforementioned results, were used to develop the "Risk-Consequence" rockfall hazard map for the studied area (Fig.10). This map can be used to protect vehicles, road users, and any infrastructure that may be constructed close to those road cuts, which are vulnerable to such risks. It is also can be used to determine the need and priority of maintenance and remediations on the road cuts.

Fig.10: Risk -Consequence rockfall hazard map for Mirawa road cuts.

- Accordingly, the following works are recommended;
 - Installing traffic signs to limit the speed of cars passing along this road.
 - Installing traffic signs before and near the high and moderate hazardous rock cuts to indicate the potential rockfall taking place, in order to attention and avoid the rockfall.
