Research Article:

A comprehensive Analysis of Dewana Dam Spillway Failure: Causes, and Consequences

Avi Ari Salahadin^{1,a,*}

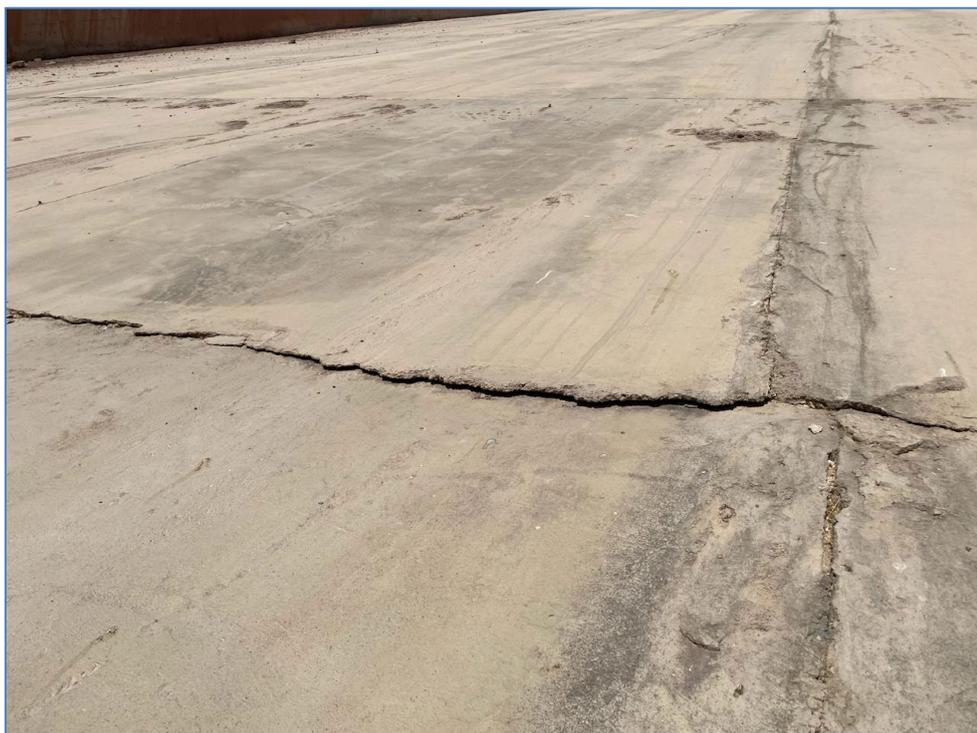
A key factor contributing to the initial distress observed on the chute floor was the presence of cracks, along with inadequate joint detailing and poor performance of waterstops. Evidence of cracking was observed shortly after the completion of construction, as shown in Figure 7, indicating potential issues related to early-age shrinkage, poor finishing, or insufficient curing. Figure 8 illustrates a substantial 10 cm vertical offset between adjacent panels, where no cushion was provided to control differential movement. Additionally, Figure 9 highlights improper waterstop installation, which allowed seepage along the joint line, increasing the risk of uplift pressure beneath the slabs. The combination of these deficiencies—cracking, joint misalignment, lack of cushioning, and ineffective seepage control—significantly undermined the structural integrity of the spillway chute and contributed to its eventual failure. In well-designed chute structures, a cushion is typically incorporated at the downstream end of a chute panel—specifically at the cutoff wall located at the upstream edge of the adjacent downstream panel—to provide structural support for the upstream panel edge. This detail plays a critical role in preventing differential movement between adjoining panels by distributing applied loads and maintained consistent contact under both static and dynamic hydraulic conditions. In the case of the Dewana Dam spillway, the absence of this cushion detail allowed adjacent panels to move independently, leading to vertical misalignments and the development of offsets within the flow path, which increased the susceptibility of the structure to hydraulic and structural failure. Moreover, the waterstops, which are critical for preventing seepage through joints, were either poorly installed or failed to maintain an adequate bond with the adjacent concrete panels. This created preferential seepage paths beneath the chute panels, promoting the development of uplift pressures and subsequent slab instability.

Figure 3:Bad Joint Arrangement Just After Construction.

- Joint systems must be fully embedded and properly detailed to prevent leakage and pressure buildup.
- Concrete slab integrity must be ensured through appropriate reinforcement, curing, and crack control measures.
- Geotechnical preparation must not be compromised by construction delays; weathered

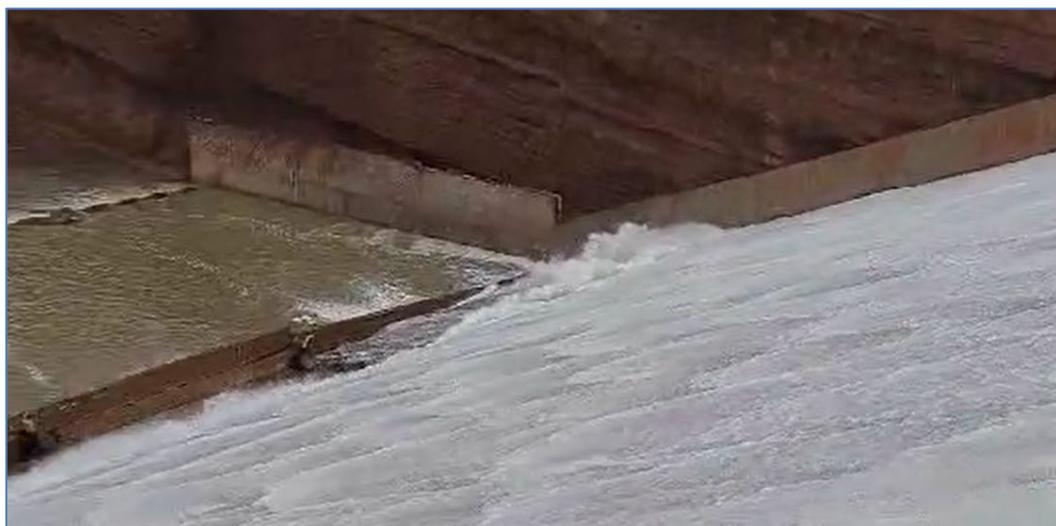
slightly higher peak discharge of around 200 m³/s caused significant structural damage to the chute spillway. Most notably, the chute slab near the stilling basin—located along the steepest section of the chute—experienced catastrophic failure. The slab broke, uplifted, and was displaced downstream, exposing the underlying low-quality foundation rock to direct high-velocity flow. This exposure initiated aggressive erosion processes, resulting in deep scour holes and further degradation of the structure. A key mechanism in such failures is flow-induced uplift pressure beneath spillway chute slabs, particularly in cases where slab joints are unvented or have poor drainage (ICOLD, 2015) (USBR, 2022). (Wahl et al., 2019) demonstrated that uplift pressures below chute slabs at unvented, open, offset joints can reach damaging levels during high-flow events, especially if foundation drainage is inadequate. Similarly, (Wahl

larger offsets generate more intense flow impingement and pressure buildup at the base of the slab. For the maximum offset of 10 cm, the computed v_y reaches 24.43 m/sec , resulting in a stagnation pressure of 298.41 KN/m^2 and a corresponding uplift force of 23,872 KN. In contrast, the smallest offset of 2.5 cm yields a lower v_y of 22.47 m/sec , stagnation pressure of 252.45 KN/m^2 , and a reduced uplift force of 20,196 KN. This clearly demonstrates that even small variations in offset height can significantly influence the hydraulic loading on the slab. Importantly, when comparing these uplift forces to the self-weight of the slab (estimated at 941.76 KN), it becomes evident that the uplift force greatly exceeds the gravitational resistance in all cases—by a factor of more than 20. This indicates a highly unstable condition, where the slab is vulnerable to displacement or complete failure (see Figure 4) unless additional resisting mechanisms (e.g., anchors or dowels) are provided.

Figure 4:Photo Showing Some Displaced Panels.

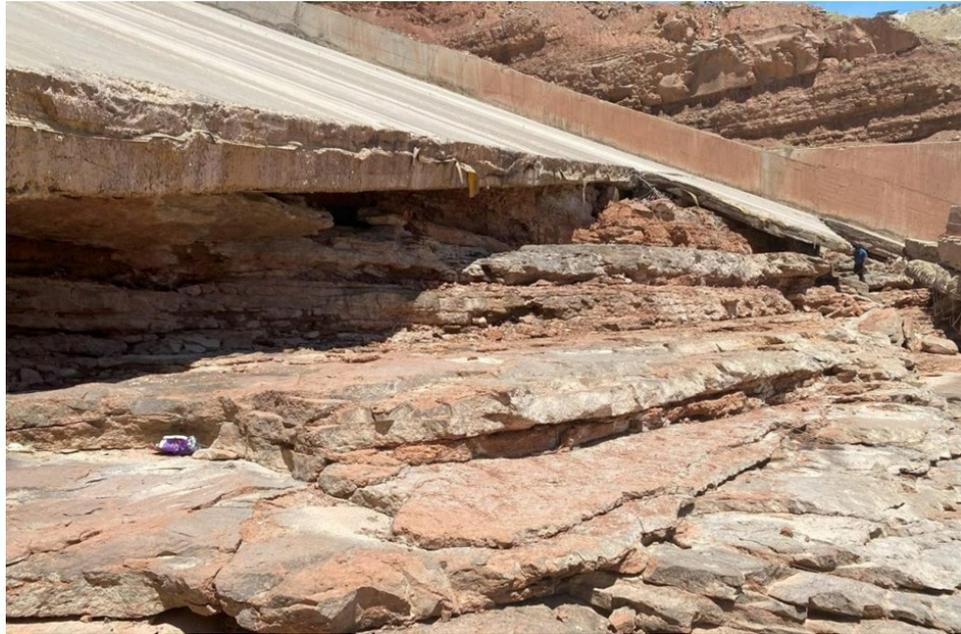
poor-quality bedrock. This substandard foundation material was highly susceptible to erosion. Over time, water infiltrating through cracks and inadequately sealed joints began to undermine the integrity of the subgrade. As the erosion progressed, it caused parts of the chute slab to crack and shift. The resulting gaps allowed even more water to enter and accelerate erosion within the foundation as shown in Figures 10 and 11. This process led to the displacement of slab sections, exposing the already weak bedrock to further degradation. Ultimately, the erosion reached a critical level, forming deep scours and severely compromising the structural integrity of the spillway. Another factor that may have contributed to the failure is the orientation of the bedding planes in the jointed rock foundation. The bedding planes were observed to be approximately parallel to the spillway chute slope, which could have facilitated the downslope movement of the concrete panels. This condition becomes particularly critical under the influence of stagnation pressure forces, which act parallel to the panel surface at locations where offsets or misalignments exist. Combined with the inherently weak shear strength of the bedrock, this geological configuration likely reduced the resistance to sliding and exacerbated panel instability during high-velocity flow events. The case might not be worsened like this if the bedding plane angle were perpendicular to the chute angle as shown in Figure 5.

Figure 5: Exposed foundation showing thin jointed beddings downstream.

foundations must be re-excavated or treated to restore strength and erosion resistance.

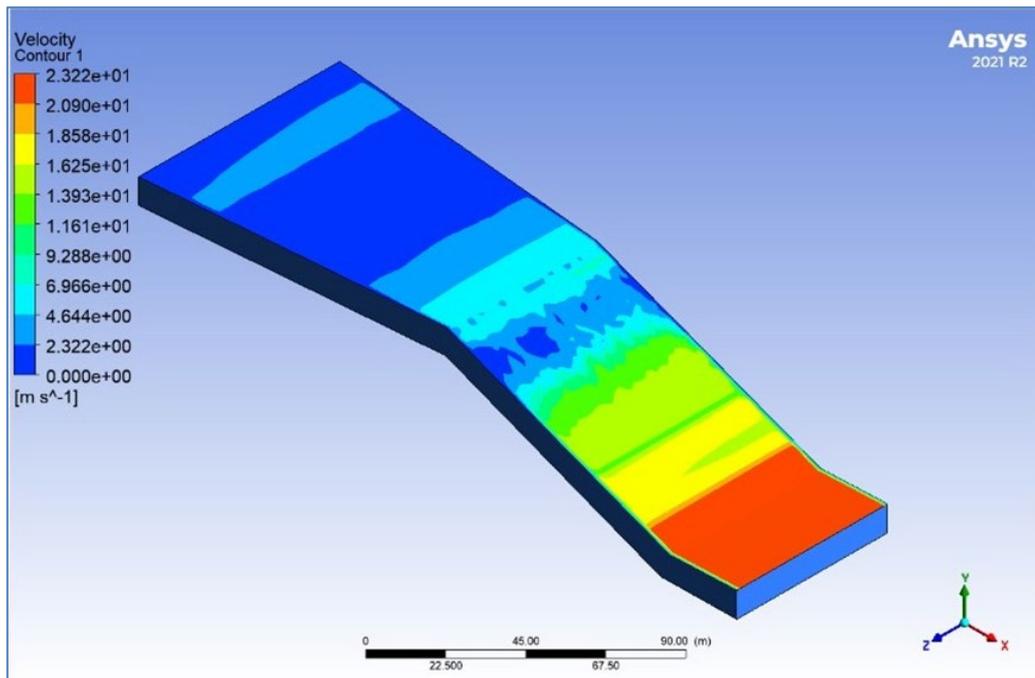
According to the numerical simulation results obtained using ANSYS Fluent, the maximum flow velocity at the downstream end of the spillway chute reached approximately 23 m/s, as illustrated in Figure 6. To assess the potential for cavitation-related damage, a detailed site inspection was conducted in conjunction with hydraulic analysis. Observations did not reveal typical signs of cavitation-induced distress such as pitting or surface degradation. Based on the simulated velocity

(23 m/s) and its corresponding flow depth of 0.1 m, the computed cavitation number was approximately 0.375 (see Equation 1). As this value exceeds the critical threshold of 0.25 suggested by (Falvey, 1990) (see Table 2), the flow conditions were not considered conducive to cavitation damage. Therefore, cavitation was ruled out as a significant contributor to the spillway chute failure in this case.

Figure 6: The Results of the ANSYS Software

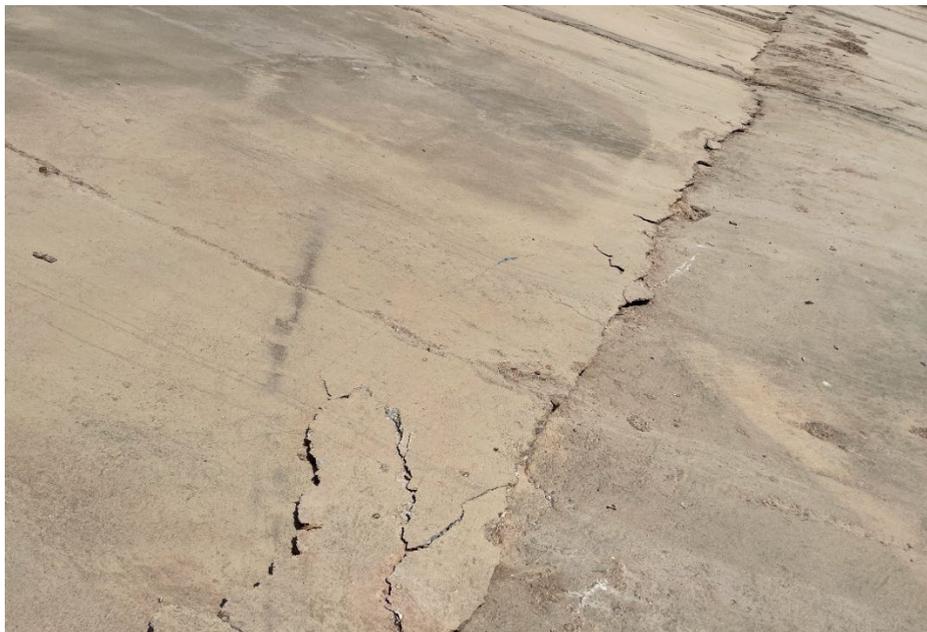
Figure 7: Cracks and bad joint finishing

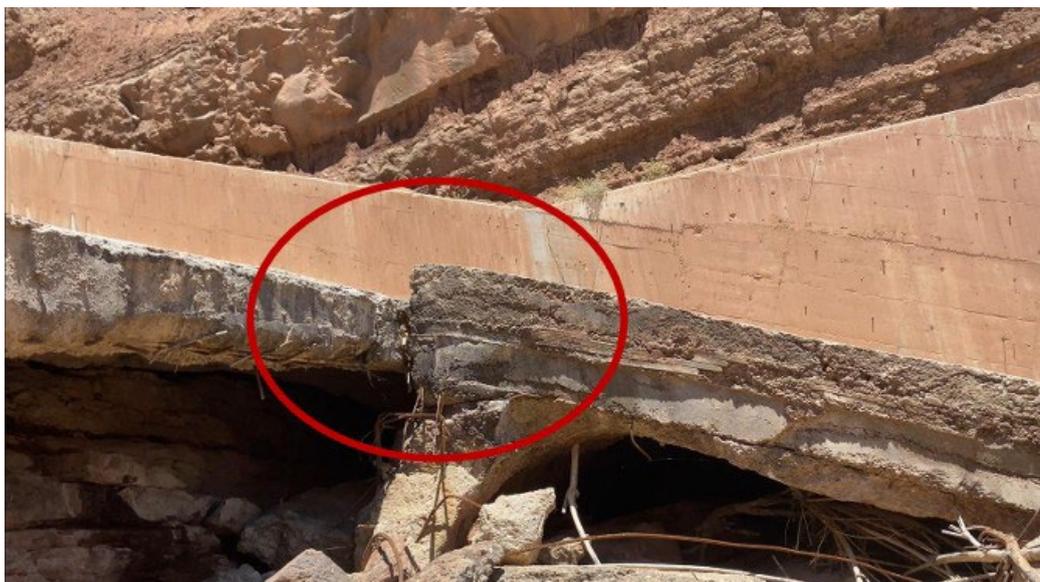
Prolonged water percolation beneath the chute panels led to progressive erosion of the underlying low-strength foundation material. The absence of a cushion at the cutoff key, which is typically used to prevent differential settlement, likely contributed to localized displacement between adjacent panels. This displacement may have created geometric offsets within the flow path. At such offsets, a stagnation zone forms where the high-velocity flow directly impinges on the upstream face of the discontinuity. In this region, the velocity head of the approaching flow is transformed into pressure head, generating stagnation pressure (Chow, 1959). This concentrated pressure can significantly increase uplift forces acting under the chute slabs, potentially leading to structural failure if not properly mitigated. When a discontinuity or opening exists within the slab joint, this stagnation pressure may be partially or fully transmitted through the joint, inducing uplift forces beneath the concrete slab (peterka, 1978). For high-velocity flow (flow over steep chutes), stagnation pressure can result in very high uplift pressures due to the conversion of the velocity head to a static head which can lead to slab uplifting (jacking) and removal of sections of the

Taking an offset height of 5 cm as a representative example, the flow velocity was calculated at the midpoint of the offset—2.5 cm above the boundary layer. At this location, the velocity was found to be approximately 23.45 m/s. Once the mid-height velocity v_y was determined, the corresponding stagnation pressure was found equal (274.95 KN/m^2) using Equation (3).

Figure 8: Offset of the panel.

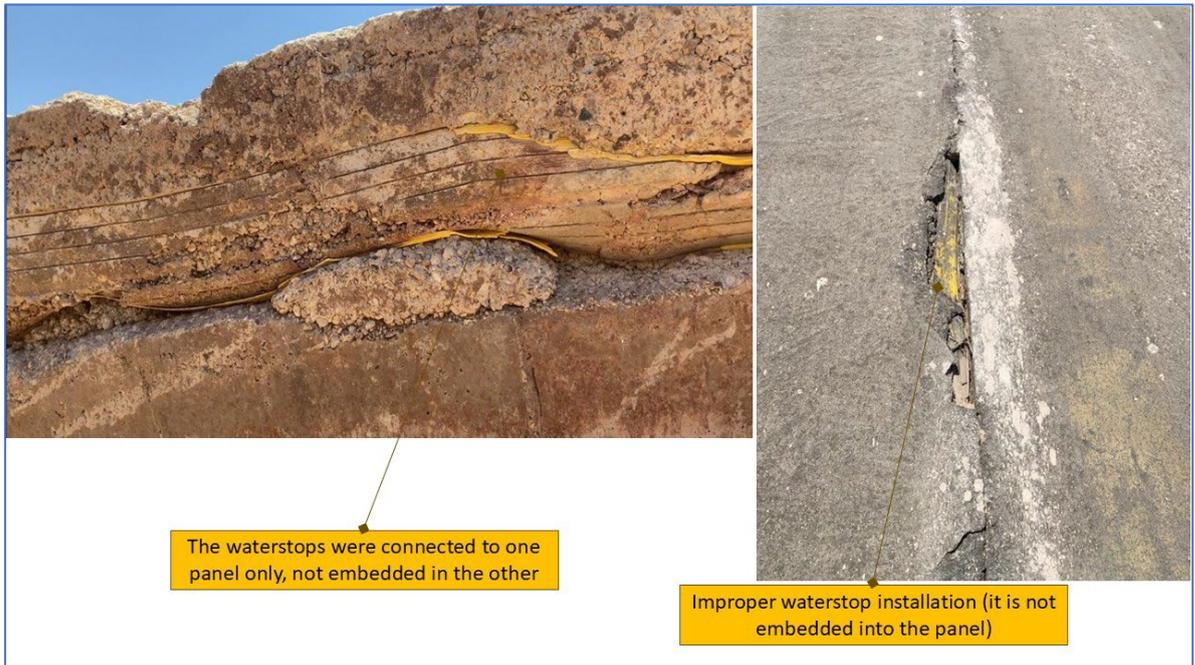
- **Cavitation:** Flow high velocity, discontinuities and surface irregularities may have generated localized low-pressure gradients, leading to cavitation erosion.
- **Joint, cracks and Waterstop Failure:** Improper installation and deterioration of waterstops enabled seepage through joints, increasing internal pressures and weakening structural continuity.
- **Poor-Quality Foundation:** The foundation, composed of friable claystone and sandstone, had not been adequately treated and was highly vulnerable to erosion.
- **Uplift Pressure:** The absence of anchorage systems and inadequate drainage likely allowed the accumulation of uplift pressure beneath the slabs, contributing to their displacement.

Figure 9:Improper waterstops installation.

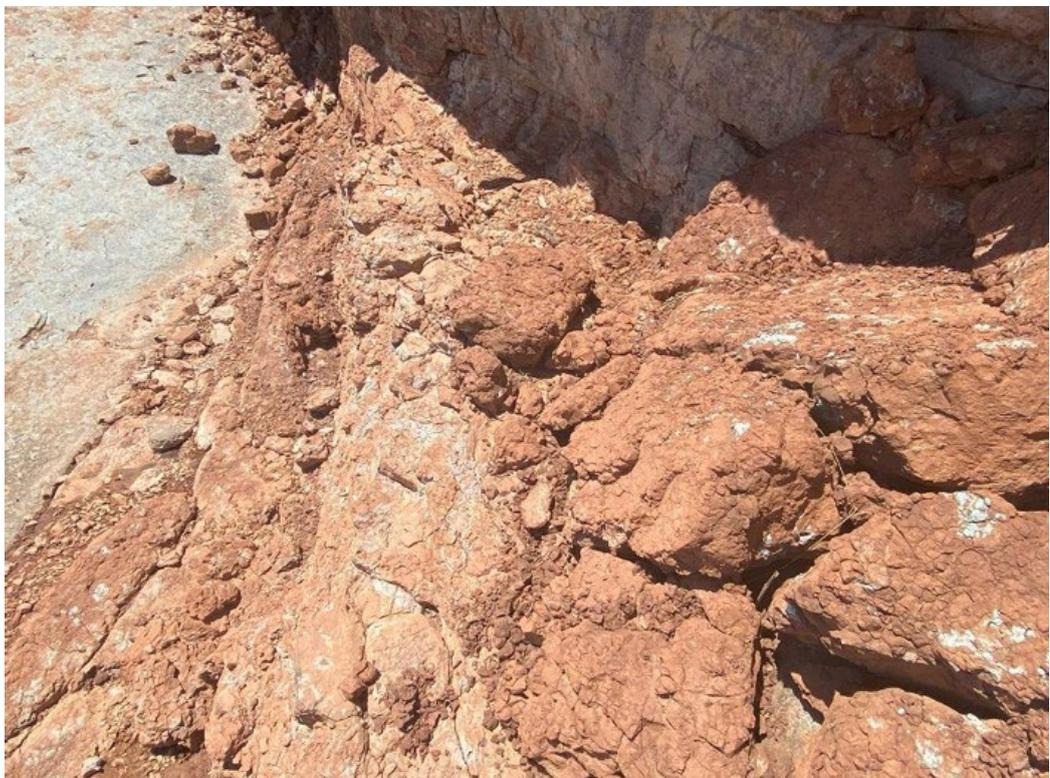
A geotechnical assessment was conducted to evaluate the foundation conditions beneath the damaged spillway slabs. Visual inspection of the exposed subgrade revealed significant erosion and material loss, particularly beneath the displaced slab sections. Erosional depths reached approximately 1.8 meters, indicating that the underlying rock was highly friable and of insufficient strength to withstand high-velocity flows and uplift pressures. To contextualize these findings, historical geotechnical investigation reports, borehole logs, and construction quality control records were reviewed. The data revealed a notable discrepancy between the originally assumed foundation conditions during design and the actual in-situ state at the time of failure. Further investigation revealed a key construction-phase deficiency: the spillway foundation excavation had been completed several years prior to slab placement but was left exposed to environmental weathering due to project funding delays. The exposed foundation—primarily composed of claystone and interbedded sandstone—underwent significant degradation over a four-year hiatus before construction resumed as shown in Figure 5 that has been taken from a reliable reference (Omed Yousif, 2024). Critically, the weathered and weakened surface layers were not adequately removed or reconditioned prior to concrete placement, resulting in a compromised bearing stratum with reduced erosion resistance.

Figure 10: Weathered rock beneath the chute slab of the Dewan Dam spillway.

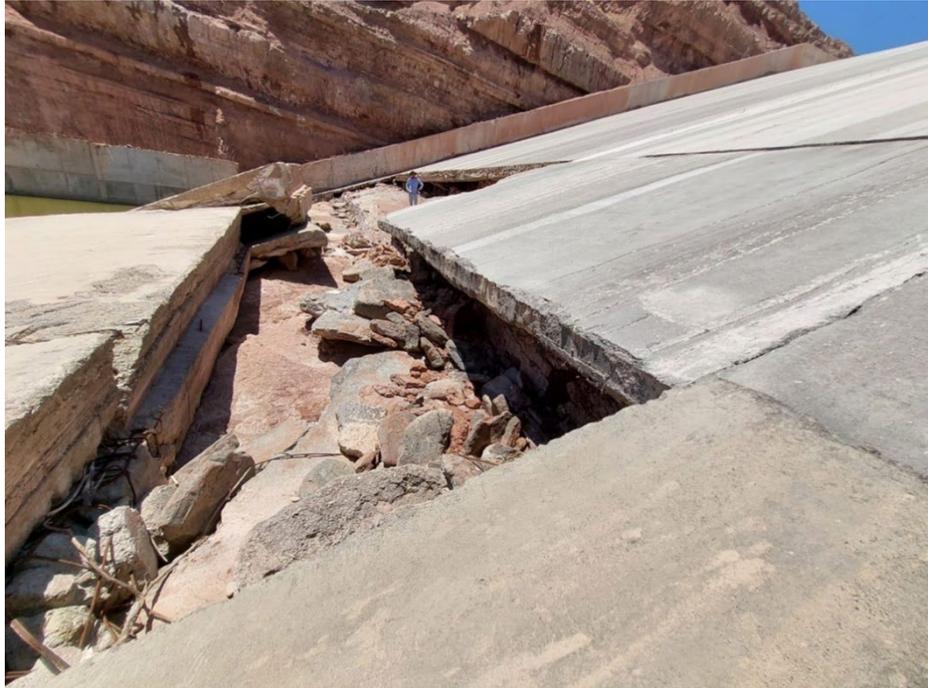
Figure 11: Poor quality rock beneath the chute slab of the Dewan Dam spillway.
