## BANKS RETREAT OF THE REGULATING LAKE OF MOSUL DAM

Thanoon H. AL-Dabbagh<sup>1</sup>, Thair M. AL-Taiee<sup>2</sup>

An increase in the shear stress that leads to bank failure in water bodies is commonly the result of rapid drawdown of water against bank face. The present research work introduces and discusses a local case study of bank failure of an artificial lake in Iraq (the regulating lake of Mosul dam). The bank susceptible to this failure extends about 4 kilometers long and 0.4 kilometers maximum width. The fluctuation of water level in the lake depends mainly on the daily release of water from Mosul main dam and on the requirement of daily flow in Tigris River. Thus, the lake banks have degraded seriously since the dam operation in 1985. The failures are generally associated with bank tension cracks. These failures are due to the rapid daily draw down of water in the lake causing imbalance condition between the hydrostatic pressure in the lake and the pore water pressure in the saturated bank. This imbalance results in insufficient shear strength against failure. Moreover, the wetting of bank materials causes an increase in its weight and decreases in its strength. The o

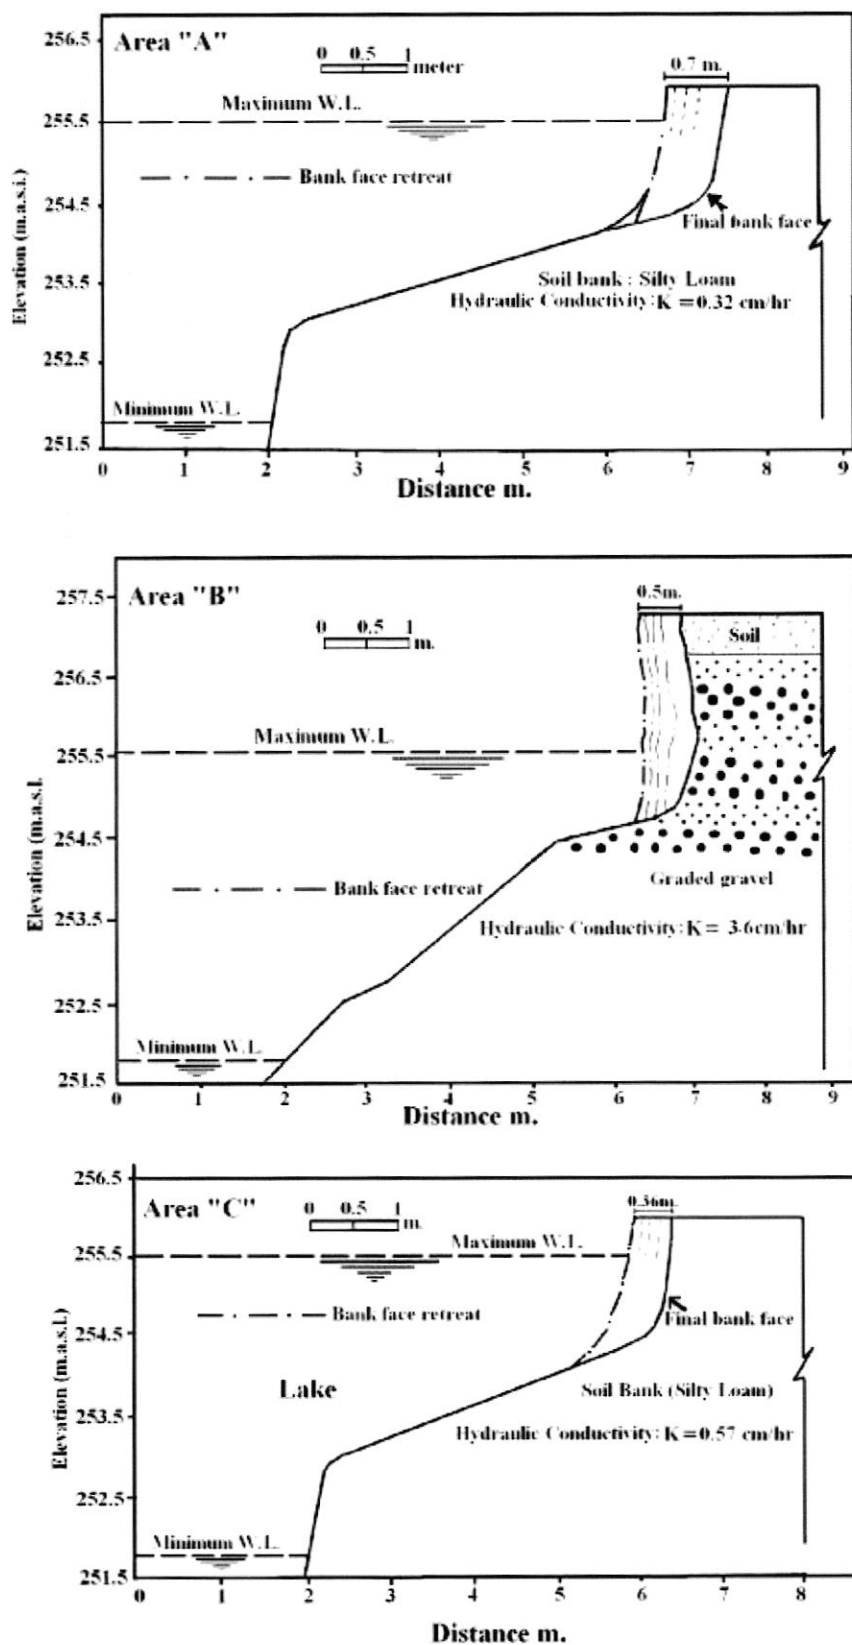
Figure 2 The cross sections of the studied areas along the bank of the regulating dam.

The results of the amount of retreat in the studied area are listed in table (1). The total amount of retreat for the study period in areas A, B, and C are 0.79m, 0.5m, and 0.45m respectively, while the average rate of retreat are 0.197, 0.125 and 0.112 m/month for the same areas respectively

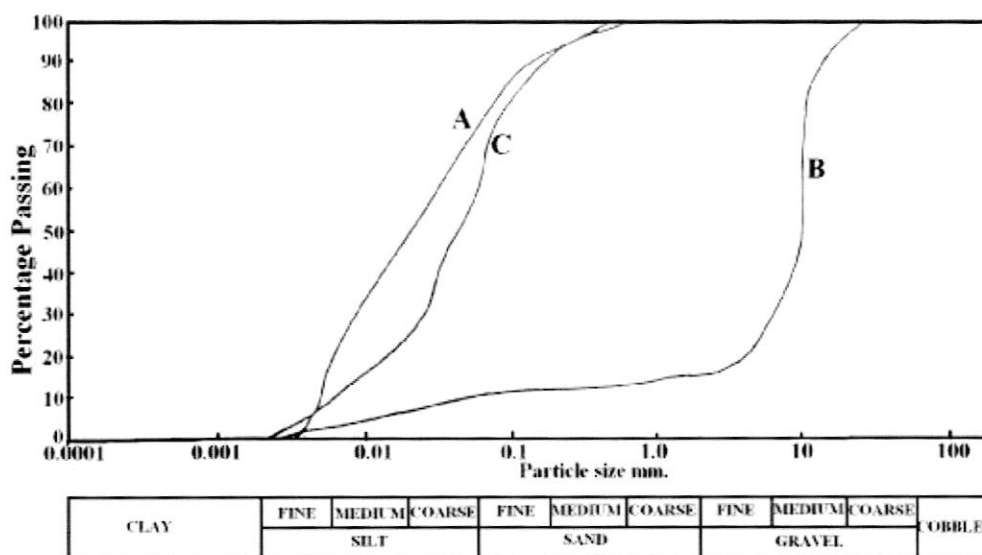
**Figure 3 Cumulative grain size distribution of bank materials for the three areas A,B,C.**

Table (1) explains the percentages of grain size analysis of the silty loam and gravels. The results show that, for location A and C at figure (1) the percentages of sand are 40% and 32% respectively, while silt percentages are 60% and 68% respectively. Clay and gravel percentages are zero for both areas. For area B, the sand percentage is 6%, silt 8% and gravel 86%. Fig.(3) reflect the grain size distribution of the three areas A, B, and C. Table (1) contains the hydraulic conductivity values of the silty loam and gravel deposits. The silty loam hydraulic conductivity values are (0.32, 0.57) cm/hr for areas A and C respectively, while for area B the gravel gave hydraulic conductivity values of 36cm/hr.

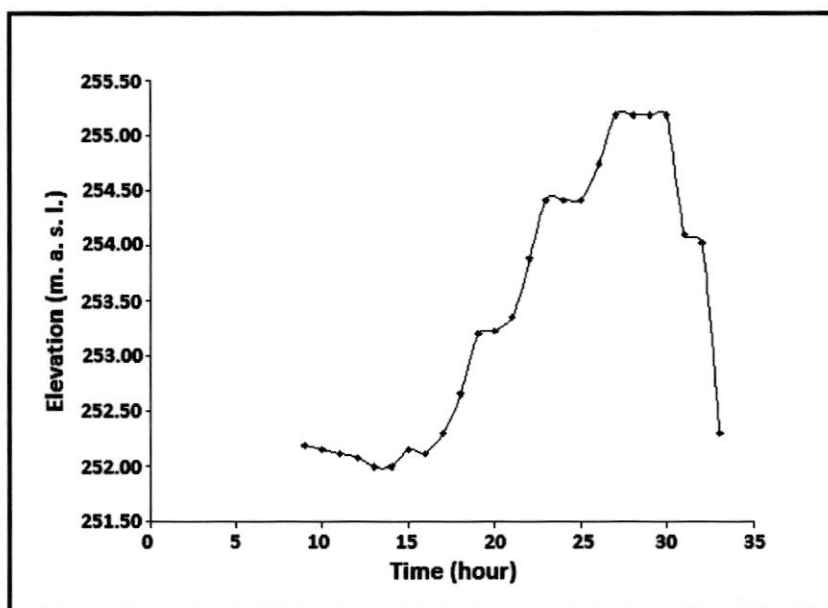
Figure 4 Diurnal water level fluctuation of regulating lake

Fig.(4) and Fig.(5) shows the diurnal and daily amount of water level fluctuation of the lake. The daily fluctuation is about 3 m and the rate of water level drawdown is 12.4 cm/hr.

When the bank is covered by water, (from 6 am to 12 pm the period of high water level of the regulating lake), the bank becomes saturated as a result of water percolation. A pressure balance forms between water in the lake and the height of saturated bank. This balance helps in keeping the bank stable. Two conditions cause bank failure, depending on the fluctuation of water level in the lake. The first condition is the quick drawdown of the water level causes a sudden removal of the hydrostatic pressure of the water in the lake where the soil can not drain quickly. In this case a pressure imbalance will be formed which may bring the lake banks to slough if the bank materials have insufficient shear strength resist failure, (fig.7). In other ward, when the capability of the bank materials to drain water, (i.e. the permeability of the bank material) is less than the drawdown velocity of water level in the lake, the probability of bank failure increases, [1]. This coincides with the present work in which the hydraulic conductivity of bank material in areas A and C was 0.32 and 0.57cm/hr respectively, table (1). These rates are less than the average drawdown velocity of the water leveling the lake, 12.4cm/hr, and fig. (4). It is clear from the figure (4) that the gradient

of the rising limb of the water level was 0.29 while the falling limb was 0.9. This inhomogeneous fluctuation of the water level between the rising and recession water velocity may lead to instability of bank material.

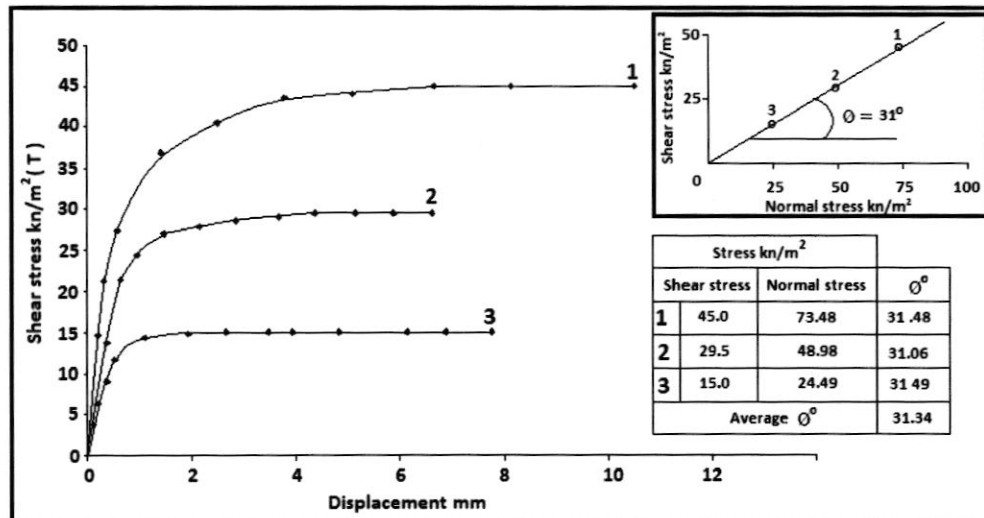
**Figure 6 Shear strength parameters of silty loam soil of study area.**

The results of the shear strength parameters are shown in fig.(6).  $\phi = 31^\circ$  and the cohesion  $c$  equal to

zero (0). These values influenced by the natural water content of soil. Okagbua and Abam,1986 found that an increase of water content by 10% decrease the  $\phi$  by 18% [8].

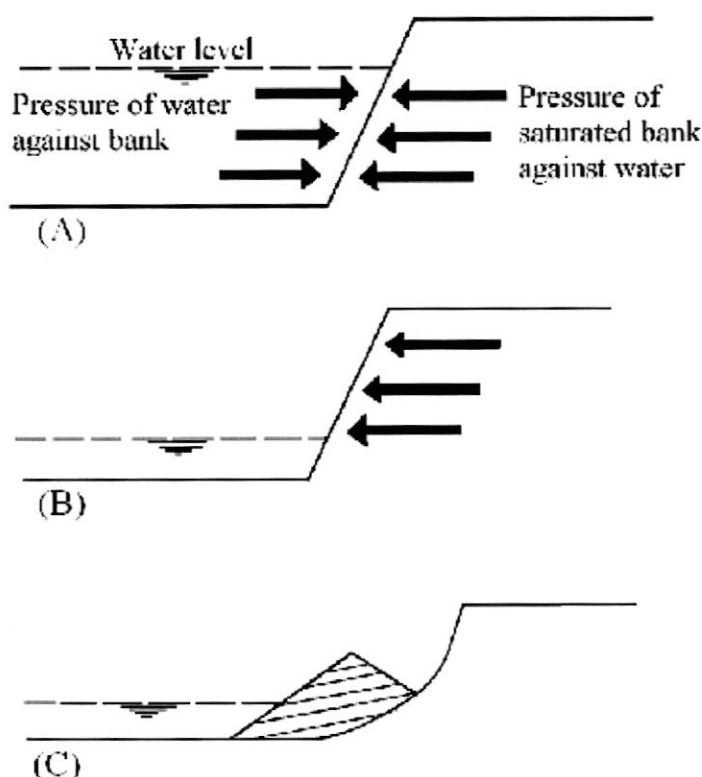
**Figure 7 Bank failure due to the water drawdown against the saturated bank being lowered faster than the bank can drain, (rapid drawdown). (A) Pressure balance of stream water and saturated bank. (B) If water surface elevation drops rapidly and the bank cannot drain quickly, a pressure imbalance will develop. (C) Bank may fail because of pressure imbalance.**

The bank failure due to the variation of the balance system between the hydrostatic pressure in the lake and pore water pressure in the saturated bank are owing to the following:

- 1- The average permeability of the silty loam material is 0.44cm/hr; this is less than the draw down velocity of water level 12.4cm/hr.
- 2- The gradient of rising limb of lake water level is less than the recession limb.
- 3- The high water level increases the load on the bank, which in turn increase the shear stress. At the
