PRESERVATION OF THE HERITAGE VALUES OF IRAQI TRADITIONAL HOUSES

*Dr. Ali Abdulhussein Al-Ghalib¹, Dr. Laith Sadiq Al-Assadi¹

1) Lecturer, Civil Engineering Department, Mustansiriyah University, Baghdad, Iraq.

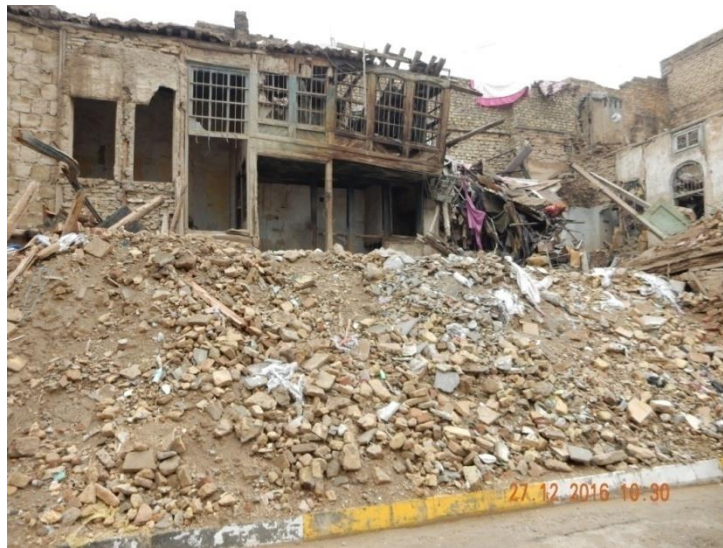
Figure 2. Example of ruins of a traditional house.

Briefly, a historic building is one that gives us a sense of wonder and makes us want to know more about the people and culture that produced it. It has architectural, aesthetic, historic, documentary, archaeological, economic, social and even political and spiritual or symbolic values; but the first impact is always emotional, for it is a symbol of our cultural identity and continuity-a part of our heritage. If it has survived the hazards of 100 years of usefulness, it has a good claim to being called historic. Nowadays, there are many examples accentuate the pitiable culture of dealing with Iraqi heritage. Fig. 2 shows only case amid many ugly pictures that our daily life full of them.

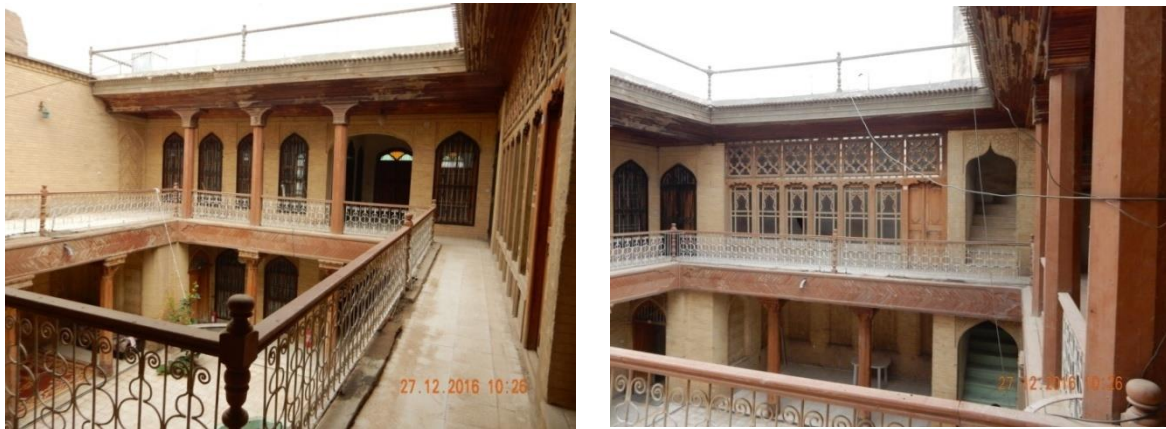
Figure 3. Examples of traditional Baghdadi house showing the courtyard (hosh) and tarma (colonnade veranda).

The present traditional houses of Baghdad, which belong to the nineteenth century, must be perceived as the ultimate and final result of prolonged stages of developments added. This final product gives a house of raised row of columns around its square courtyard, Fig. 3.

In its ideal form, through a house's ornamental doorway the passageway (mejaz) leads into courtyard (hosh). The hosh includes central openings and long urisi (room with large windows opened on the courtyard and normally has side access) between them. Rooms of fixed purpose such as kitchens, lavatories and bathrooms are kept unnoticeably in iwans, under the stairs and in corners of the ground floor. The rooms are kept in the first floor around the central courtyard and opened on to a common foyer or tarma [1].

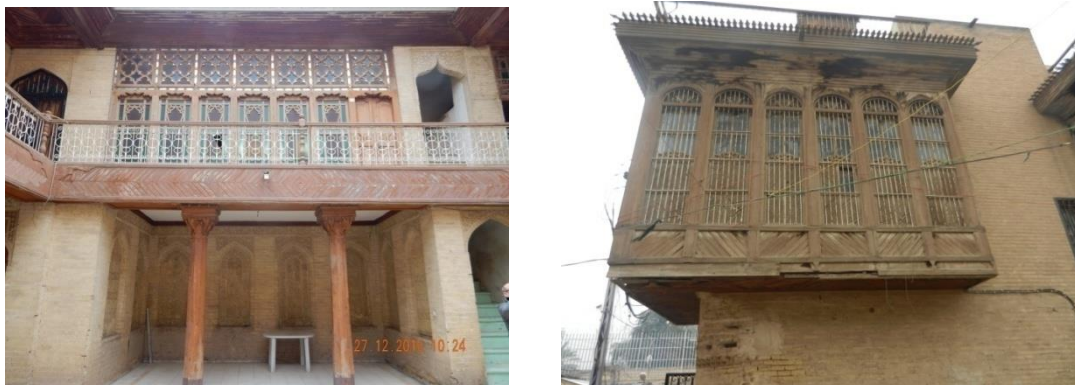
Figure 4. Examples of talar in Baghdadi house (left) shanashil landed into the street (right)

Such houses have two stairs: one leading to the diwankhana (where strangers are received), the other leading to the harem (where the family can have access). The iwan and the talar (colonnaded iwan) are smaller openings off the tarma and basically served as open rooms that extend the space to the daily activities, Fig. 4.

The ursi room in the first floor occasionally opened to the outer world through oriel window (shanashil), Fig.4. The shanashil helps to provide natural fresh air and opportunity to watch the life of the street.

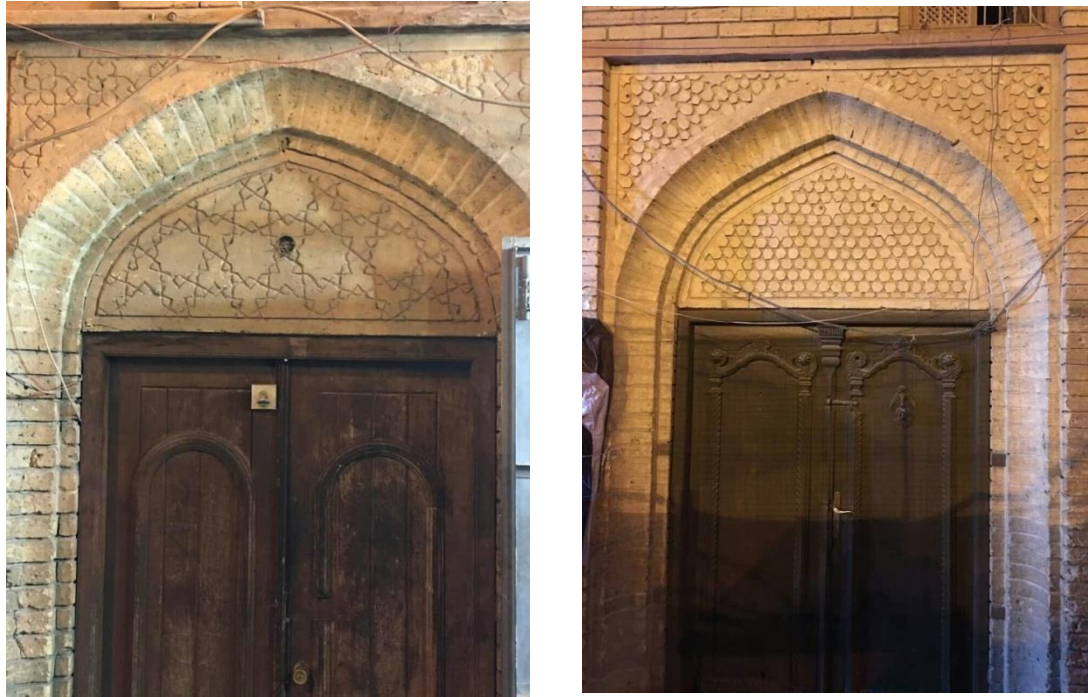
Figure 5. Decorated carved and mosaic brickwork of two different entrance doorways.

Engraved, clean-cut and moulded bricks were used to introduce geometric and arabesque decorative brickwork to doorways, windows openings and facades. Occasionally, mosaic modelled bricks were utilised in spandrels, cornice and friezes over the surface of the building to make complex shapes, Fig. 5.

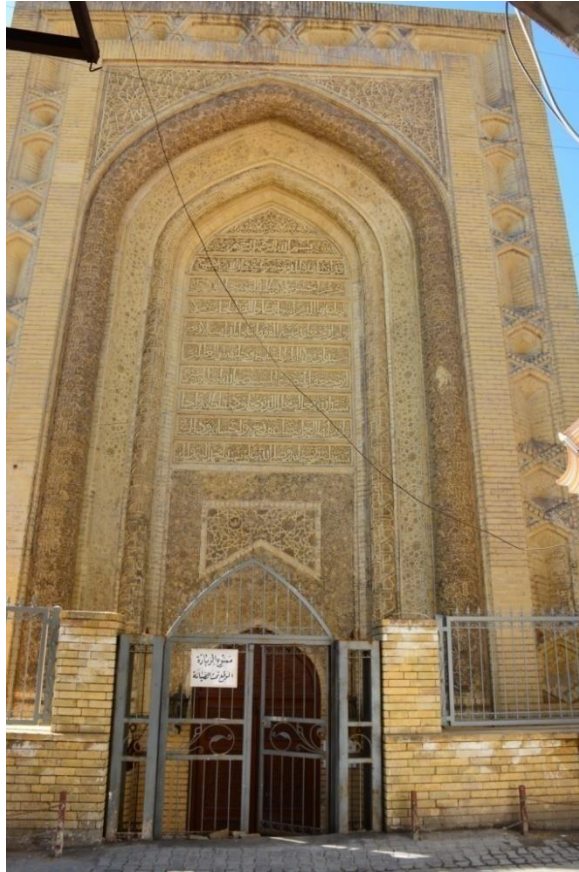
Figure 8. Example on bad conservation (new bricks do not match the old in color and texture)

Crumbled brickworks are replaced with brick of same patina provided with damp proofing layer. It is very important that new bricks should match the old in color and texture, and that the old form of bonding and jointing should be followed. Fig. 8 shows a contrast between the new bricks and old bricks in conservation of Al-Mustansiriyah school of Baghdad.

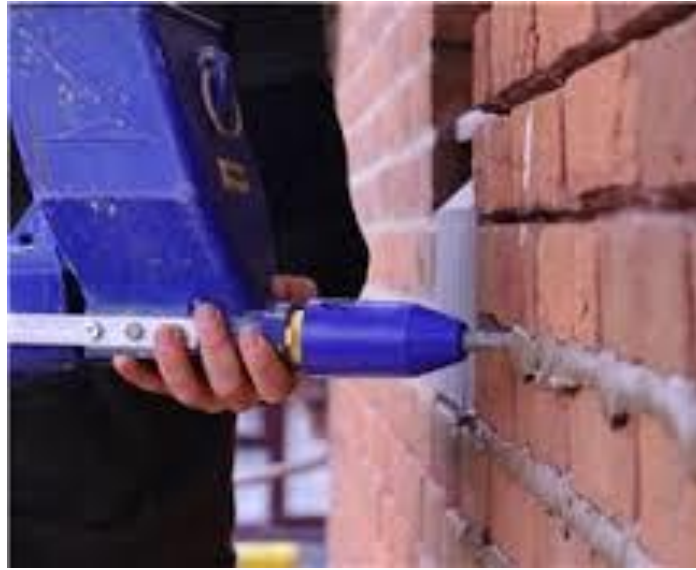
Figure 9. Repointing process using cement mortar in a brick wall.

One of the major defects of aged courtyard houses is the deterioration of the pointing. New mortar of same colour and texture should be provided to repointing and sealing the joints. The appearance of a brick wall is significantly affected by the colour and texture of pointing because the pointing sometimes cover 30-40% of the area. Cleaned and brushed edges of bricks are essential. In repointing action, old pointing of brickwork should be scratched and removed out to a minimum depth of 30mm and the pointing inserted with a special tool (mortar gun), as shown in Fig. 9. The new mortar is made of lime which is compensated with sand to give darker colour. The resistance of a brick wall to rain water and its durability mainly depend upon the success of the pointing. If it is too light in colour it gives a recently re-pointed wall a garish and stark appearance. Earth colours can be used to reduce the whiteness of some limes. If a natural darkish buff-coloured hydraulic lime can be obtained, this is the best. The colour

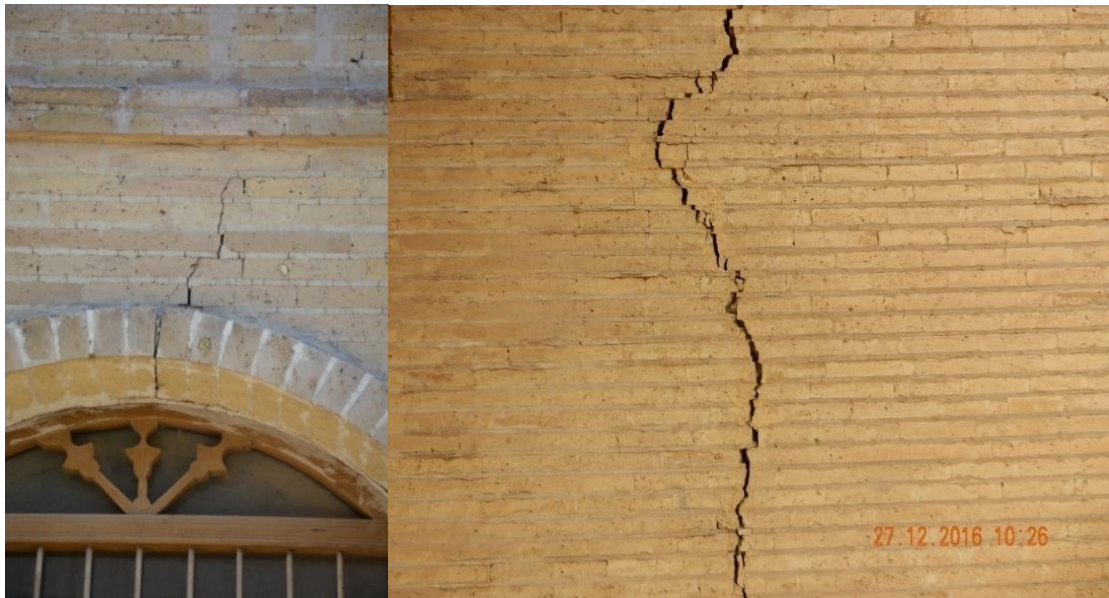
Figure 11. Cracks in two historical houses in Baghdad.

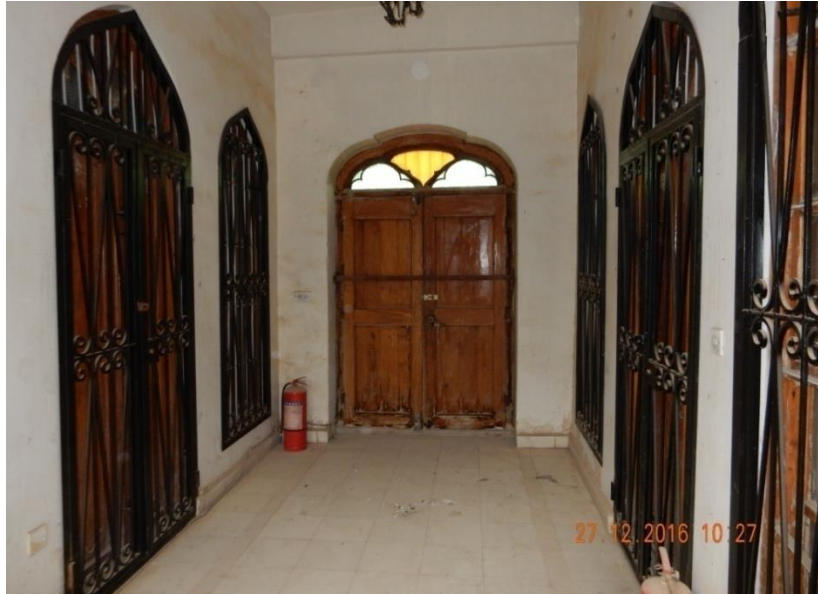
Figure 12. The problematic use of Portland cement in repairs

The repair materials must be compatible with the original materials, for all types of construction. This can be applied to the bricks as well as the mortar. Mortars of Portland cement have the advantages of workability, high stress level and their relatively impervious nature. These mortars may also be used to mitigate the soluble salts and frosting effects. It is appropriate for works subjected to high stress and use with actions required appropriate strength, such as building or rebuilding of brickworks, underpinning of foundation and repair of damaged walls. In order to compensate the disadvantages of Portland cement especially its high stress, it is advisable to replace Portland cement to sand mortar with appropriate proportions of Portland cement and lime. Mortars of cement: lime: sand are designed by replacing part of the cement in a 1:3 cement mortar by an equal volume of lime, so that the binder paste still fills the voids in the sand. In this way, good working qualities, water retention, bonding properties and early strength can be achieved without the mature strength being too high. Nonetheless, Portland cement is not designed for use in mortars or plaster on historic buildings due to its consequences and shortcomings on traditional materials. Disadvantages such as: its strength in compression, bonding and tension compared to weak materials of historic buildings [14]. Also, its impermeability and low porosity traps vapour and water and prevents evaporation. As a result, it is not good to be used in repairing damp walls. Additionally, it shrinks on setting, leaving cracks for water to enter, and because it is impermeable such water has difficulty in getting out. Therefore, it increases defects caused by moisture. Portland cement should not be used for mortars or plasters in historic buildings, but as a last resort a small proportion of Portland white cement should be added to the lime with no more than 10% of the volume of the lime without expert advice. Fig. 12 shows erroneous use of Portland cement in rendering walls historic building in Baghdad.
