Original Research

STRUCTURAL PERFORMANCE OF COMPOSITE BOX BEAMS WITH CORRODED BOTTOM FLANGE UNDER MONOTONIC AND REPEATED LOADS

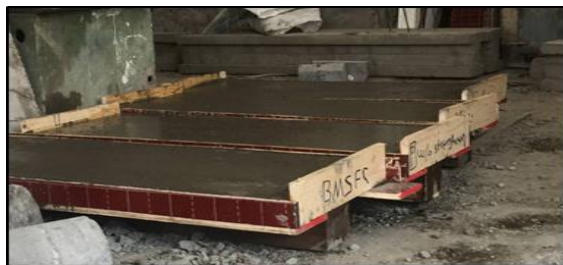
used throughout the present study. The raw materials and admixtures of the adopted concrete mix were mixed using a rotary mixer with a capacity of (0.2m³). Six wooden molds were made by using plywood with inside dimensions of (400x50x1100mm) were used to produce the concrete deck slab which represents a major part of the composite box beam. The wooden molds were fixed to the top of the steel box beams by using steel screws (shear connectors). The inner faces of the molds were oiled to make the stripping process of the specimens easier; then, before pouring the concrete mix, the necessary reinforcements were placed inside the wooden mold. As soon as the concrete mixing process is completed, the pouring process is started by placing the concrete mix in the mold which was prepared to get a deck slab (50mm) thick. After the casting process is completed, the specimens were placed on the table vibrator for compaction purposes, and then left on laboratory conditions. After 2 days, the wooden molds were removed from the concrete specimen and cured by using wet burlap for 28 days.

Figure 2. Beam Specimen Deck Slab Cast

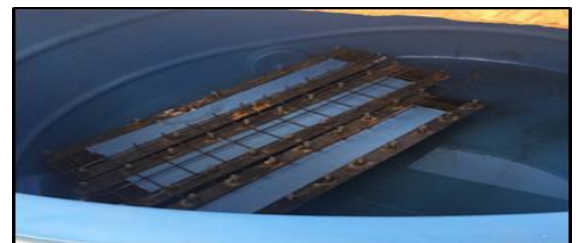
As mentioned in the experimental program, four box beam specimens were made with corroded bottom flange; therefore, four beam specimens were subjected to rapid corrosion by being laid in a polyethylene circular basin of (1.5m) diameter, containing a diluted sulfuric acid solution with (10%) concentration, Fig. 3.

Figure 3. Beam Specimens in basin contained a diluted sulfuric acid solution

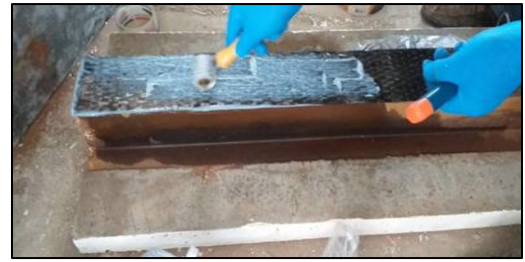
As mentioned in the experimental program, two of the four corroded bottom flange specimens, (BMCSF) and (BRCSF), were strengthened by using CFRP strips. As a first step, the corroded layers were removed from the substrate by using an electric steel brush and cleaned of any debris, dust, foreign particles, etc. Then, the strain gauges were fixed on the bottom flange of each specimen for the subsequent testing requirements and were protected by a silicon pad before applying the epoxy resin. Then, the CFRP pieces were prepared to the required

dimensions of (1100x100mm) by cutting the CFRP fabric by a scissor, Fig. 5.

Figure 5. Strengthening of corroded bottom flange by CFRP Strip

The final step is preparing the epoxy resin by mixing two components thoroughly for about five minutes, and then the prepared epoxy resin is used directly onto the substrates as the first layer by an ordinary brush. Then the CFRP pieces are attached carefully to the applied epoxy resin and smoothed by hand and derive out any irregularities or air pockets by using a hand steel roller until the resin was squeezed out of the slots of the fabric. Finally, another thin layer of epoxy resin was applied on the CFRP strip, and the specimens were left out for not less than 2 weeks for curing and hardening of CFRP.

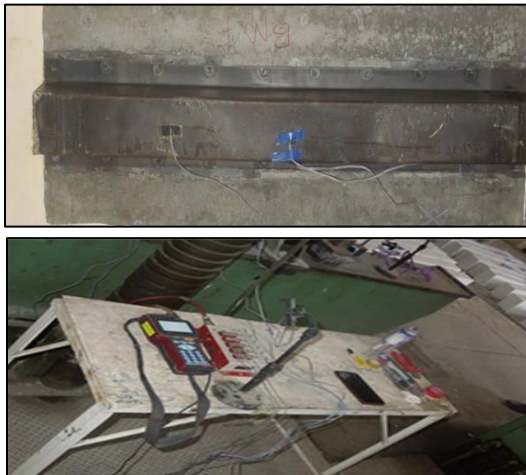
instrument of type (TML/ TC-32K) was used to convert the electrical signal emanating from strain gauges to a corresponding strain reading. The strain gauges were fixed in four different locations, as shown in Table 3.

Figure 6. Data logger and location of strain gauges

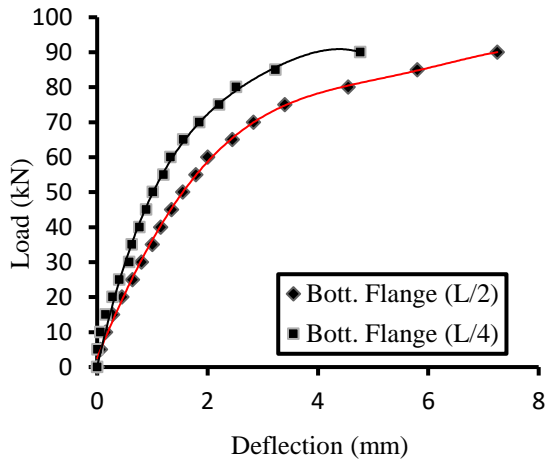
Figure 7. Load-deflection curve of the specimen (BMF)

As mentioned before, the vertical displacements (deflections) were measured by using two dial gauges located underneath each tested beam specimen at the mid-span and quarter of span. The load-deflection curves of the tested beam specimens are plotted and provided in Fig. 7 to Fig.12. It can be observed from evaluating the relationship between the repeated load and deflection that the vertical deflection values increased as the number of repeated cycles increased, owing to a decrease in beam stiffness. The deflection values were increased in comparison with the reference specimens; the presence of corrosion leads to reduced beam flexural stiffness, and the results show an increase in vertical deflection. In the opposite direction, the strengthening by the CFRP strip leads to increased beam flexural stiffness and decreases the corresponding deflection as compared with the reference specimens.

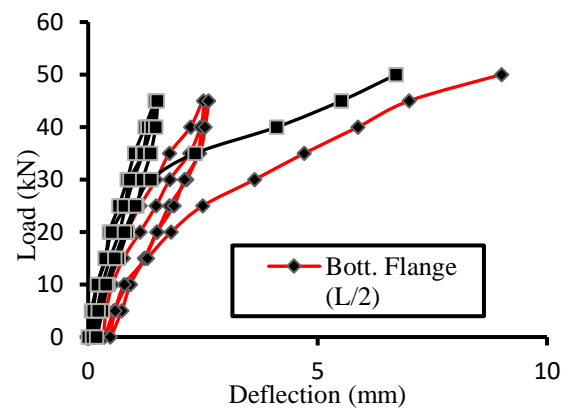
Figure 11. Load-deflection curve of the specimen (BRCF)

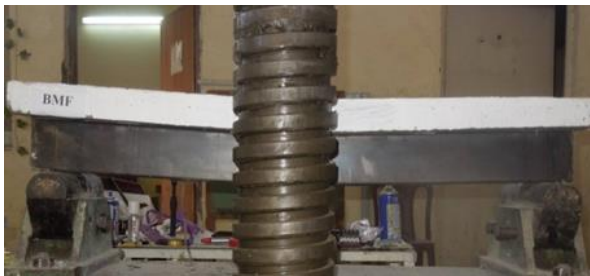
Figure 13. Mode of failure of beam BMF

The tested beam specimens (BMF), (BMCF), and (BRF) failed by a flexural mode of failure due to the yielding of the steel box section at the

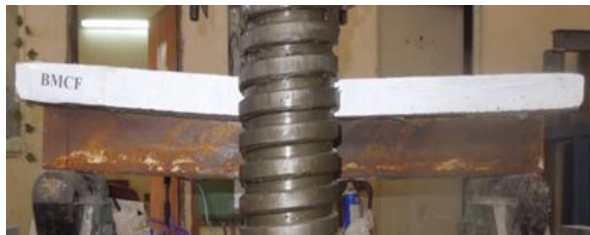
Figure 14. Mode of failure of beam BMCF

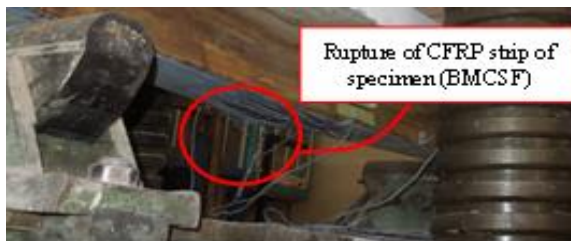
Figure 15. Mode of failure of beam BMCSF

bottom flange. Also, the tested beam specimen (BRCF) failed by flexural failure due to the yielding of the steel bottom flange and then by the local buckling failure of the top steel flanges. While for the corroded-strengthened beam specimens (BMCSF) and (BRCSF), the failures occurred due to rupture of the CFRP strips, which means that the CFRP strips reached their ultimate tensile strength before rupture.

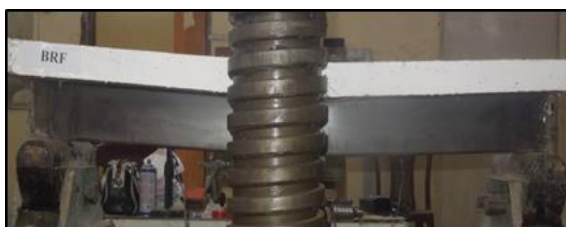
Figure 16. Mode of failure of beam BRF

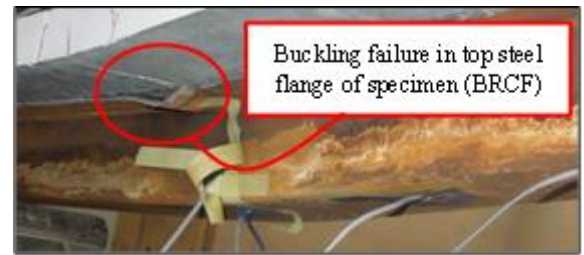
Figure 17. Mode of failure of beam BRCF

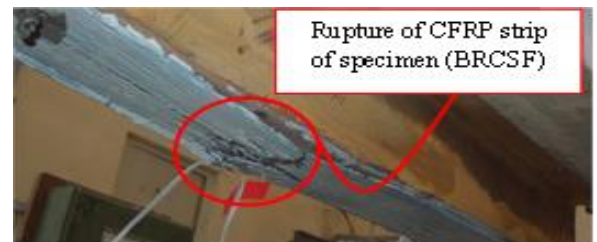
Figure 18. Mode of failure of beam BRCSF
