## LABORATORY INVESTIGATION OF SHEAR REPAIR OF REINFORCED LIGHTWEIGHT AGGREGATE CONCRETE BEAMS WITH STIRRUPS

\*Dr. Mu'taz Kadhim Medhlom

Lecturer, Road and Transportation Eng. Department, Al-Mustansiryah University, Baghdad, Iraq.

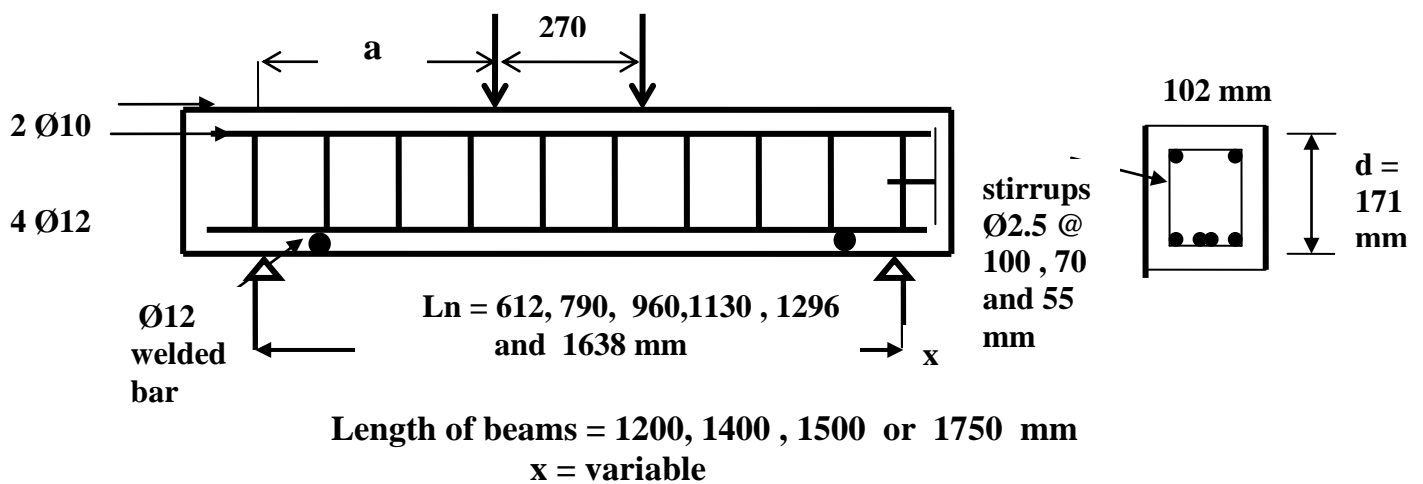
Fig. 1. Specimen Details for Test Beams

A total of 12 reinforced LWAC beams with web reinforcement were cast and tested by *M.K.Medhlom* ,PhD candidate at the University of Technology ,Iraq, under the supervision of professor *K.F.Sarsam* in 2005 [12] ."Table 1" lists the materials for  $f_c' > 20$  MPa mixes and 12 mm maximum size aggregate were chosen for the mixes [12]. Three groups of beams with shear reinforcement index ( $\rho_v f_y$ ) of 0.493, 0.704 and 0.896 MPa (stirrups at 100, 70 and 55 mm respectively) were loaded symmetrically with two equal concentrated loads .These beams had  $a/d$  ratios of 4.0 ,3.0 ,2.5 ,2.0 ,1.5 and 1.0 .Smooth wire (2.5 mm diameter ,yield and ultimate strength of 512 and 588 MPa respectively) were used in fabricating the stirrups . "Fig. 1" and "Table 2" give all the specimens details .Each specimen is identified by a label  $S_{xyz}$  where  $x$  is a number denoting the longitudinal steel ratio ,  $y$  denotes  $a/d$  and  $z$  representing the amount of shear reinforcement .

Beam specimens	Ln mm	a mm	$\rho_w$ %	$a/d$	$\rho_v f_y$ MPa	Spacing (mm)
S 341	1638	684	2.593	4.0	0.493	100
S 331	1296	513	2.593	3.0	0.493	100
S 321	1130	430	2.593	2.5	0.493	100
S 311	960	345	2.593	2.0	0.493	100
S 312	960	345	2.593	2.0	0.704	70
S 313	960	345	2.593	2.0	0.896	55
S 3Ö1	790	260	2.593	1.5	0.493	100
S 3Ö2	790	260	2.593	1.5	0.704	70
S 3Ö3	790	260	2.593	1.5	0.896	55
S 301	612	171	2.593	1.0	0.493	100
S 302	612	171	2.593	1.0	0.704	70
S 303	612	171	2.593	1.0	0.896	55

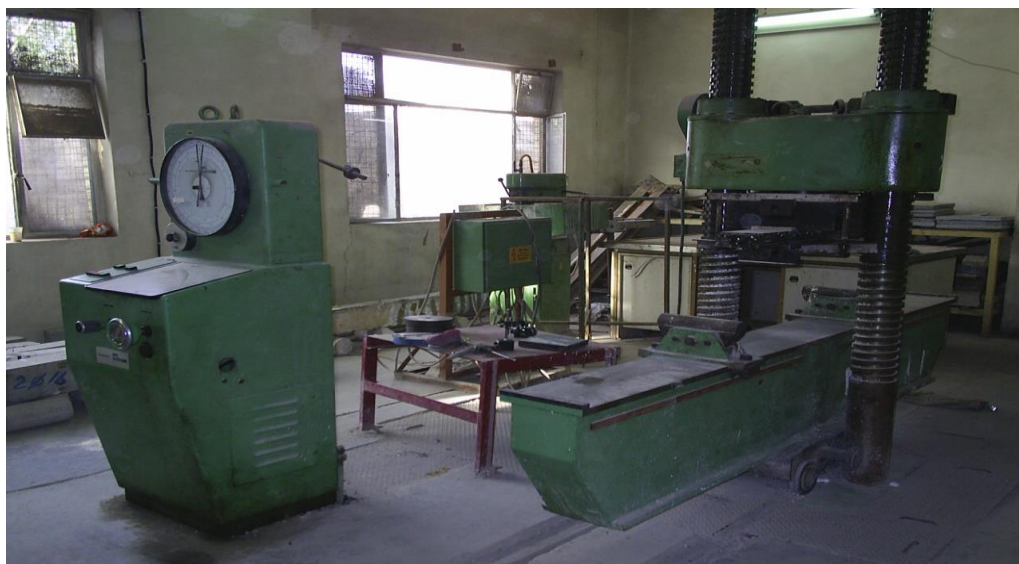
Fig. 2 : Test Machine

After repairs became effective ,beams were tested in a 300 ton hydraulic testing machine (MFL) ,as shown in "Fig.2" , and loaded in increments of 4 kN until failure .At each load stage deflection reading and the development crack pattern was marked on the beam surface .The testing sequence of the 12 model specimens is summarized in "Table 4" .

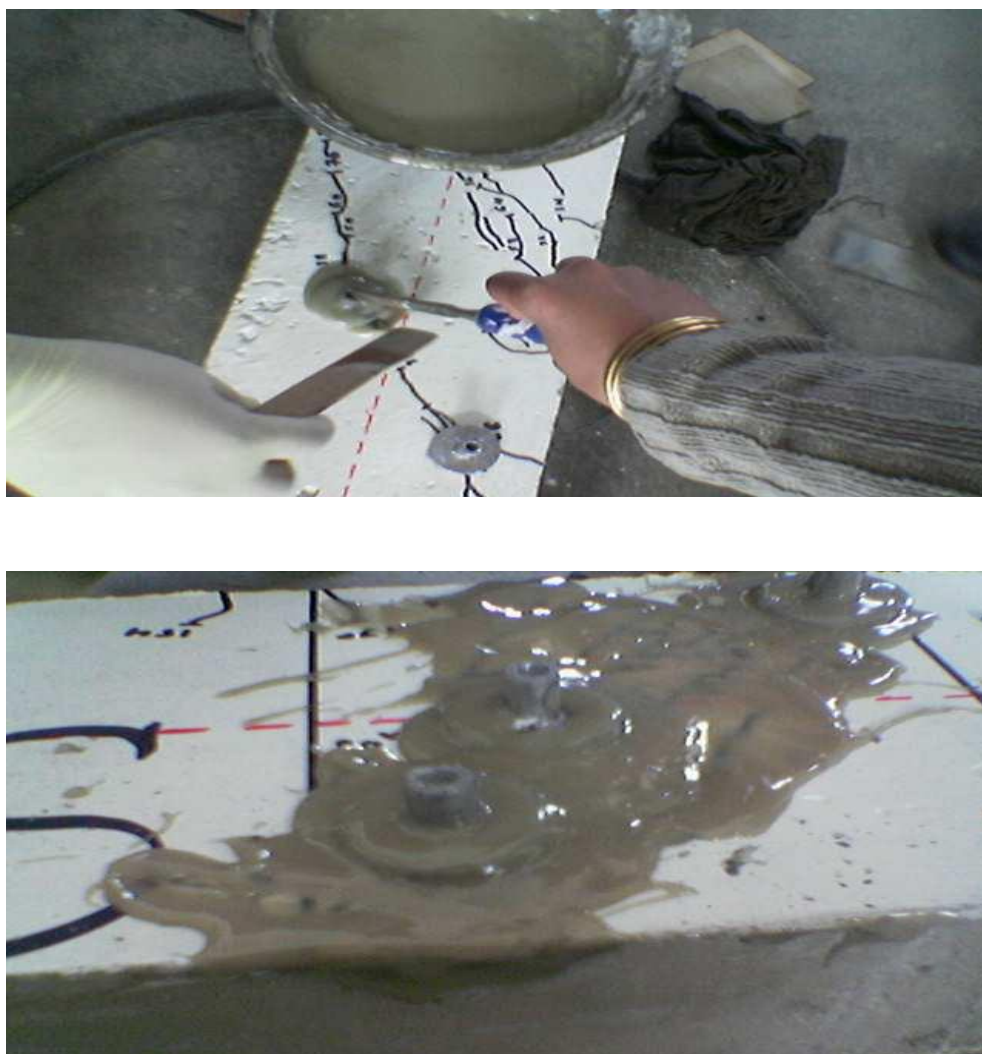
Fig. 3 . Epoxy Injection Process

5. A mechanical injection gun is fed with the mixed epoxy and the injection process starts. The injection process begins by pumping epoxy into the lowest port until the epoxy begins to flow from the port above it. The first port is then plugged with a cap ,and the process is repeated until the crack has been completely filled and all ports have been capped .Low pressure is used in injecting epoxy into cracks .A curing period of about 24 hours is provided to the injected epoxy .

6. After the injected epoxy has cured, the ports are removed by striking with a hammer and the surface seal is chipped. Fig.(3) shows the injection process.

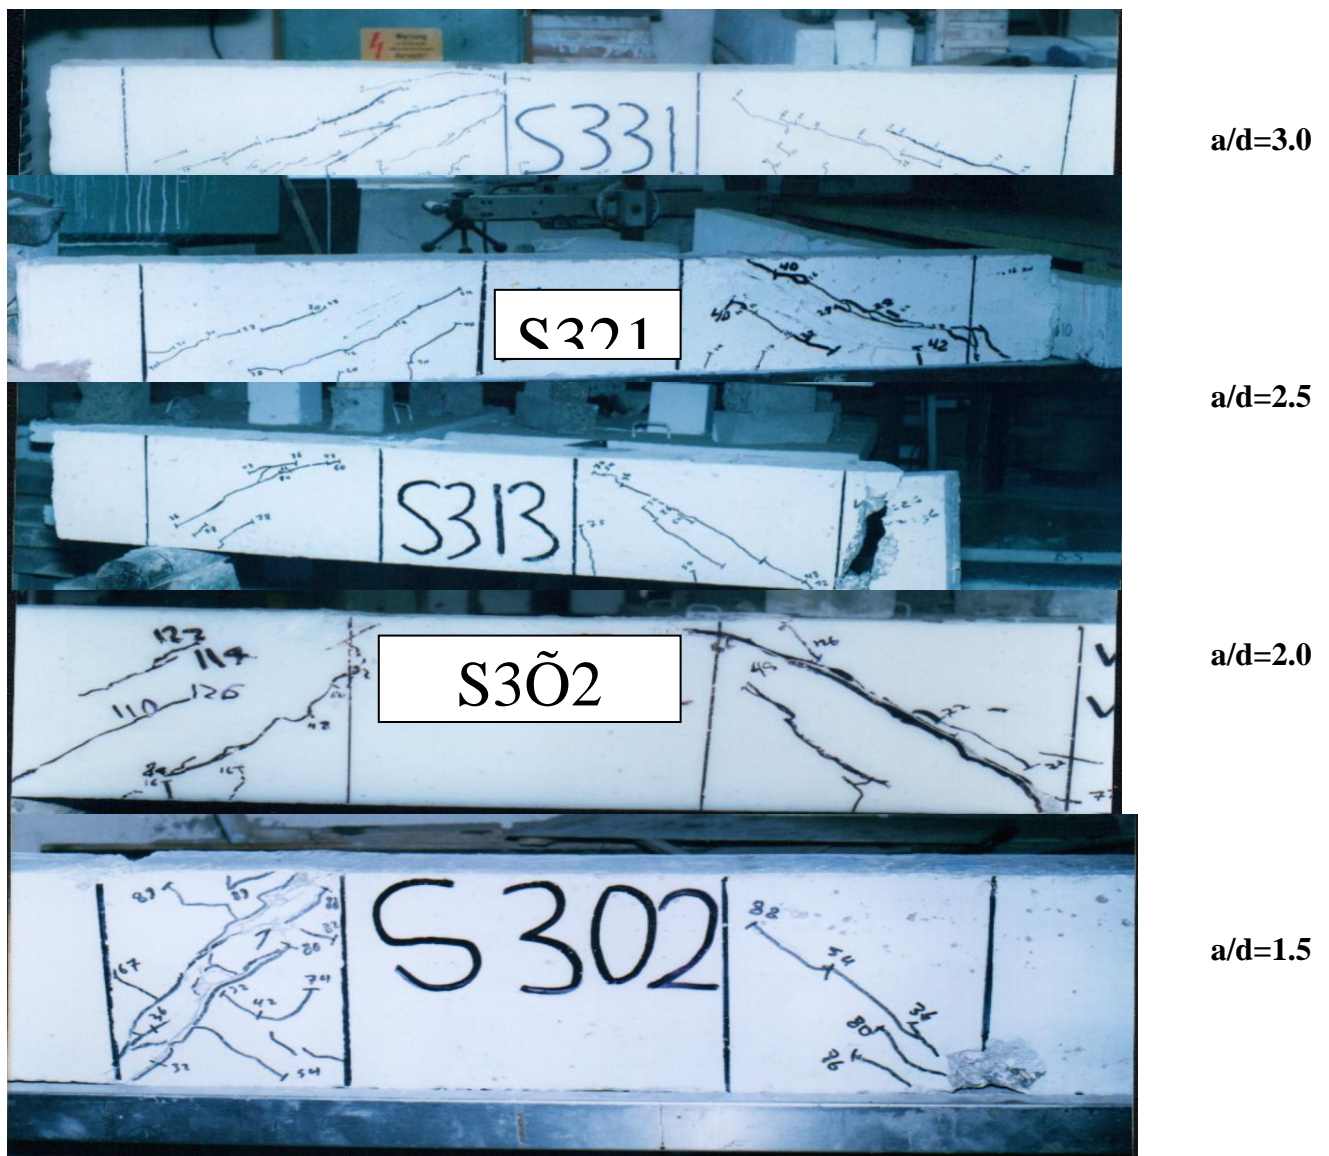
Fig.4 . Crack Pattern Development for Typical Beams

Prior to discussing the test results, it is helpful to discuss the general behavior of the repaired beams .All 12 beams tested failed in shear. Photographs of test specimens that show typical observed cracked patterns and failure mode are shown in "Fig. 4" .In this study the diagonal cracking force was defined as the shear force at the time when the critical diagonal crack became inclined and had crossed the mid-depth [13].

After testing the repaired beams, the repaired diagonal cracks in all beams do not reopen except the beams S302 and S302 .The beams failed due to new diagonal cracks development with approximately the same formation sequence as the diagonal cracks in the original beams.The new diagonal crack is developed adjacent to or near the repair crack.

In a slender beam with a long shear span the exact location of the initiating flexure crack is not too important, because the inclined crack can adjust its path as it extends towards the load. In a deep beam the initial inclined crack develops suddenly along almost its entire length as shown in "Fig.4". The initial crack location is critical and helps determine if much arching action can develop leading ultimately to crushing of arch rib (as in all deep beams except the beam S313 which failed in crushing over the support).

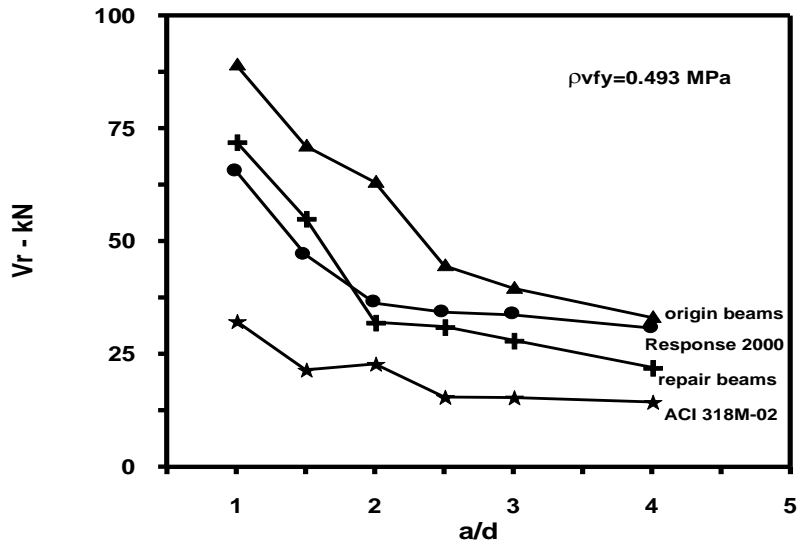
Fig.5 :Effect of shear span to depth ratio ,  $\rho_{vfy} = 0.493$

Experimental failure loads for the repaired and original beams with stirrups are compared with predictions using *ACI 318M-02 code* [14] and the modified compression field theory (MCFT) by the program of "Response 2000" [11] as shown in Table 5 and Fig.5 through Fig.7. In this clause, the *ACI 318M-02 code* analysis the deep beams using the strut-and-tie model to predict values of shear capacity of D-regions in such members. These regions are idealized as trusses consisting of concrete compressive struts and reinforcing steel tension ties interconnected by nodal zones of multi-directionally compressed concrete. The truss shall be capable of providing internal load paths for all the forces acting on the regions. For more information see Appendix B in *ACI318M-02 code* and Appendix C in PhD theses in reference [12].

Test results indicate that the ratio of  $V_rR / V_r\text{-ACI}$  and  $V_rR / V_r\text{-Response}$  has an average of 2.2 and 0.97 respectively. The results shown in "Fig.5" through "Fig.7" indicate that the ACI 318M-02 code is conservative compare to the experimental results and program of "Response 2000". The results demonstrate that the program of "Response 2000" un conservative for LWAC repaired beams ,because the stirrups in repaired beams were yielded. The program gives conservative predictions for original beams .

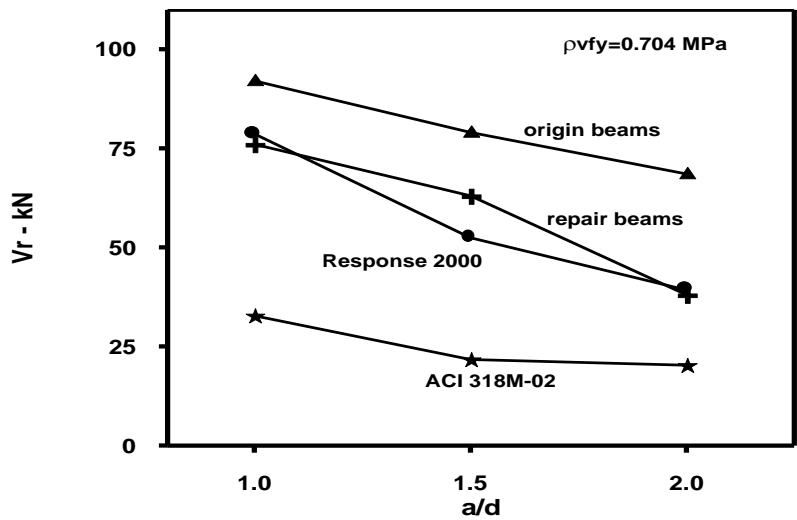
Fig.6 :Effect of shear span to depth ratio ,  $\rho_{vfy} = 0.704$

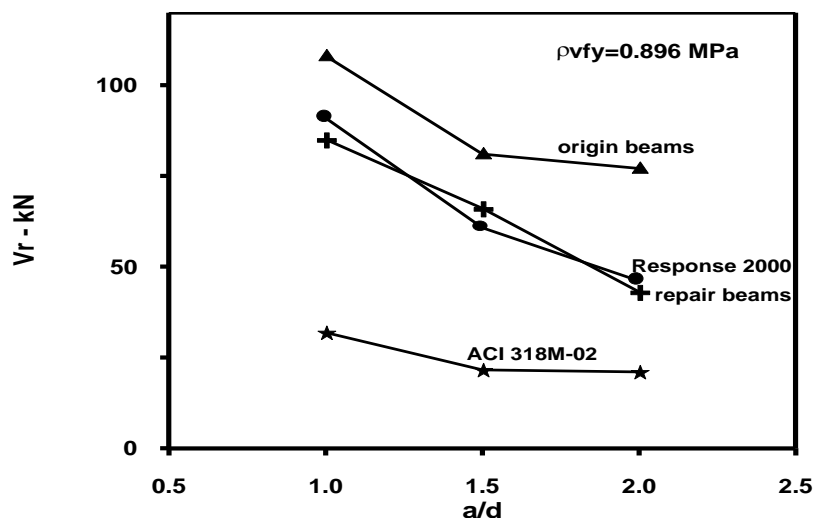
Fig.7 :Effect of shear span to depth ratio ,  $\rho_{vfy} = 0.896$
