## Structural Behavior of Reinforced Concrete Corbels With Transverse Opening

Hadeel sadek mohammed Hassan Ammar Yasir Ali

Department of Civil Engineering ,University of Babylon ,Hilla, Iraq

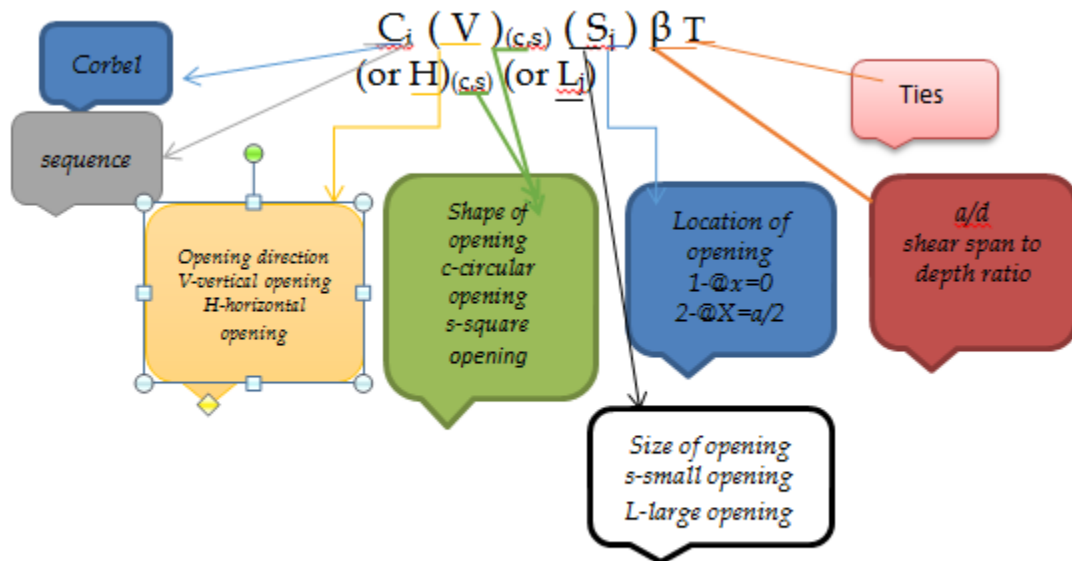
Figure 7 Designation for symbol of tested corbels.

Symbols used in specimens designation refer to sequence of specimens in the test groups according table 1.

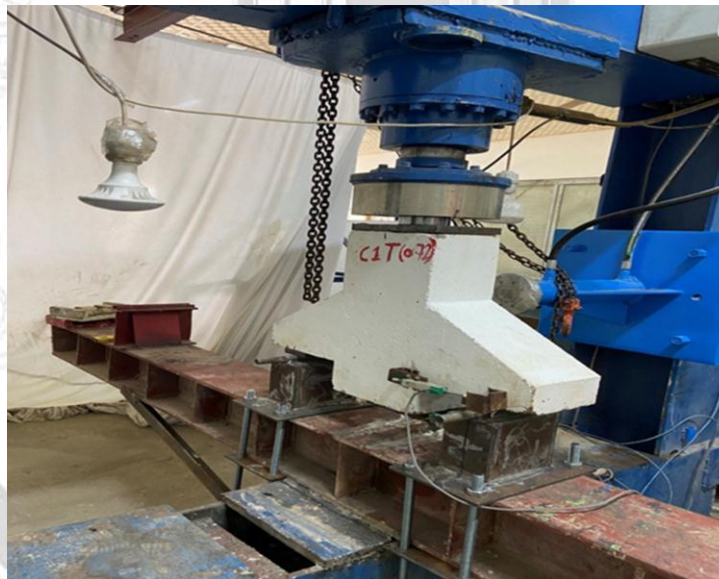
Figure:8 – Test setup with corbel specimen

Servo-hydraulic actuators with a 2000 kN capacity that were available in the structural laboratory of the College of Engineering at Karbala University were used to test the corbel-column systems. Each specimen underwent incremental vertical load application at the upper edge of the corbel while being tested inverted as shown in Figure 8. Deflections in accordance with the applied stress, the emergence and spread of cracks.

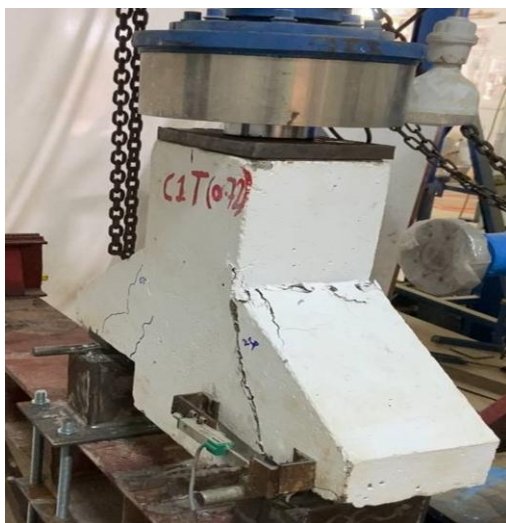
Figure:(9-a) Mode failure of specimen C<sub>1</sub>Figure:(9-b) Load-deflection of specimen C<sub>1</sub>

In this specimen, the corbel was made without opening and is a source for other model Fig.9-b depicts the effect of the load on the deflection of reinforced concrete corbel. A maximum load of 149 kN was recorded . At load 40 kN (about 26.8% from the ultimate load), a flexural crack in the corbel appeared at the face of column junction line with maximum crack width of 1 mm. Due of the huge vertical force, the corbels' initial vertical crack might be predicted. The crack pattern reflected the diagonal splitting specimen failure as illustrated in Figure 9-a. Post cracking stiffness is high as shown in Fig 9-b and number of crack is minimum for this specimen.

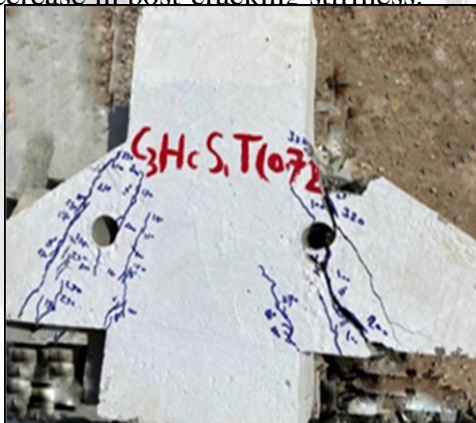
Figure : (10-a) Mode failure of specimen C<sub>3</sub>

The opening in this particular corbel is 40 mm in diameter and is located on the horizontal plane and tangential to face of column at mid depth. At load 40 kN (about 27.2% of the ultimate load) and the maximum width of the crack of 1.75 mm, an increase of nearly 75% from the reference corbel C<sub>1</sub>, a major crack in the corbel (diagonal crack) from the place of support. At load 147 kN, the corbel failed due to the crack under the opening along the compression strut adjacent to the hole in the corbel enlarging. The crack pattern indicated that a diagonal splitting+ flexural compression failure, as shown in Figure 10-a, and (ductile failure) had occurred, which was consistent with the failure of the control specimen and the modal failure of the opening (frame type). As can be seen in Fig.10-b, the ultimate load capacity was reduced at a value of about 1.34%, followed by an increase in service deflection about 338% and decrease in post-cracking stiffness.

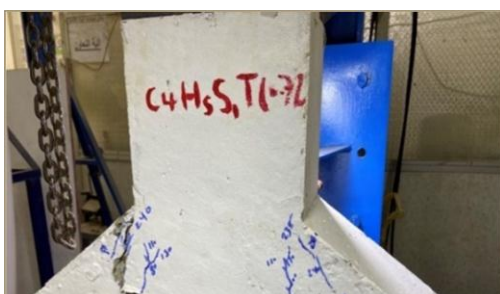
Figure:(11-a) Mode failure of Specimen  $C_4$  Figure:(11-b): Load-deflection of specimen  $C_4$  and  $C_1$

In this specimen, the corbel was made with a horizontal, square (35X35mm), small tangential to face of column at mid depth. The first major crack in corbel (flexural crack) appeared at face of column at 25 kN (approximately 18.38% of the ultimate load) and a maximum width of 1.1 mm, with an increase about 10% compared with reference model C<sub>1</sub>. The crack under the opening along the compression strut close to the hole in the corbel widened to the point of failure at a load of 136 kN, as shown in Figure 11-b. The crack pattern indicated that a diagonal splitting failure as shown in Figure 11-a (ductile failure) had occurred, which was consistent with the failure of the control specimen and the modal failure of the opening (frame type). service Deflection increased by 139% and post-cracking stiffness decreased when compared to the control specimen C<sub>1</sub>, and reduction in ultimate load capacity at roughly 8.72%.

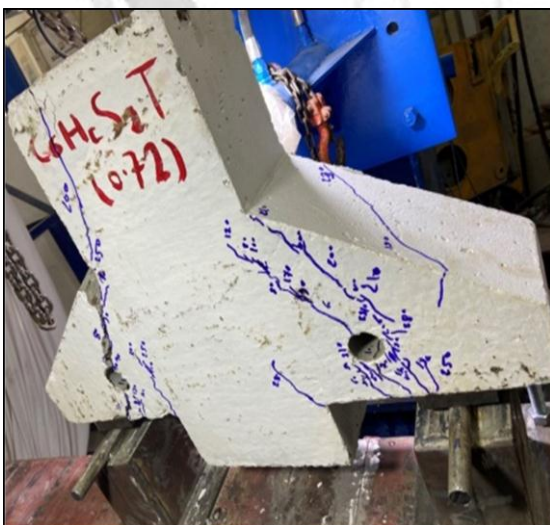
Figure :(12-a) Mode failure of specimen  $C_6$  Figure :(12-b) Load-deflection of specimen  $C_6$  and  $C_1$

In this specimen, the corbel was made with a horizontal circular small opening; the distance from the column to the center of the opening was 75 mm, and the location from the top face of the corbel was 70 mm, and the diameter of the opening was 40 mm. The first crack in the corbel (diagonal crack) appeared above and under the opening at a load of 30 kN (approximately 20.6% of the ultimate load) and the maximum width of the crack was 2 mm, with an increase of about 100% from the reference corbel  $C_1$ . Failure in the corbel happened suddenly when the crack crossed from the top to the bottom of the opening through the opening and along the compression strut until failure at 145 kN Fig. 12-b. Different from the failure of the control specimen and the mode failure of opening (beam type), the failure type that emerged from the crack pattern was a diagonal splitting + shear failure as can be seen in Fig. 12-a, the presence of the hole in the concrete corbels at a distance from the column alters the behavior of failure to brittle failure, resulting a decrease in the ultimate load capacity at about 2.7%. Additionally, there is increase in service deflection about 38.7% and decrease in the post cracking stiffness compared with the control specimen  $C_1$ .

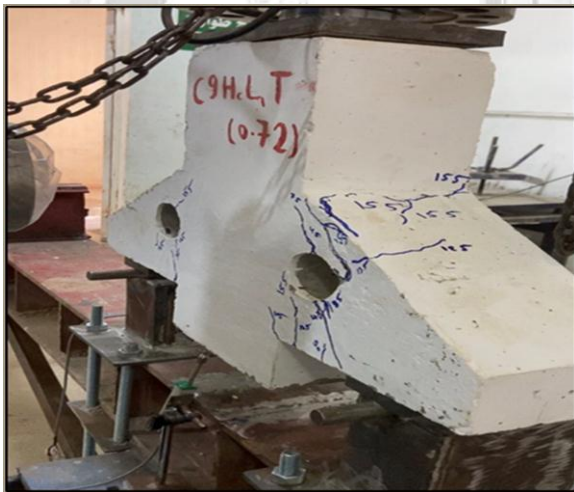
Figure :(13-a) : Mode failure of specimen  $C_9$  Figure(13-b) : Load-deflection of Specimen  $C_9$  and  $C_1$

This specimen has a large opening; its diameter is 70 mm, tangential to face of column at mid depth. At a load of 22.5 kN (about 24.3% of the ultimate load) and a maximum crack width of 2 mm, this was an increase of almost 100% from the cracking load of the reference corbel  $C_1$ . a significant crack in the corbel (diagonal crack) occurred above and under the opening; corbel failure began at load 92.5 kN, as shown in Fig.13-b, when the crack under the opening along the compression strut close to the hole in the corbel widened. Diagonal splitting+ shear failure as shown in Fig. 13-a (ductile failure) was the failure type that emerged from the crack pattern, and the mode failure of opening (beam type). Compared to the control specimen  $C_1$ , the ultimate load capacity of the test specimen may be reduced by roughly 37.9%, followed by an increase in deflection at service load of 830% and decrease in post cracking stiffness.

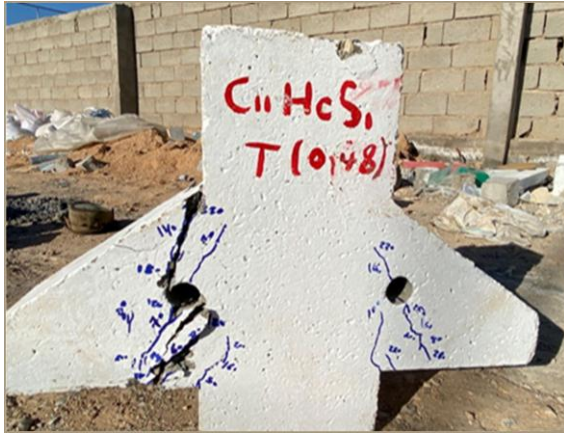
Figure :(14-a): Mode failure of specimen  $C_{11}$

This specimen is the same as model  $C_3$ . The corbel contains small circular of diameter 40 mm tangential to face of column at mid depth, but differs in shear span ( $a/d$ ) = 0.48. The first major crack in corbel (diagonal crack) appeared at the face of column at 25 kN parallel opening (approximately 13% of the ultimate load) and a maximum width of crack of 0.75 mm, with a decrease of about 25% from the reference corbel  $C_1$ . As shown in Fig. 14- b, the corbel failed at a load of 190 kN because the crack under the opening along the compression strut next to the hole in the corbel widened. Diagonal splitting failure as shown in Figure14-a (ductile failure) was the failure type that emerged from the crack pattern, mirroring the failure of the control specimen and the mode failure of the opening (frame type). As can be seen in Fig. 14-b, the ultimate load

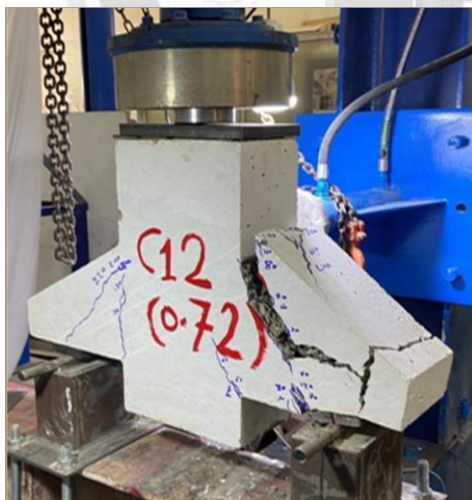
Figure :(15-a) : Mode failure of specimen  $C_{12}$

This specimen does not contain horizontal ties, nor an opening; it is considered as reference for the following models. The first significant crack in corbel (diagonal crack) appeared at the face of column at 30 kN (approximately 24% of the ultimate load) and a maximum crack width of 1.25 mm. The failure of the corbel was initiated by the propagation of crack from a point load along the compression strut to 125 kN, as depicted in (Fig.15-b). shear failure is a failure variety that resulted from the crack pattern as shown in Figure 15-a.

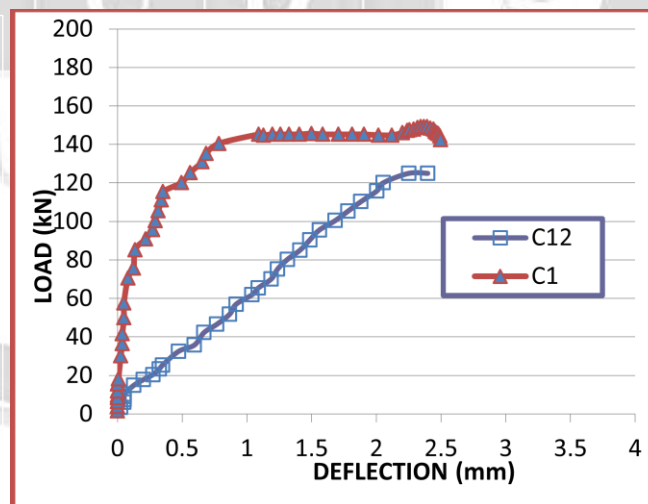
Figure :(15-b): Load-deflection of Specimen  $C_{12}$  and  $C_1$

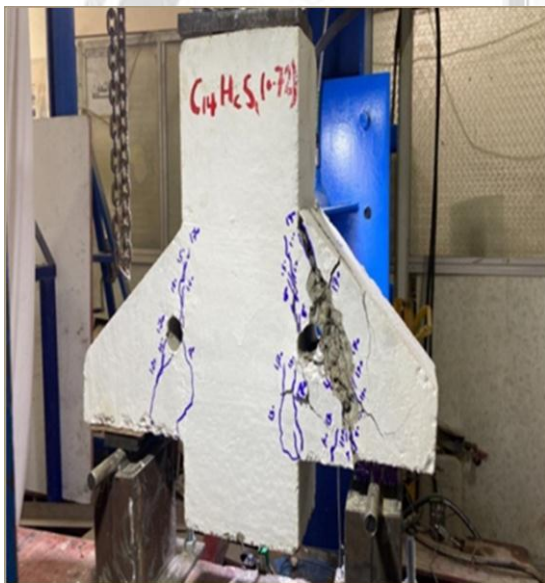
Figure : (17-a) Mode failure of Specimen C<sub>14</sub>

This specimen without ties, The corbel contains small circular diameter 40 mm tangential to face of column at mid depth. The first major diagonal crack in corbel (flexural crack) around opening and at 25 kN (approximately 23.5% of the ultimate load) and a maximum width of crack of 2mm, with increase of about 33.3% from the reference corbel C<sub>12</sub>. As shown in (Fig. 16- b), the corbel failed at a load of 106.5 kN because the crack around the opening along the compression strut next to the hole in the corbel widened. As shown in Figure 16-a diagonal splitting failure was the failure type that emerged from the crack pattern, and the mode failure of the opening (frame type). As can be seen in Figure 16-b, the ultimate load capacity was significantly decreased by about 14.8%, followed by increase in service deflection by 30.8% and a reduction in post-cracking stiffness.

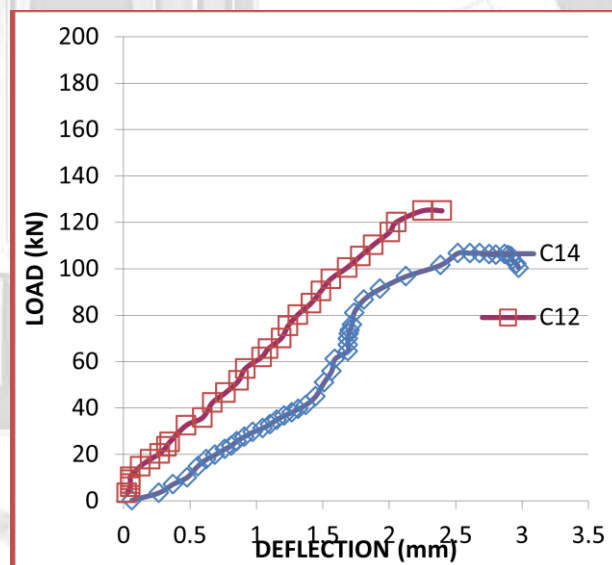
Figure : (17-b) Load-deflection of specimen C<sub>14</sub> and C<sub>12</sub>
