Bank Erosion and Land Use Change of a Part of the Euphrates River between Al-Sadda and Al-Hindia Cities

R. M. AL-Hussainy -Karbala University, College of Engineering, Civil Department

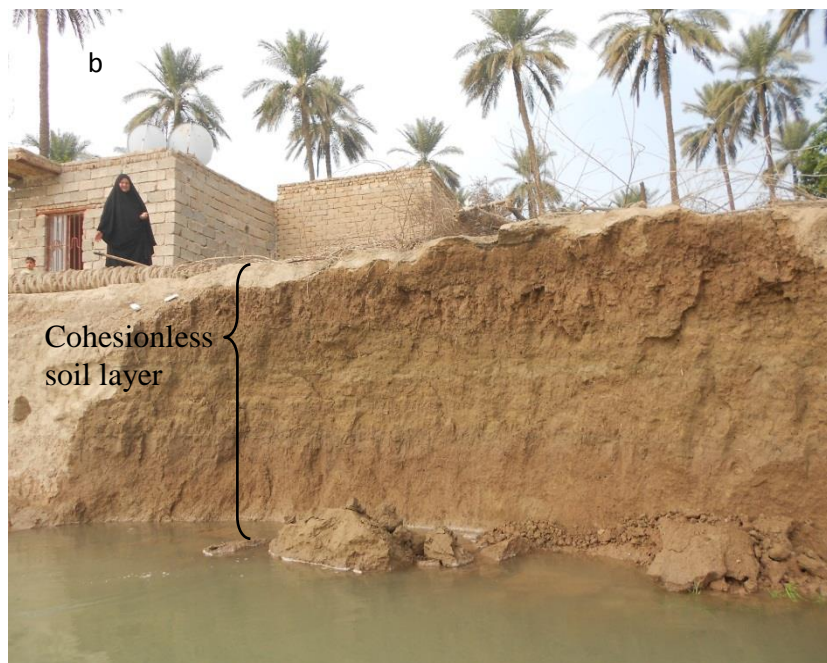
Fig. 2-b Bank erosion and their effects on settlement land put peasants' houses under tangible dangerous. The distance between the house and the new river bank is (5 Meters).

At both banks of river, land use categories differ along the studied part, mainly agricultural land considering the predominant land use. Settlement, fishing, tourism and recreation represents another use for land, cane and bulrush growing at both banks, and using as principal forage for droves of cattles. Field observations shows that the human and natural activities made great impact on river bank stability due to disturbance on river system, this disturbance represented by bank erosion problem and causing in big losses in agricultural land and put some of farmer houses under tangible dangerous (Fig. 2-a) and (Fig. 2-b).

One of them, it is so dangerous because the new bank backing away to be more close to the farmer house and putting his house under tangible dangerous (Fig. 2-b).
