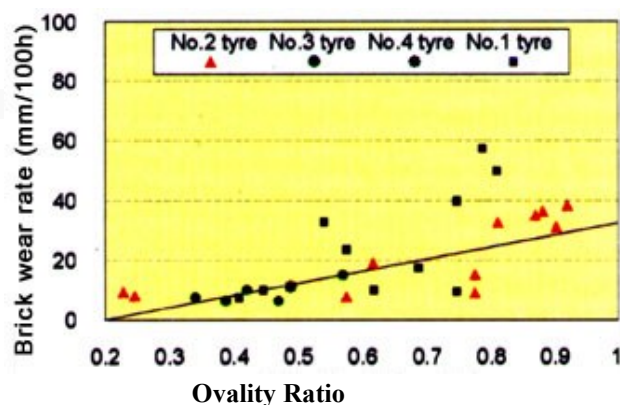
The graphics data [Tuchiya 1996] (Figure 1) clearly illustrates an increased brick wear rate with increased Ovality

Fig 1: Brick wear ratio vs. Ovality

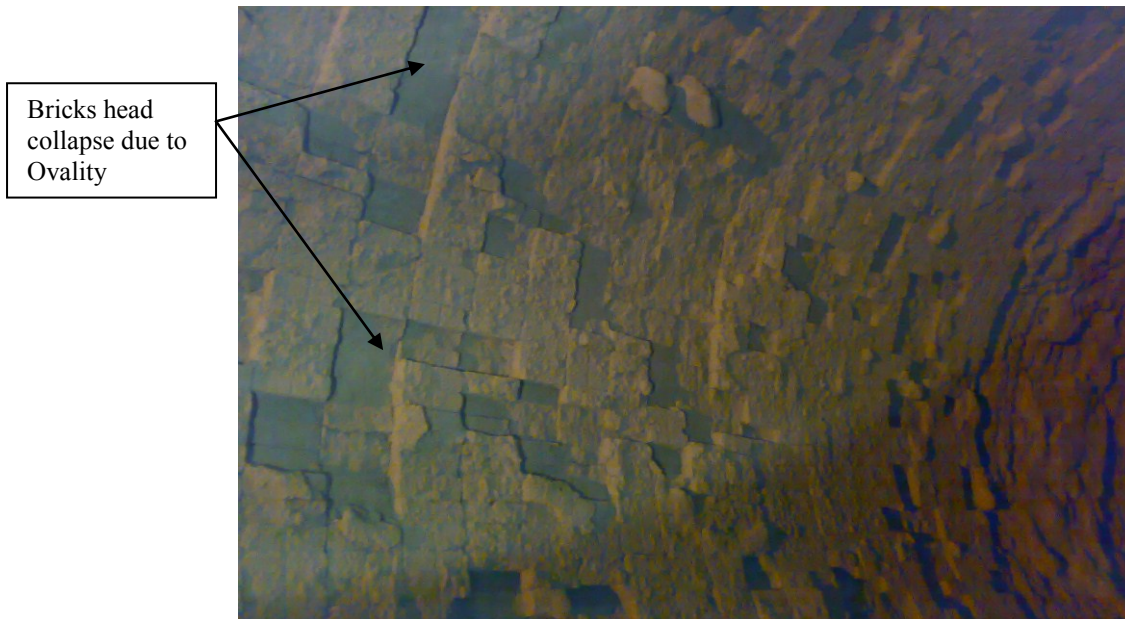
Fig 3 : Damage of refractory bricks due to Ovality (about 3 months of kiln operation ,Kufa cement plant, kiln No.2,tire base No.2) about 20% of brick thickness is fall down.

The total cost of replaced brick is about 700-750 thousand \$ for each kiln by year. So the failure of refractory lining in cement kiln is expensive, not only the cost of refractory replacement but also the lost in production time. Re-lining a kiln requires that the system be completely shut down, and under the best circumstances take about 12 days for a partial rebuild ,longer for complete rebuild. A rebuild involves cool down up to 6 days and teardown and repairs 5 days for a partial rebuild and 7-10 days or longer for a full rebuild[Department of kilns ,Kufa cement plant]. Figure 3 shows the damages occur in bricks due to Ovality while Figure 4 show the refractory rebuilding in Kufa cement kilns.

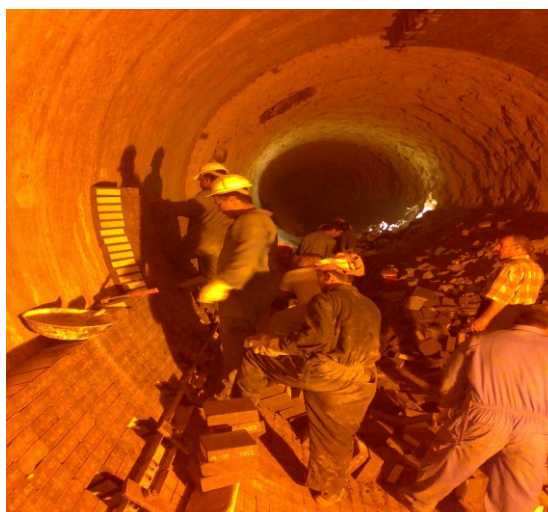
Fig 4 :Refractory Brick Re-building at Kufa Cement Factory (Kiln No.2).

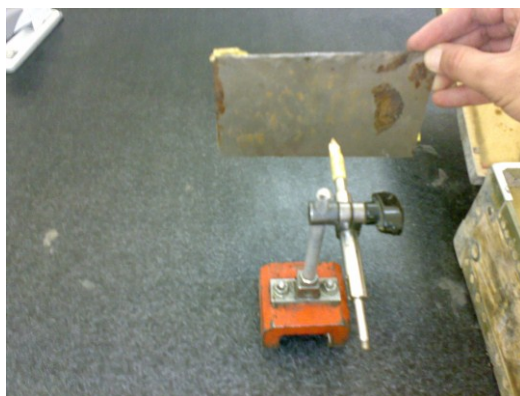
The technique for Rotary Kiln Ovality measurement, by Shell test apparatus, has been developed way back in the beginning of 1950's by G.Rosenblad[Geraldo 2002]. Practically Ovality can be measured with a simple device shown in Figure 6. It consists of a pointer and a recording plate. The pointer is attached to the kiln shell by a magnet and pressed in contact with the recording plate which is secured with help of a magnet on to the tire. The creep "U" and the tire clearance "S" can be read directly from the plotted profile. Or the creep can be determined by suitably marking tire and the shell and then by measuring displacement between tire and shell.

Fig 6 : The Ovality measuring device.

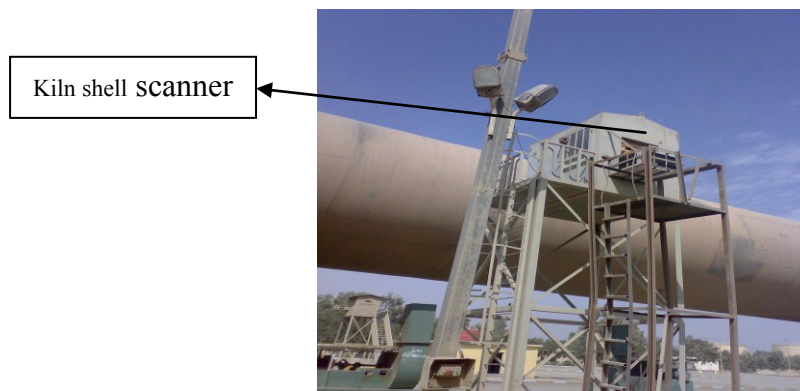
The temperatures distribution of the kiln shell was measured practically by simple device called kiln shell scanner (Field located analyzer that measures the temperature of a kiln shell.) as shown in Figure 7, this device connected to computers in the control room using special software called (Data Temperature CS100).Figures 8,9 represent the first and Second 50 m of the kiln shell temperature distribution .This program measure the real temperatures of critical zones from 0 to 150 meters of kiln shell.

Fig 7: Kiln shell scanner

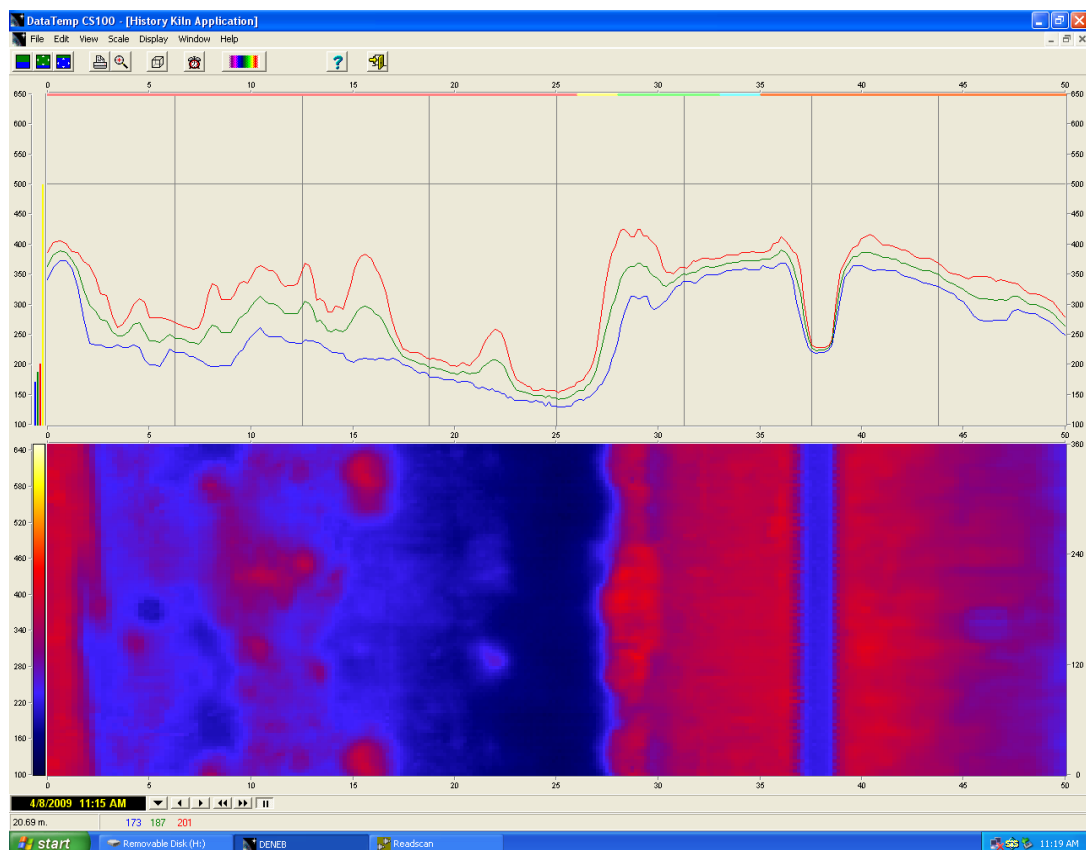
Fig 8 : The First 50 m of Kiln Shell Temperature distribution.

- The number of scanned shell temperature points taken for a complete rotation of the kiln was twenty five. The temperature of each calculation point through axial position was assumed an average mathematical value of all points.
- The shell temperature in any required point on the surface could be correlated by making an interpolation between the curve points of figures 8,9 as in the following Eqns.:

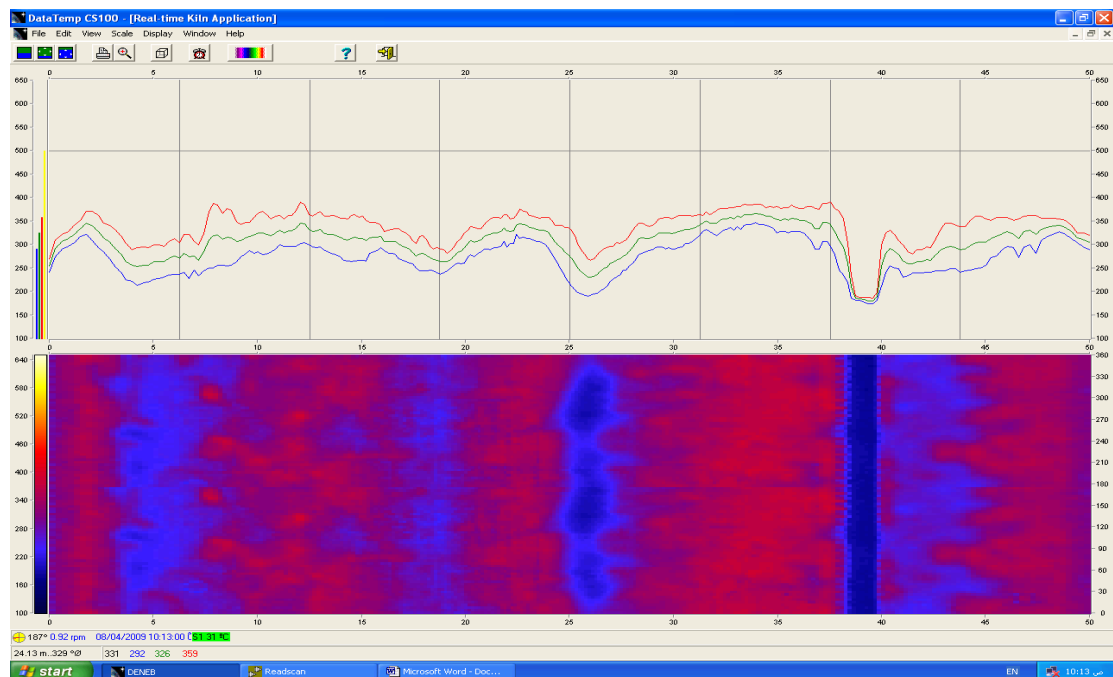
Fig 9 : The Second 50 m of Kiln Shell Temperature distribution.

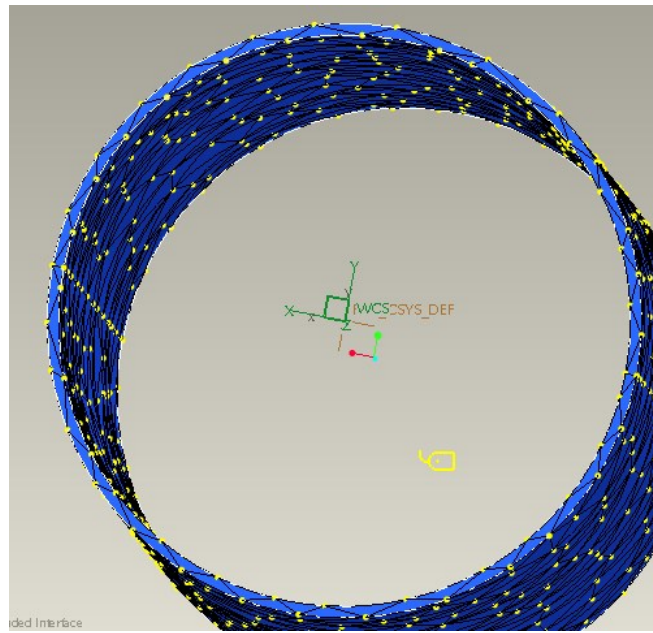
Fig 10: Mesh of 10 meter of Kiln Shell (6537 solid element eight-node) and the axis direction.

The types of elements and axis direction was shown in Fig. 10 and Fig.11.

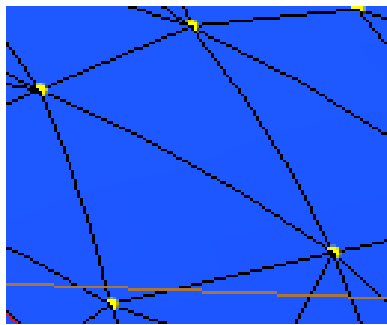
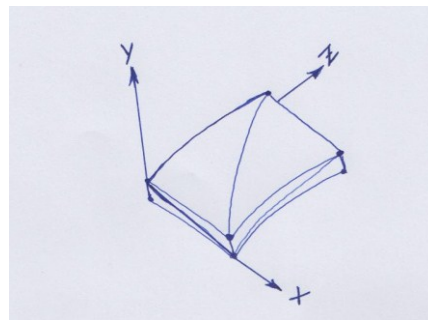
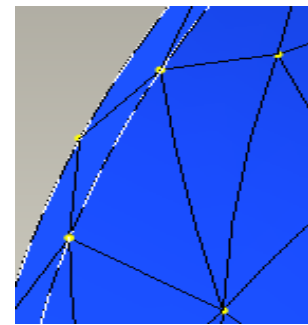
**Fig 11: (a) 0.6 x 0.55 x 0.5 x 0.45 m face and 0.2m thickness solid element 8-node.
(b) The direction of element axis.
(c) The element edge.**

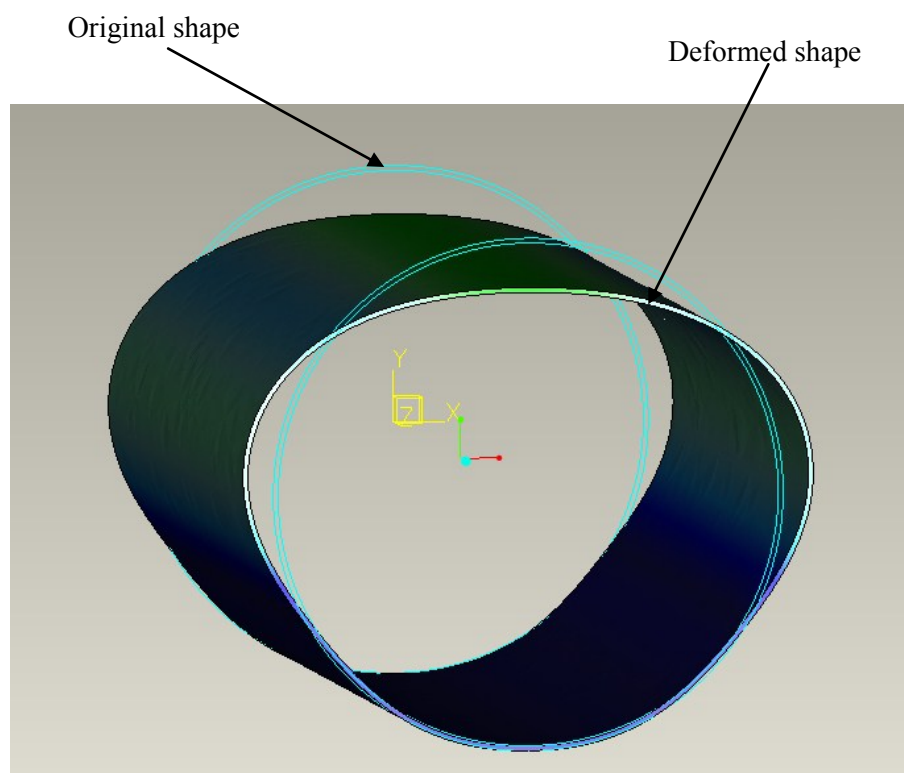
Fig 12: Kiln Shell deformation Due to Ovality (Pro-Engineer Results)

The results of kiln deformations from Pro-Engineer software are shown in Fig 12-14:

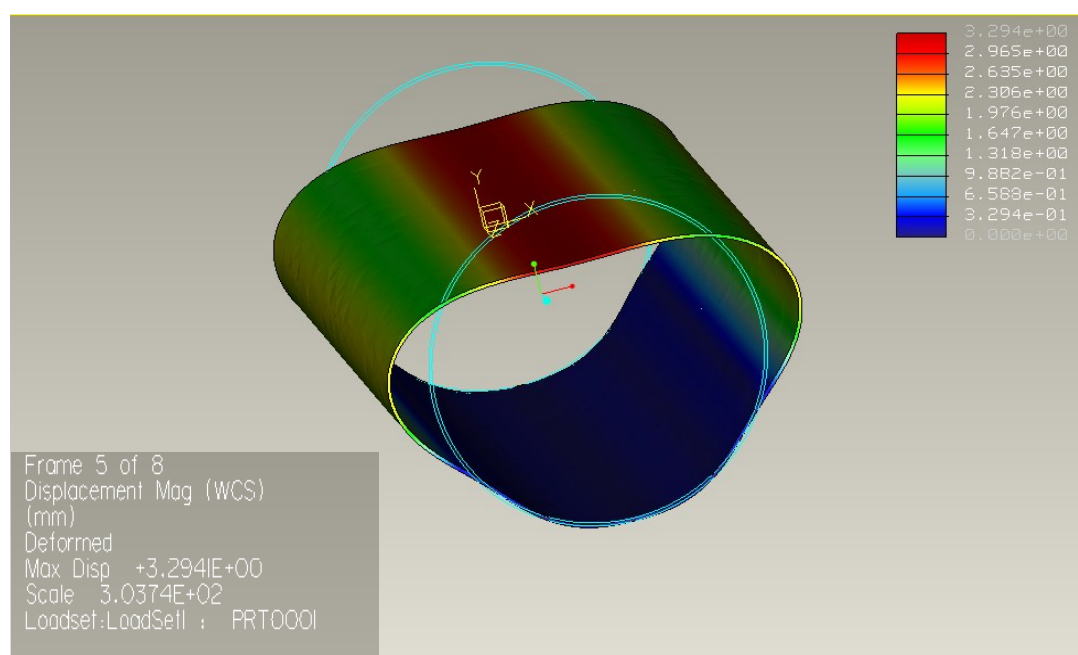
Fig 13 : Maximum clearance between tire and shell (S)=3.29 cm at temperature =200°C, tire base No.2 (90 m)

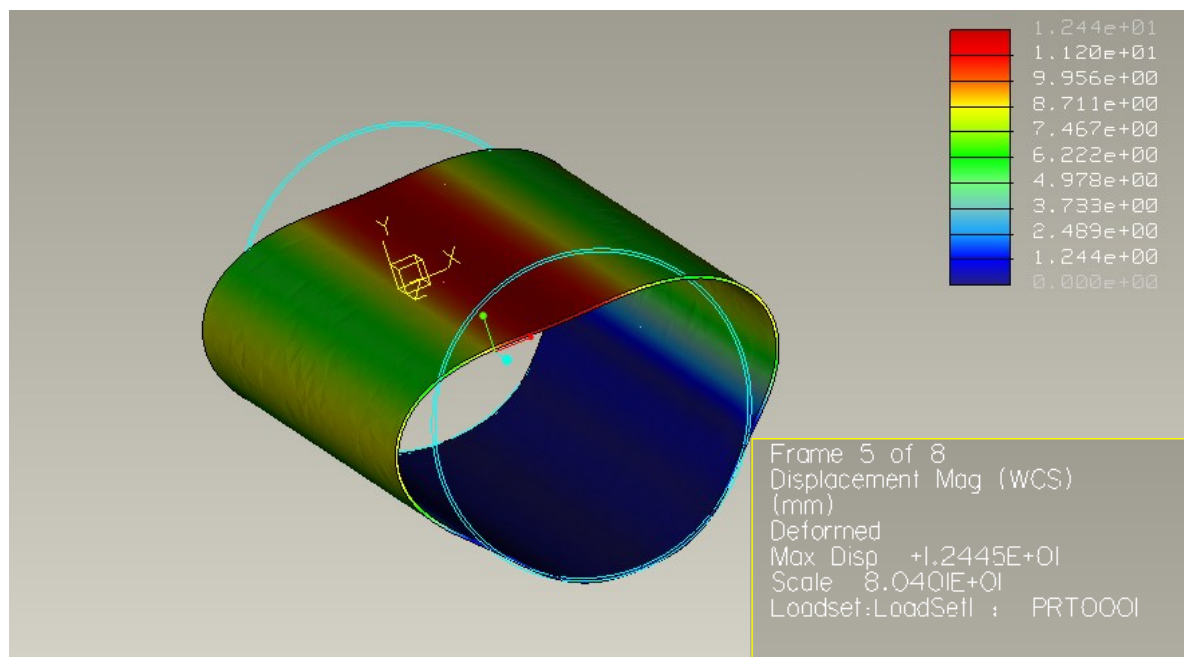
Fig 14: Maximum clearance between tire and shell (S)=12.44 cm at temperature =350°C, tire base No.1 (45 m)

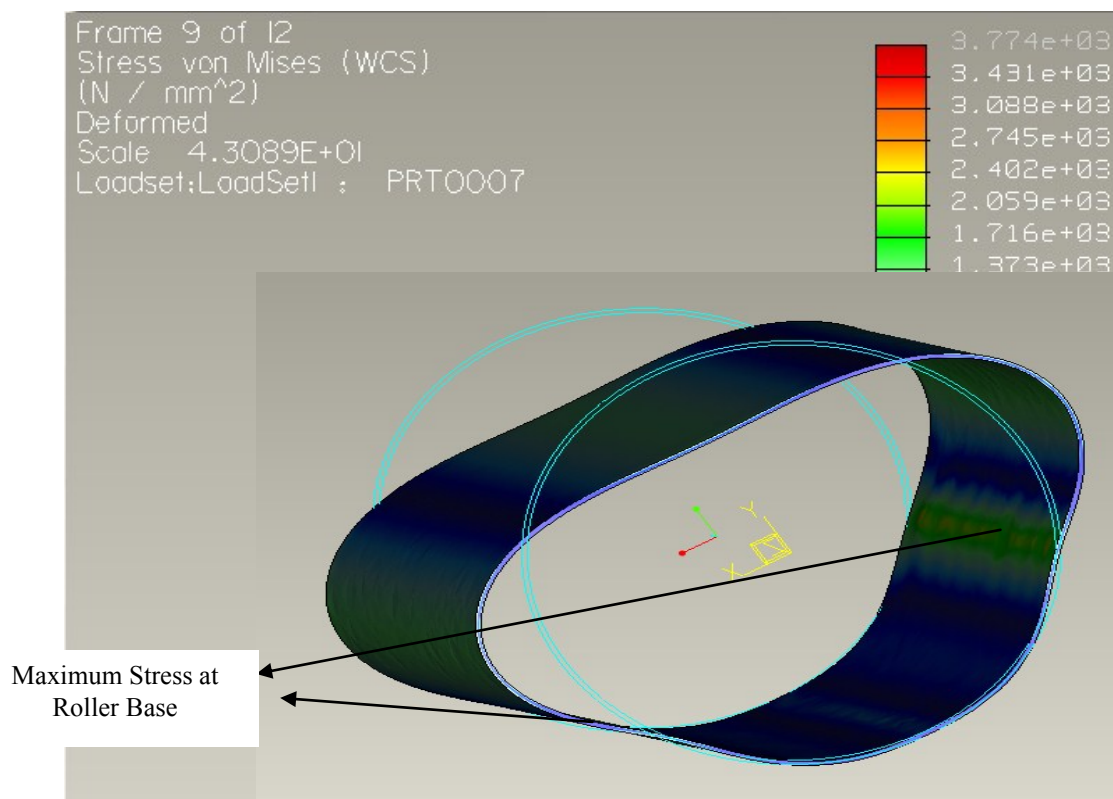
Fig 15: Stresses due to Ovality at temperature =400°C

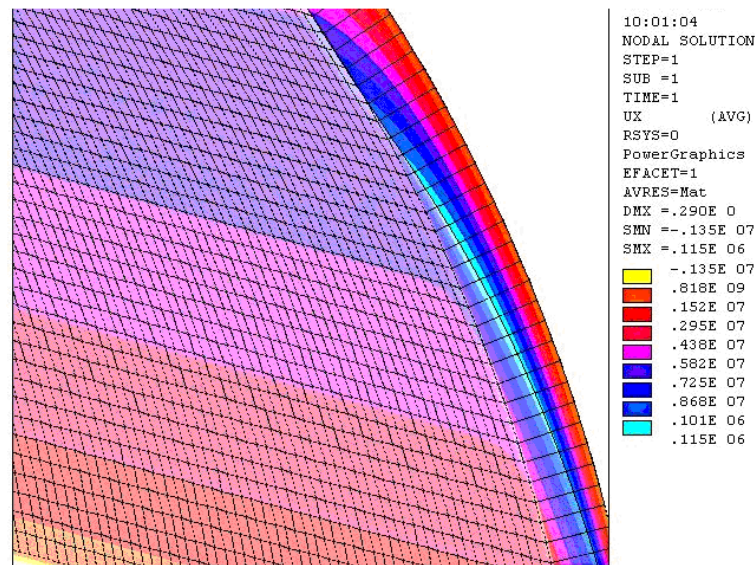
The stresses in lining brick due to Ovality are shown in Fig 16.

Fig 16: Stresses (N/cm²) due to Ovality on a quarter kiln lining brick (at kiln shell temperature=350°C and brick {Alumax 75 A} temperature=1000°C) in upper transition zone.

When maximum axial stresses exceed the strength of brick which represented by MOR (Modulus of Rupture) and hot MOR the failure will occur.

Max axial stress $SMX_{brick} = 18.4 \text{ MPa}$

So the value of maximum stress for each Alumina (Alumax 75) brick exceed the MOR (Table 1 which equal to 12 MPa) lead surely to failure.

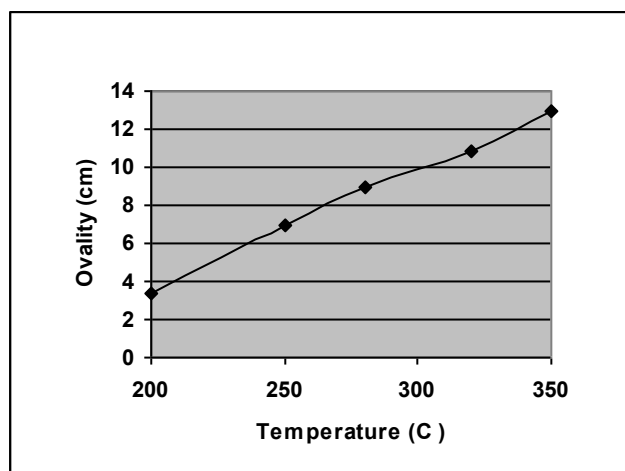
Fig 17: The Ovality Phenomena vs Temperature at tire No.1 (1st 50 m) length.

It is shown from Figure 17 that there is increasing in Ovality phenomena with increasing temperature. The stresses (as shown in Figure 18) was concentrated in the region near the last quarter (14 cm) of brick length leading to failure because of the displacement of the bottom of brick was assumed zero.

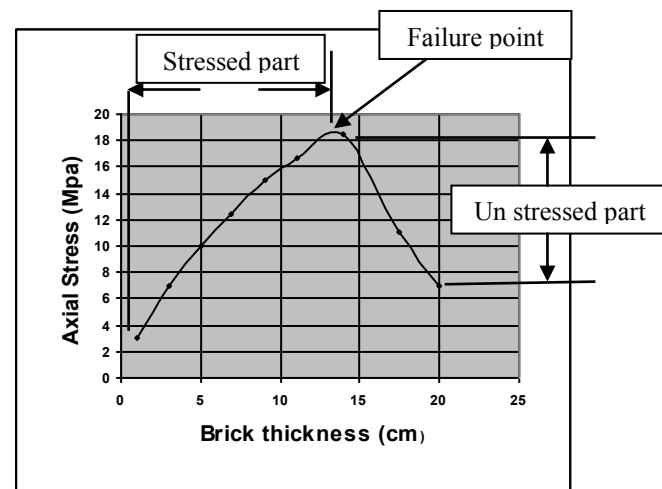
Fig 18: The axial stress along the brick

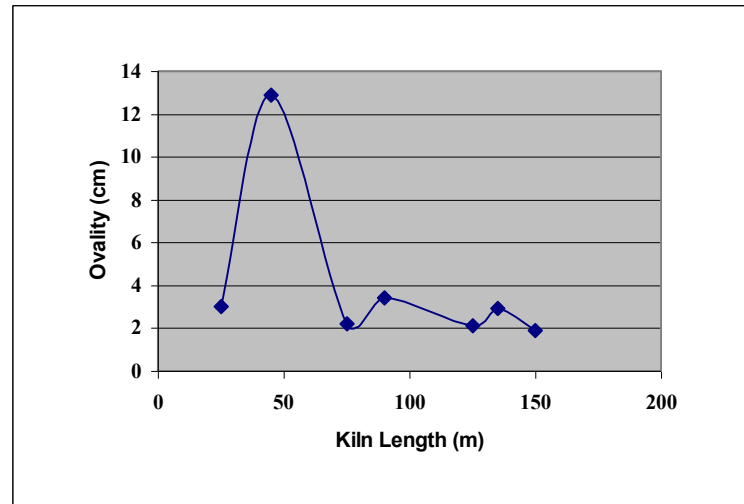
Fig 19: The Ovality Phenomena along the kiln length.

Figure 19 show the Ovality along the kiln length, it is shown that the first quarter of kiln is exposed to high deformations due to temperature increasing, as well as, it is shown that the Ovality is high on tires.

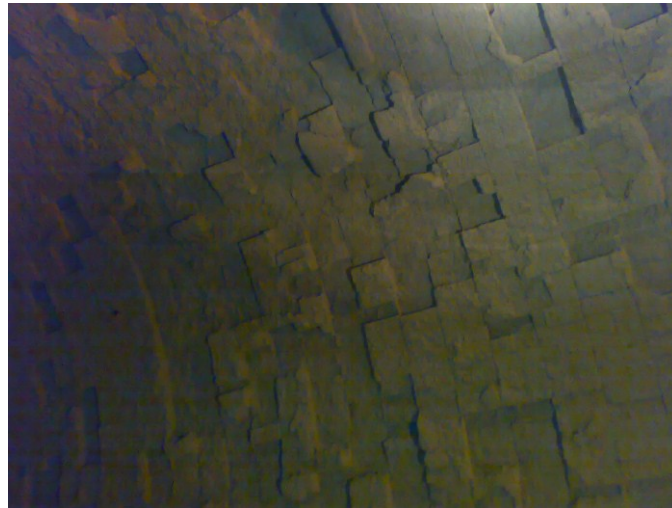
Fig 20 : Ovality (about 3 months of kiln operation ,Kufa cement plant, kiln No.2,tire base No.1) about 20% of brick thickness(4 cm) is fall down.

1. Because the tire is supported primarily at the bottom, its own weight will cause it to sit flat. This flattening of the tire makes the horizontal axis a little longer than the vertical axis.
2. Each tire has two point loads where it sits on the two support rollers. The two point loads work to straighten out the tire. As a result, the degree of curvature decreases from the nominal at each roller.
3. As the shell flexes inside the tire, a gap forms between the shell and tire .
4. The brick lining exhibit shifting, crushing lead to cracking because of compression stresses on the two sides of brick.
- 5- As the final results of Ovality a parts of bricks thickness will fall down as shown in Figure 20 .

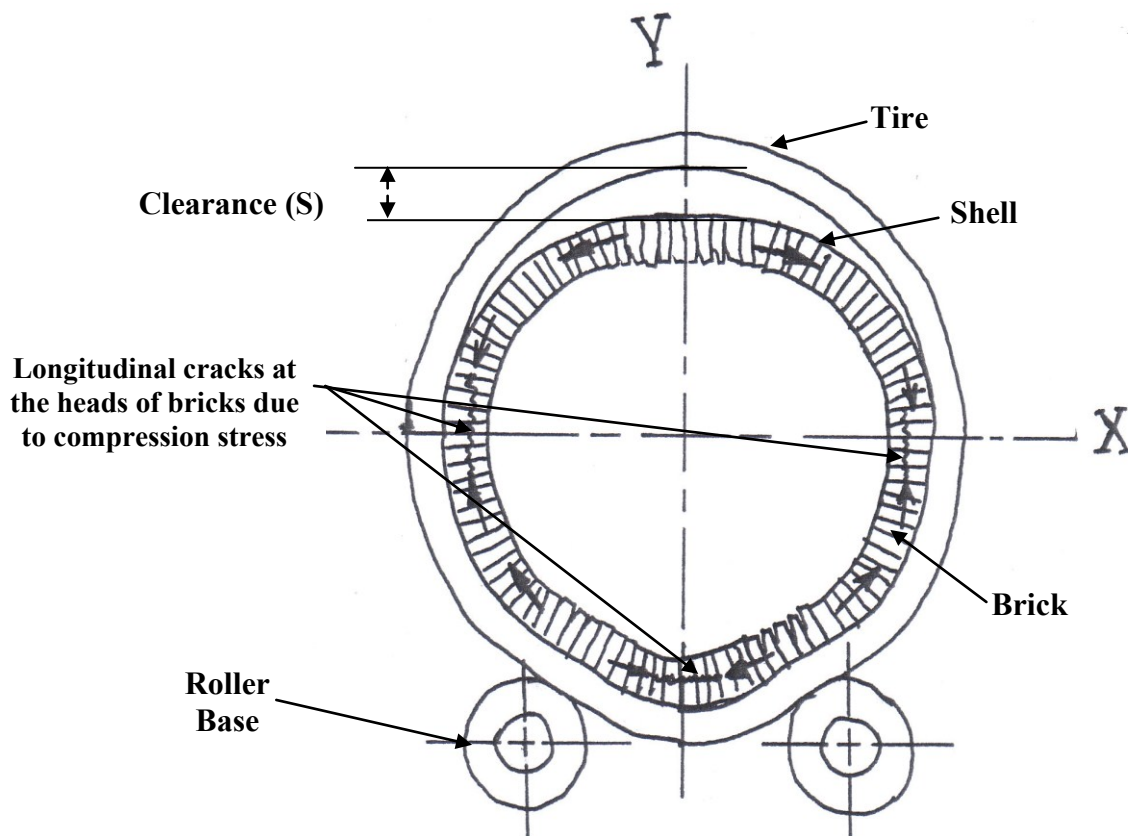
From above results we can show what happen on lining brick during each kiln turn in
Figure 21

**Fig 21 : Ovality condition and its effect on the brick lining
(a cross section in cement kiln).**

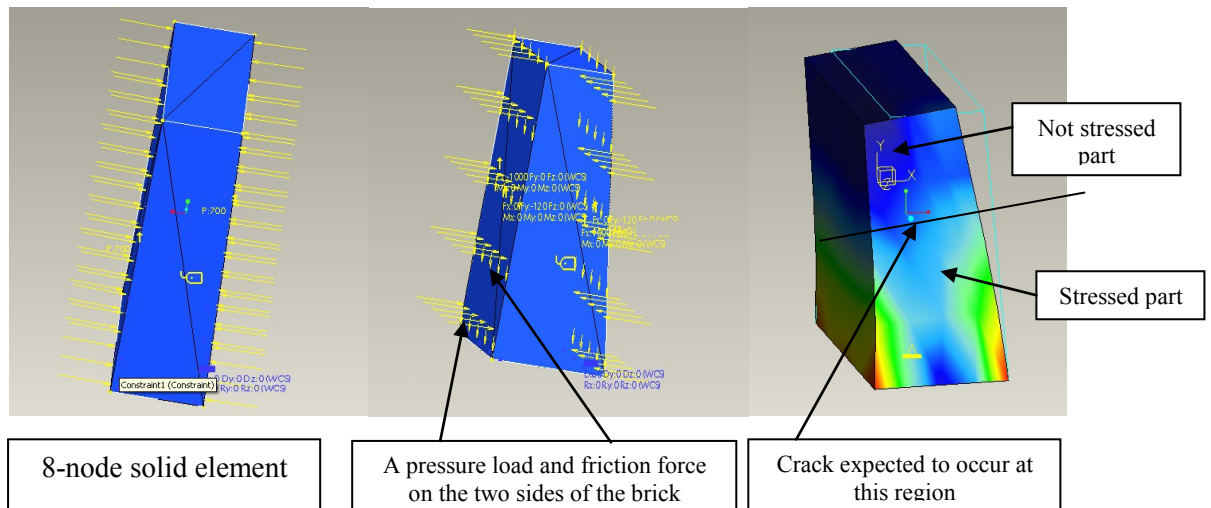
Fig 22: The type of element mesh, loads and crack expected for a brick exposed to Ovality.

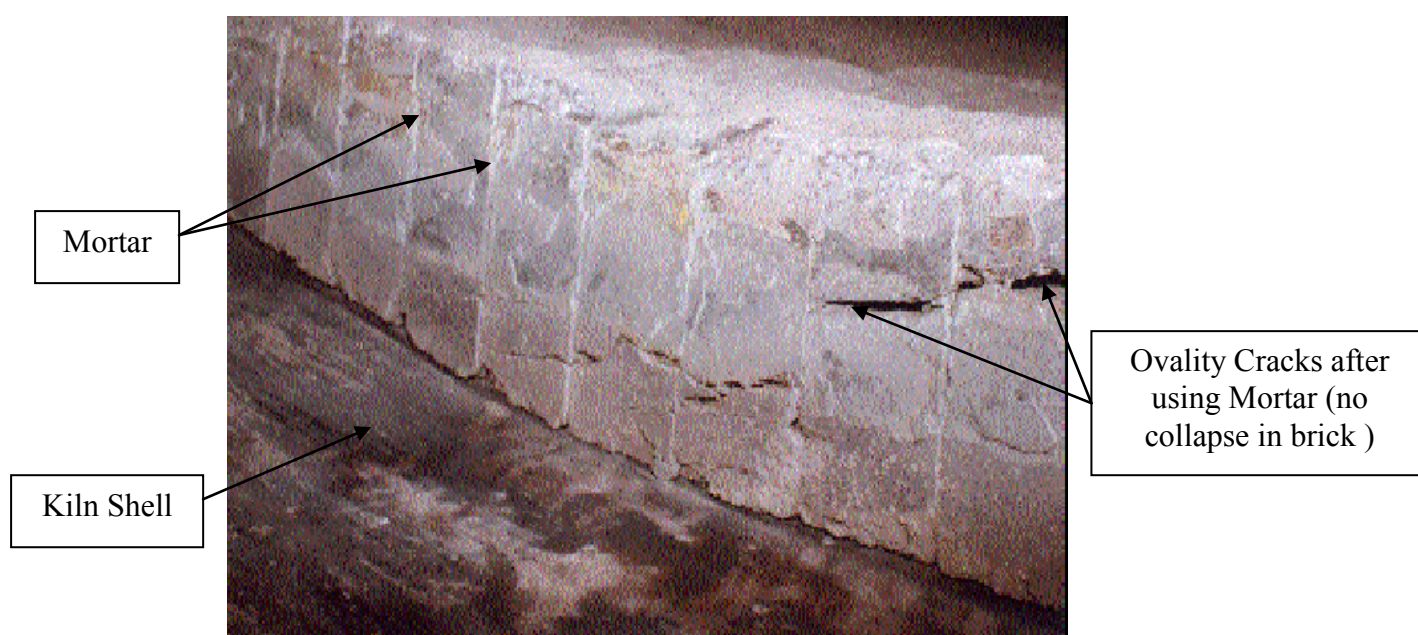
2-Installing the brick lining at tires section must done with mortar [Resco 2001]. Mortar will absorb the vertical forces through a compressibility of the mortar bed this method was applied as shown in Figure 25.

Fig 25 :Using of mortar between bricks to improve its resistance due to Ovality(Resco line Vol.2 2001).

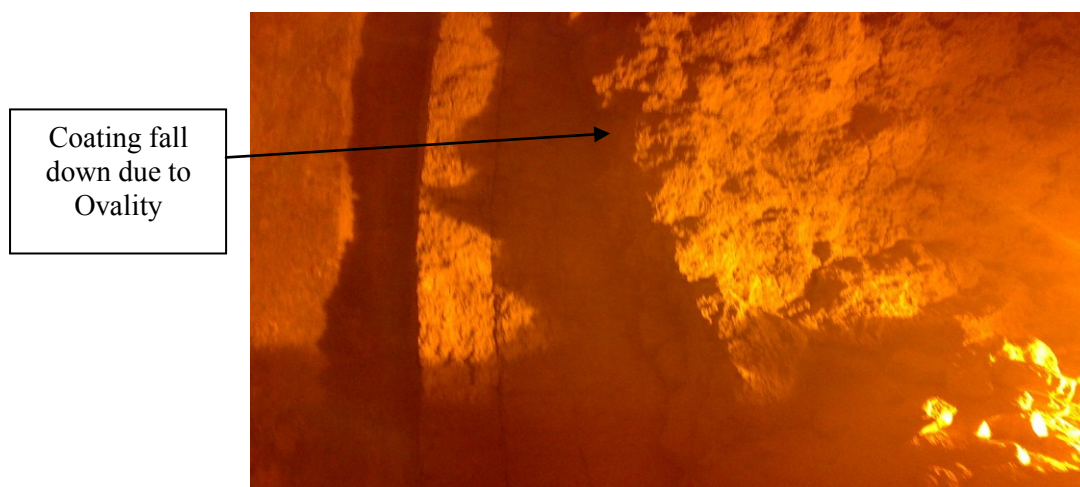
Fig 26: Coating falling down due to Ovality at Burning zone, Kufa cement new factory.

7- In the burning zones. I.e. tire 1, the brick wear rate is extremely sensitive to Ovality since large Ovality makes the coating unstable as shown in Figure 26 and subsequently the bricks are thermally stressed. Thus it is more important that the Ovality of tire 1 is especially kept within the limit for extended refractory life. So that it is recommended to study this case separately.
