## Corrosion Mechanism of Refractory Bricks Lining the Cement Kiln

### ABSTRACT:

Present work investigates causes of damage of two types of refractories, the magnesite 80% MgO and high alumina  $> 70\%$   $Al_2O_3$  lining kiln of ordinary Portland cement at the burning and lower transition zones respectively. To estimate degree of penetration of cement clinker during kiln operation, chemical analysis was conducted for bricks after use for a limited period of time, and also for clinker before and after burning to eliminate detrimental corrosive materials (like alkalis, sulfur, chlorine).

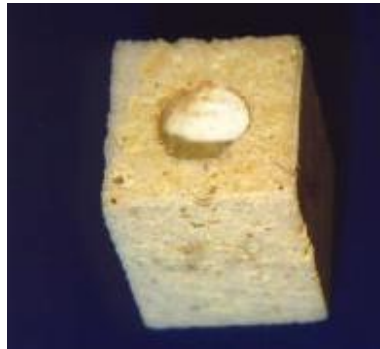
**Fig 2: 50 mm length cube specimen with 25 mm diameter half sphere for alkali attack test (high alumina refractory)**

To study the alkali resistance for high alumina, an experimental laboratory test (ASTM C-201) is done by taking a refractory cube of 50 mm length contain a half sphere of 25mm diameter as shown in **Fig 2** . The half sphere is filled with clinker which contain the alkali's ( Na<sub>2</sub>O , K<sub>2</sub>O ) and then heated to an elevated temperature of (1000 -1100 °C) with a heating rate of 5 °C/ min for reaction duration up to 6 hour.

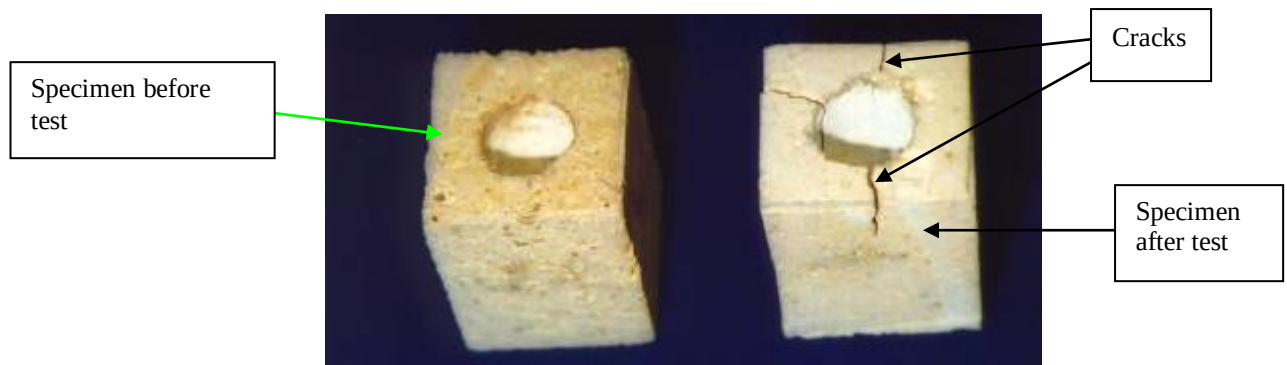
The experimental test of alkali resistance for high alumina specimens results visible cracks as shown in Fig 5 , the alkali resistance is measured by evaluating the degree of cracking in the samples.

**Fig 5: The alkali attack test result in visible cracks caused by volume increasing (High alumina brick).**

Generally, refractories are rigid and tend to crack; the crack here is due to change in volume and external stresses. High alumina brick react with the penetrated alkalies (mention in **Table 4**) like soda ( $\text{Na}_2\text{O}$ ) to form sodium alumina silicate and potash ( $\text{K}_2\text{O}$ ) to form potassium alumina silicate (Hall 2002). This alkalies reaction are detrimental because they are expansive in nature, so the alkali Alumina silicate have much greater volume than the original refractory and the affected brick will crack (as shown in **Fig 5**) to relieve the stress caused by the increasing in volume.
