# Experimental Study on Shear Strengthening of Reinforced Concrete Beams Using Different Techniques of Concrete Jacketing

## Abstract

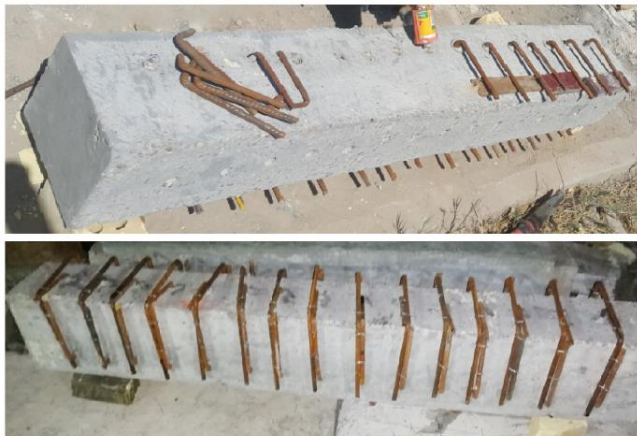
As shown in Fig. 4, the dimensions of the concrete jacket were the same as the previous one. The difference between the strategy used to strengthen this beam and the previous one is in the details of the concrete mixture and the addition of stirrups instead of using steel fiber. The concrete jacket was cast by Self Compacted Concrete (SCC) after adding stirrups. Details of the added shear reinforcement in the concrete jacket are shown in Fig. 4. The mixture proportion and the mechanical properties of the hardened (SCC) mixture are presented in Tables 8 and 9, respectively. The mix design used in (SCC) is the same as (SCFRC) that used in the beam (S.-J. + Stirrup) with the difference of cancellation the steel fiber, which led to a decrease in the proportion of water and plasticizers necessary to obtain fresh mixture within the self-compacted concrete requirements.

**Fig. 4** Details of the beam (S.-J. + Stirrup).**Table 8.** Mix proportion of (SCC).

When the beam (Jac. + Stirrup) reached 28 days' age, the following steps were taken to strengthen it. The first step was to prepare the concrete substrate by grinding its face using a rotary diamond grinder. Then holes of 8 cm deep and 12 mm diameters were made by an electric drill. The holes were made on the concrete surface in the locations specified to add anchors. Steel reinforcement of 10 mm diameters (D10) with angle shape was used as a shear connector. The details and the dimensions of the anchors are presented in Fig. 4. The beam surfaces and the drill holes were cleaned using compressed air. Then the shear connectors were installed by using Sika AnchorFix®-2 + Tropical epoxy resin. Then, after the end of the five-hours curing period, the stirrups were bonded to the anchors. The mechanical and physical properties of the Sika AnchorFix®-2 + Tropical epoxy resin are summarized in Table 10. Then after completing the process of adding shear reinforcement, the beam was cleaned and remolded. A 1 mm layer thickness of the Sikadur®-32 LP was applied to the concrete. Finally, the (SCC) jacket was cast and cured for 28 days by a wet burlap cover.

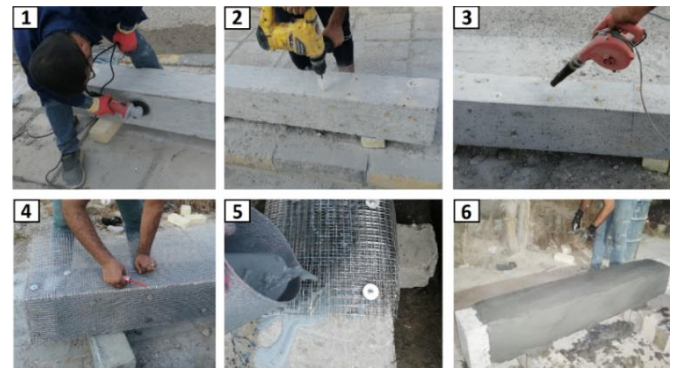
When the age of the beam becomes 28 days, the sample was prepared for strengthening. The concrete surface was roughened by a grinder, many holes were drilled randomly on the concrete surface, the holes and concrete surface cleaned using compressed air, then the plastic fisher screws were inserted inside the holes (see Fig. 6 (1-3)). The pre-prepared six layers of U wrap steel wire mesh was applied on the three sides of beam faces (the web and the tension zone) and mechanically fixed by using bolts and washers (see Fig. 6 (4)). The pre-prepared bonding bridge liquid was applied to the concrete surface (see Fig. 6 (5)). Finally, the beam was plastered with a 20 mm thick high-quality adhesive mortar and cured for 28 days by a wet burlap cover as shown in Fig. 6 (6).

**Fig. 6** The steps involved in the strengthening of the beam (S.-J. + Ferrocement).

In this technique, due to the presence of wire mesh, it is not possible to paint the concrete surface with epoxy. Three steps were taken to avoid getting debonding failure and achieve an acceptable connection between the surface of the beam and the ferrocement jacket. The first one was by using mechanical fasteners. The second step was by using a synthetic rubber emulsion (Sika Latex) old-new bonding agent material. The third step was by using high-quality adhesive mortar as a plaster by using the same material. The high-quality adhesive mortar was prepared by using the mix proportion proposed in the datasheet of the Sika Latex. The amount of the mixed materials and the results of its cube compressive strength at age 28 days are presented in Table 12.

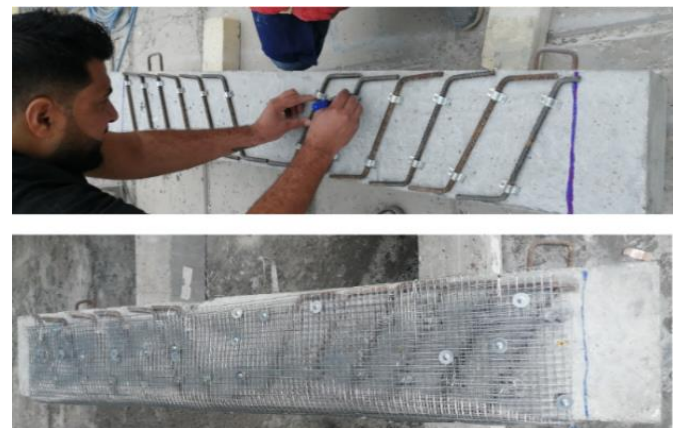
This specimen was strengthened in the same way and the details used in the previous one, with the difference that external steel reinforcing bars were added and mechanically connected on the surface of the beam before the wire mesh wrapping. As shown in Fig. 7 twelve deformed bars of 10 mm (D10) were used on each side of the beam web. The added steel bars were distributed at a distance of 80 mm center to the center and were arranged to be perpendicular on the path connecting the loading point and the beam support.

**Fig. 7** The configuration of the externally bonded steel rebars used in the strengthening of the beam (S.-J. + Ferrocement + R).

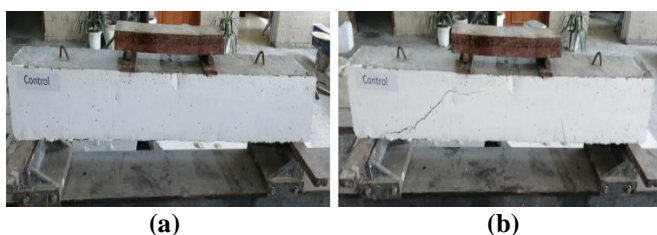
The control beam displayed a shear failure by forming a major diagonal crack. The first crack appears at a total applied load of 80 kN. The crack was initiated near the support and then propagated to the load application point as the load continues to increase. The complete collapse occurred at a total applied load of 136 kN, and the corresponding ultimate mid-span deflection ( $\Delta_U$ ) was 4.87 mm. Fig. 10 shows the control beam (a) before the test and (b) after the failure.

**Fig. 10** The control beam (a) before the test and (b) after the failure.

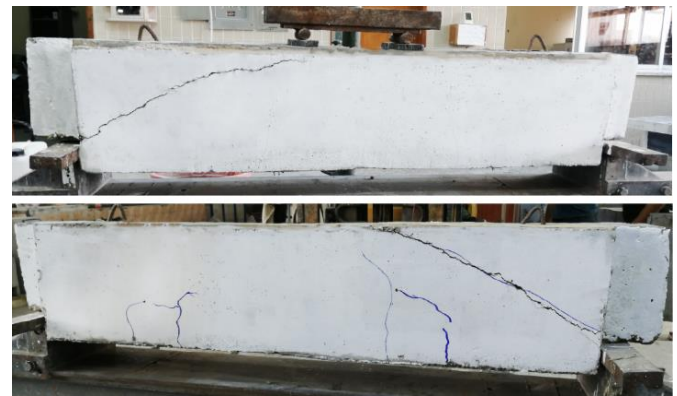
As presented in Table 13 the specimen (S.-J. + Steel Fiber) contributed to increasing the load-carrying capacity of the unstrengthen beam by 35 %. The specimen failed due to a significant diagonal crack. The shear crack was initiated under the edge of the loading plate at 94.4 kN applied load, then propagated toward the support point. The beam failed at a 184 kN load with a 5.63 mm corresponding deflection. Fig. 11 shows the two web faces of the (Jac. + Steel Fiber) specimen after failure.

**Fig. 11** The (S.-J. + Steel Fiber) beam after the failure.

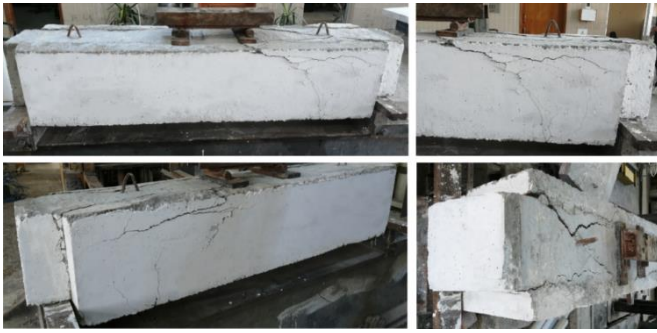
The initial and ultimate failure load of the specimen (Jac. + Stirrup) was 108 kN and 216 kN, respectively. In comparison with the unstrengthen beam, there is a 59 % increase in the load-carrying capacity and a 35 % delay in the initial failure occurrence. The deflection was  $\Delta_U = 6.3$  mm at the ultimate load. The beam demonstrates a considerable increase in the shear capacity and the stiffness of the original beam. It was found through the study that the strategy used to strengthen this beam is considered the best approach among all the methods used to enhance the rest of the specimens. Fig. 12 shows the (Jac. + Stirrup) specimen after testing.

The failure mechanism started with the appearance of a vertical crack at the end of the concrete jacket. The crack was initiated on the surface of the original beam and above the edge of the support plate. The crack extended until it arrived at the top surface of the specimen. As shown in Fig. 12, when the applied load approached the ultimate failure load, some cracks appeared on the cover of the concrete jacket. At the final failure load, the beam failed in explosive mode, and widespread cracks appeared on the upper surface of the original specimen.

Fig. 12 The (S.-J. + Stirrup) beam after the Testing.

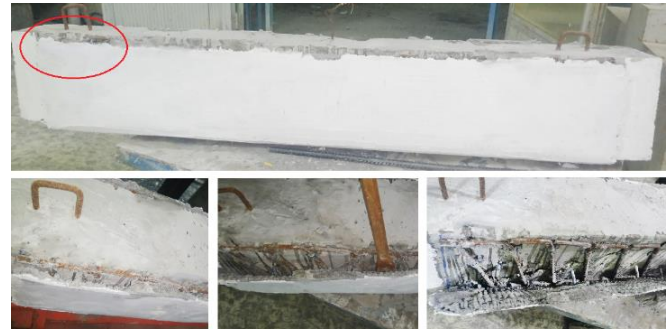
Fig. 14 The (S.-J. + Ferrocement + R) beam after the failure.

Based on the experimental results and as shown in Fig. 9, it was observed that the structural behavior of the beam (S.-J. + Ferrocement + R) was very similar to (S.-J. + Ferrocement) until initial failure load. Compared to the results of the specimen (S.-J. + Ferrocement), the addition of externally bonded steel bars slightly contributed to increasing the rigidity of the strengthened beam. When the applied load has reached 144.2 kN, the beam suddenly failed by debonding the ferrocement jacket, and a large crack was formed connecting the points of support and loading. The shear crack did not appear on the ferrocement jacket but rather was observed after removing the jacketing layer. This type of failure occurred due to the presence of externally bonded steel bars which caused a gap between the surface of the beam and the ferrocement jacket. For this reason, there was a decrease in the adhesive force exist to resist the shear flow. Fig. 14 shows the specimen (S.-J. + Ferrocement + R) after the failure.

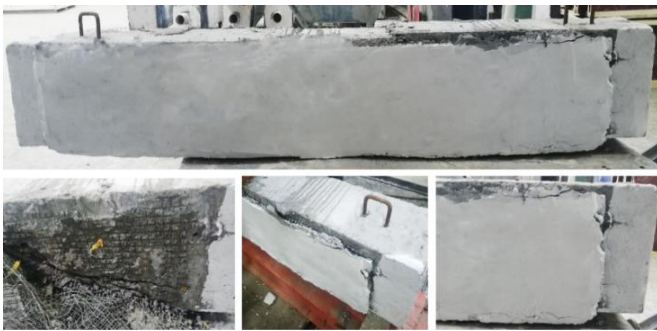
The ferrocement jacket contributed to enhancing the initial and ultimate failure load by 81 % and 30 %, respectively. The technique used in strengthening this beam significantly improved the shear capacity in terms of cracking load. The first shear crack appeared when the applied load reached 82 % of the ultimate failure load. When the applied load became 145 kN a narrow crack appeared near the support plate on the jacket surface. With the increase in applied load, the crack began to expand towards the loading point until the applied load reached the ultimate failure load at 176.3 kN. Debonding of the ferrocement layer occurred at the ultimate failure load, which was accompanied by a sudden shear failure. Fig. 13 shows the specimen S.-J. + Ferrocement after the failure.

Fig. 13 The (S.-J. + Ferrocement) beam after the failure.
