Flexural Behavior of Repaired Reinforced Concrete Slabs with Different Typed of Concrete

Mazen D.Abdulah*

Civil Engineering , College of Engineering ,University of Basra.

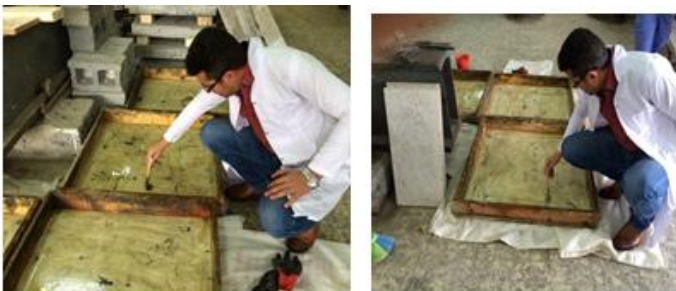
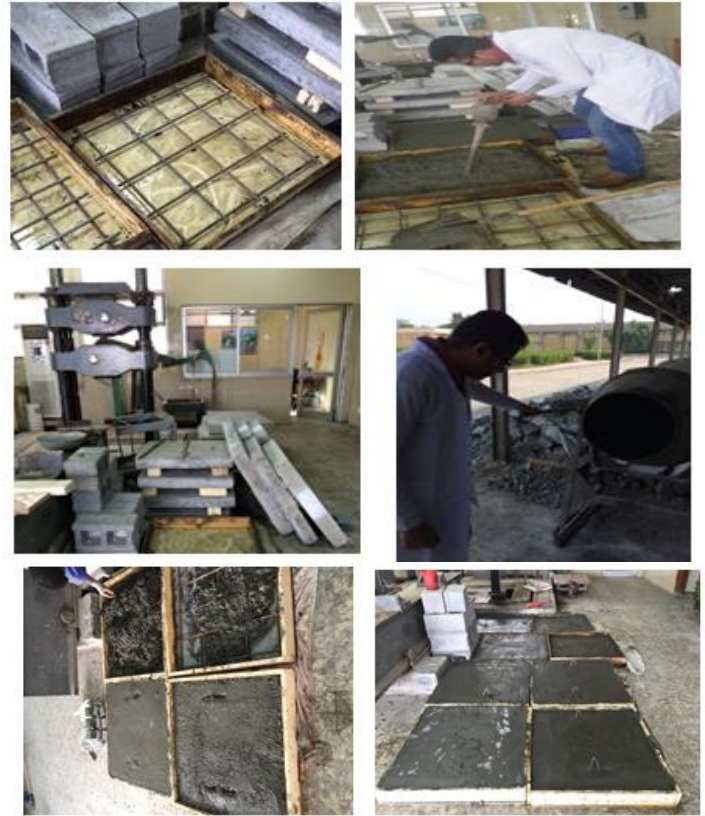
Figure 1: The steps of casting process

The steps of casting process of specimens are shown in Fig. (1).

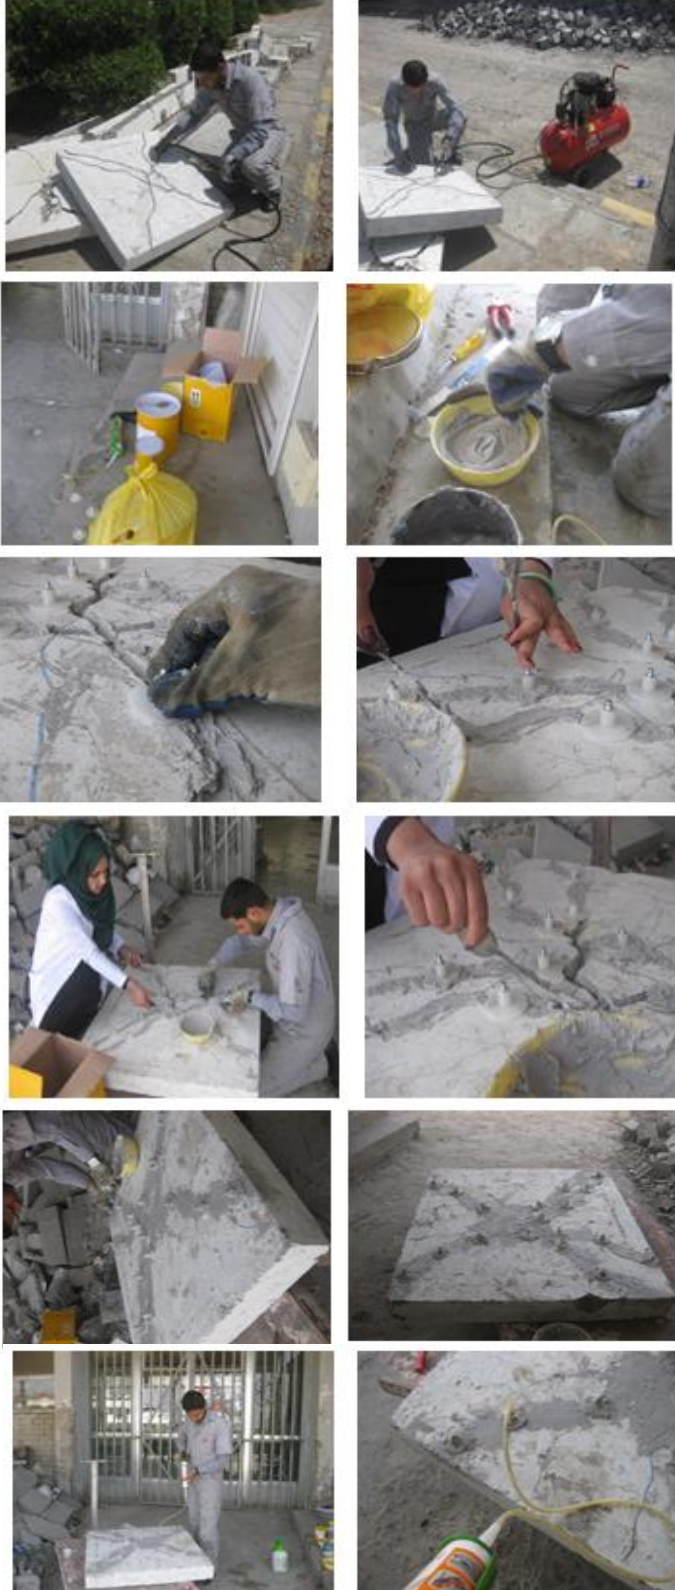
Figure 2:Repair procedure

Fig.(2) shows the injection process. The injection process for all slabs is done successfully and easily for slabs loaded to 100% of the ultimate load obtained for control slab. On the other hand, for slab loaded to the level of loading less than 100% of the ultimate load obtained for control slab, this takes relatively longer time.

1. After failure, cleand major and minor cracks from dust by a compressed air to ensure proper bond of the crack paste and good penetration of resin
2. The surface ports has an opening at the top are placed 10 – 15cm apart along considered crack
3. Fixed the surface ports by applying an epoxy.
4. Seal over the exposed cracks and surface ports by used epoxy paste. To prevent resin seepage 30mm paste is extend with 3mm thickness on either sides of crack .
5. Mixed two components of epoxy resin according to the manufacturer's instructions,(hardener: base) of (3:1) by volume. Theis two components of epoxy resin are mixed by using mechanical stirrer.
6. Injection process starts by usind mechanical injection gun. The epoxy injecte from the lowest port to the above port by using pumping, the injection continue until epoxy begins to flow from port above. The cap used to plugged the first port.

7. The process of injection repeated until all crack has been completely filled with epoxy resin.
8. Provide a curing period to the injected epoxy about 24hours.
8. Remove the surface ports .

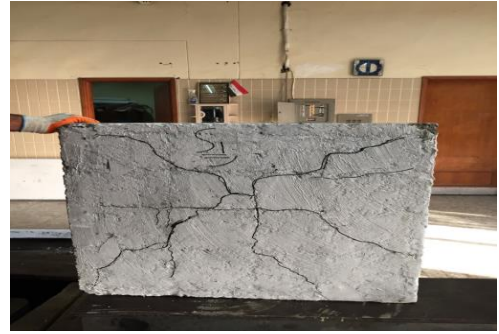
Figure 4.1: Slab (S1) after repairing and retesting

After repaired major and minor flexural cracks in all tested slabs, these cracks do not reopen. The failure in repaired slabs were happened due to developed new flexural cracks, these cracks as the same formation and sequence as the major flexural cracks in the original slabs. Near or adjacent to the repaired major crack the new flexural cracks developed. See Figs.(4.1) to (4.3).

For the repair of epoxy injection of reinforced concrete slabs, after testing the repaired slab the flexural cracks (major and minor) do not reopen in all slabs except slab S8 & S9, approximately with the same sequence and formation as the major flexural cracks in the original slabs the new flexural cracks developed to cause a slab failure. The new flexural crack is developed adjacent to the repaired major crack in slabs S4, near the repaired major crack in S1&S5 and away from the repaired major crack at other slab S2. In all slabs near the repaired minor flexural crack a new minor flexural crack is developed. See Figs.(4.1) to (4.5).

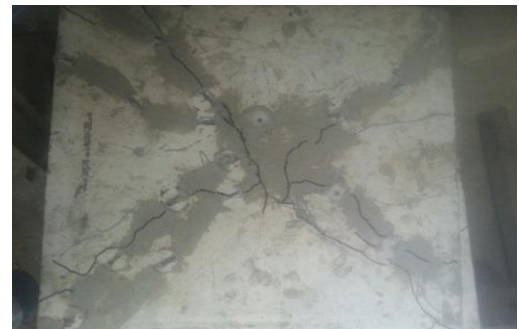
Figure 4.4 : Slab (S6) after repairing and retesting

After repaired major and minor flexural cracks in all tested slabs, these cracks do not reopen in slabs S6 and S9. The failure in repaired slabs were happen due to developed new flexural cracks, these cracks as the same formation and sequence as the flexural cracks in the original slabs. Near or adjacent to the repaired major crack the new flexural is developed in slab S6. The repaired major flexural cracks in the repaired slabs S8 and S9 are reopened, as shown in Figs.(4.4).

The major flexural cracks for HSC differs from case of NSC slabs, their cracks may reopen and cause failure.

The above results indicate fact that the compressive strength of HSC slabs is approximately similar to the compressive strength of epoxy used in repaired slabs and reopening of cracks may occur. See Fig.(5.6)-(5.9) and Table (7).

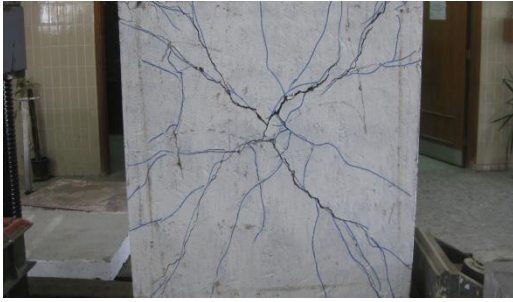
Figure 4.5 : Slab (S11) after repairing and retesting

The repaired slab S11 exhibited the same behavior as the repaired slab S10 until the repaired minor crack reopened which caused an early failure before the repaired slab develops its full capacity which may exceeds the original slab capacity (as in slab S10).

For the minor diagonal crack in slab S11, the injection process is done with longer time and some difficulty, because the width of flexural crack is relatively small, the epoxy resin penetration became difficult and limited to penetrate into the crack, this will happen in slab loaded to level of load less than 100% of the ultimate load obtained for control slab.

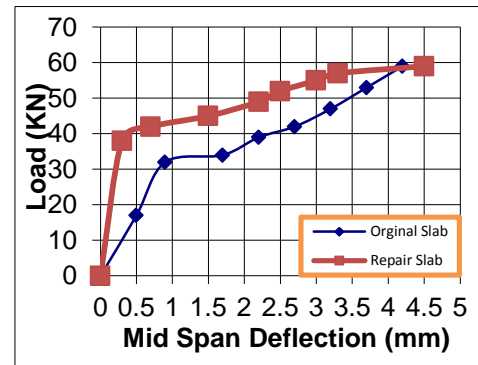
Table(8) and Figs.(5.1) to (5.11) show the load-deflection behavior of the original and repaired slab, the behavior of these two slabs is nearly similar. For original slabs the maximum deflections and deflections at flexural cracking loads are less than corresponding deflections of repaired slabs, also a greater ductility and lower stiffness of the repaired slabs compared with the original slabs is shown in these figures, because the difference in stiffness between a repaired and original slab. Difference in

Table(8) and Figs.(5.1) to (5.5) show the load-deflection behavior of original and repaired slab, the behavior of these two slabs is nearly similar. For original slabs the maximum.

deflections and deflections at flexural cracking loads are less than corresponding deflections of repaired slabs, also a greater ductility and lower stiffness of repaired slabs compared with original slabs is show in their figures, as may be expected. This may be attributed to the hair line cracks, which presence in the repaired slab, and the difference in stiffness of original slab and stiffness of repaired slab.

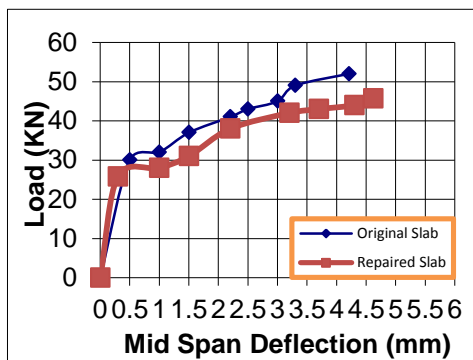
Figs.(5.9) to (5.11) show the load-deflection behavior of the original and repaired slab, the behavior of the two slabs is nearly similar. For repaired slab S10 the deflections at flexural cracking loads is greater than the corresponding deflections of the original slabs. The maximum deflections of the repaired slabs S10 is greater than the maximum deflections of the original slab. For slab S11, deflections at flexural cracking loads and the maximum deflection of the repaired slab is lower than the deflection of the original slab. A greater ductility and lower stiffness of repaired slabs compared with original slabs is shown in these figures, as may be expected. This may be attributed to the hair line cracks, which presence in the repaired slab, and difference in stiffness of original slab and stiffness of repaired slab.

Figs.(5.9) to (5.11), show that up to pre-failure stage the ductility increase and reduction in stiffness for original and repaired LWC slabs are less than those for HSC and NSC slabs. At failure, increase in maximum deflection in repaired slabs records its highest value in slab S10 which is made of LWC among all NSC and HSC slabs, Table (8).
