## **Rock Slope stability of the Pilaspi Formation Rocks in the Bina Bawi Anticline at Darbandi Gomaspan / Erbil- Iraq**

### **Abstract**

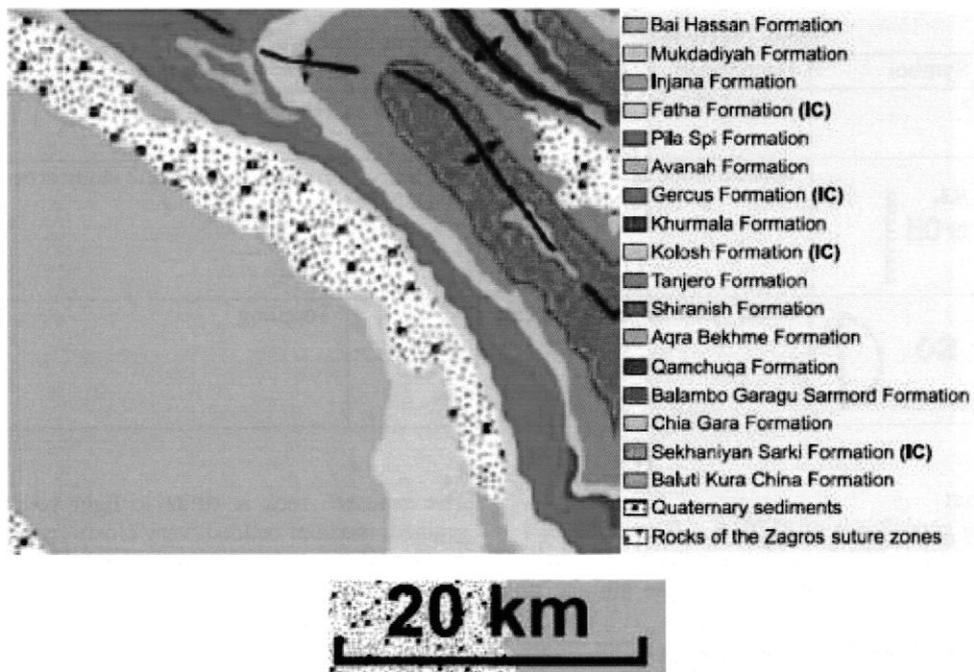
Figure 2 Geological map of the studied area and district (11 and 15).

The formation forms continuous high ridges with very common flat iron morphology, the formation consist mainly of limestone, which are crystalline, dolomitic and clayey or chalky, the color is white creamy, light gray and yellowish white, well bedded, the thickness of the individual bed ranges from less than 0.4 m to 1.5 m, hard to very hard occasionally the limestone is fossiliferous. Fossils are mainly Foraminifera and Gastropods. The thickness of the formation is about 90 m, the lower contact is unconformable with Gercus Formation.(12)(14), Table 1 and Figure 2.

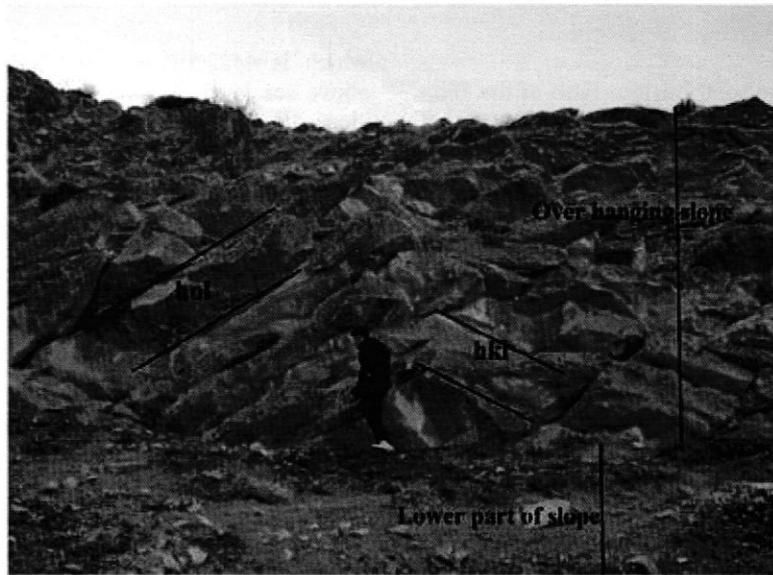
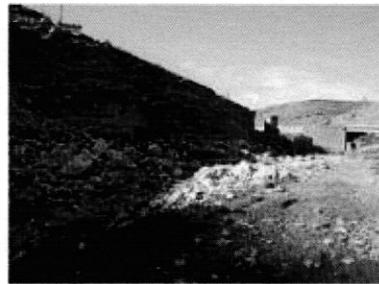
Plate 1. Station 1. A. Slope view in the South direction. B. General view of slope and Gomaspan valley is filled of rock fall aggregates and accumulated down in the valley

There are three types of discontinues, the first set of the joints attitudes is joints with attitude S60W/50NW, S55E/45NE and N10E/80SE. The joints spaces ranges (1-2)cm. The main type of the failure is rock fall because of the differential erosion which Gercius Formation is less resistance than Pilaspi Formation and led to overhanging slope while the cohesion through the discontinuities is zero. Figure (4).

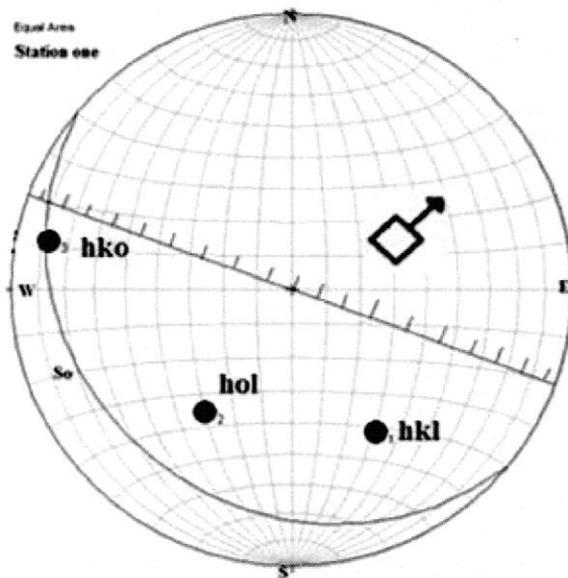
Figure (4) Stereogram shows the relationship between slope, bedding and discontinuities at station one

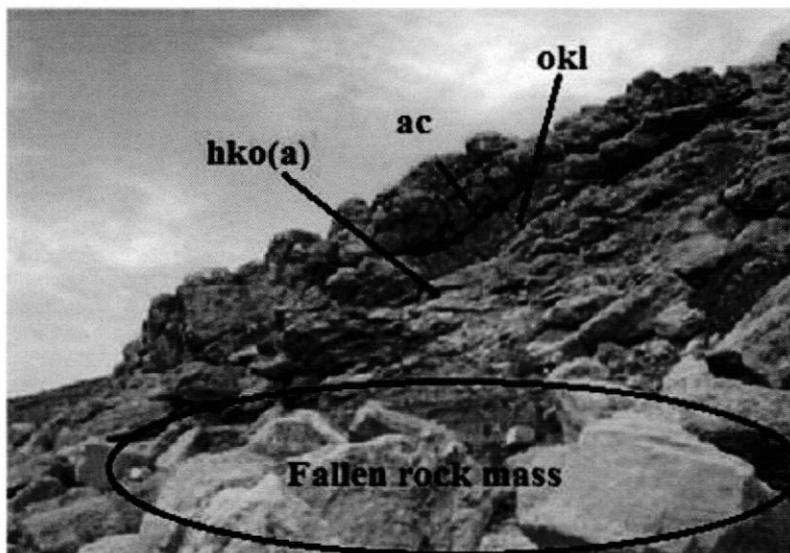
**Plate 3** Frontal view of Station 2(photograph direction is to the North).

The beds are cut by three sets of joints. Mode of failure is rockfall and the rock mass rolling on the slope face.

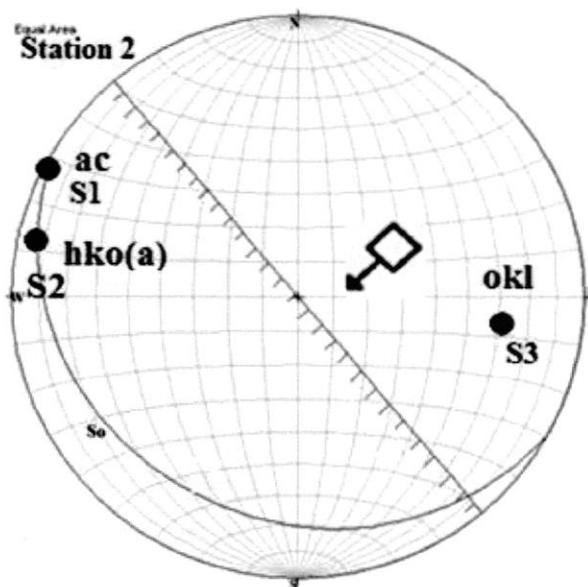
**Figure (5)** Stereogram shows the relationship between slope, bedding and discontinuities at station two.

The average bedding plane attitude is N60W/34SW with dip angle 34°.Figure(5).The type of slope is oblique lateral because (d=40°), left emergent, concordant according to(3) classification.

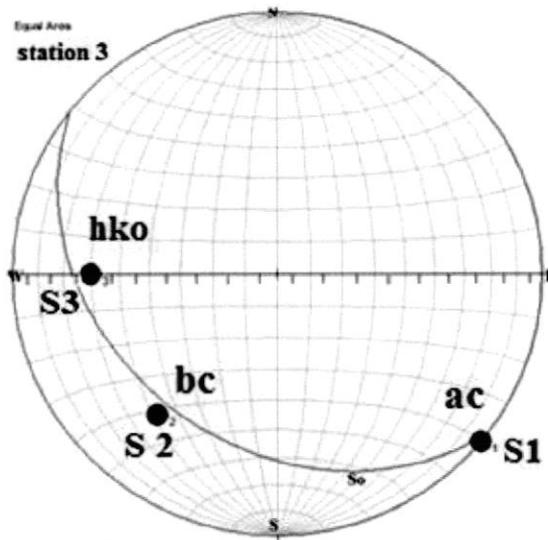
Figure (6) Stereogram shows the relationship between slope, bedding and discontinuities at station 3 .

There are three types of discontinuities, the first set of the joints attitudes is joints with attitude S40W/88NW, S50E/36NE and NS/60E and bedding plane joints. The joints spaces is about (5) cm. The main type of the failure is toppling and probable toppling will occur when the cohesion equals zero, Figure (6).

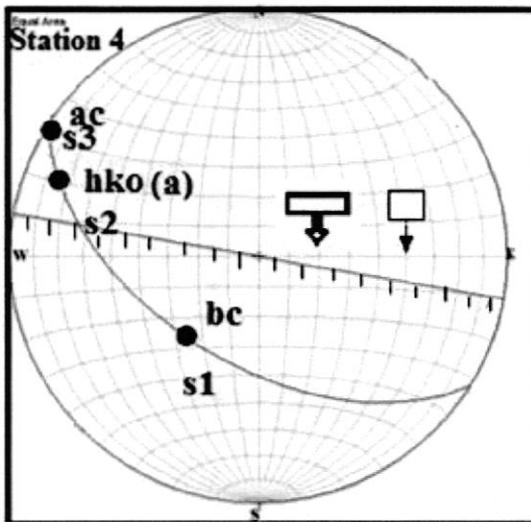
Figure (7) Stereogram shows the relationship between slope, bedding and discontinuities at station four.

There are three types of discontinues, the first set of the joints attitudes is joints with attitude N50W/90, N25E/90 and S35w/90. The joints aperture is about (1-4)cm. The main type of the failure is toppling and rock fall and afterward rolling. Figure (7).

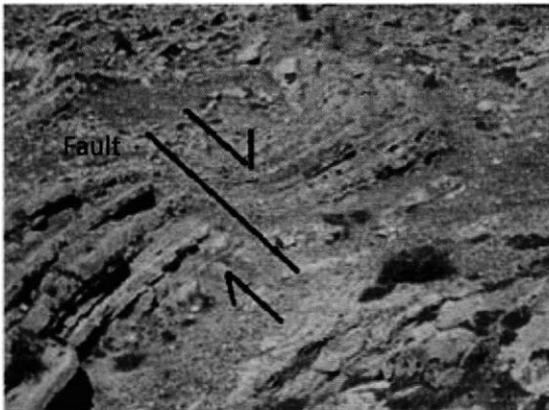
Plate (6) The normal fault.

On the top of this station slope a fault is recognized as shown in plate (6) which consider as a normal fault which noticed an obvious change in amount of the beds angle of dipping.

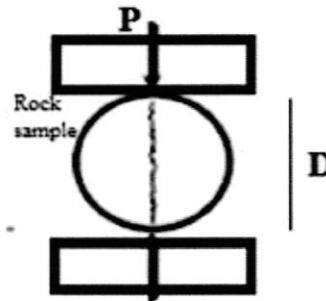
Figure (8) Sample for tensile strength test.

This test carried out in the mechanical engineering laboratory in the engineering college / Tikrit University. Three circle plate samples of limestone rocks were prepared Figure (8) Table (5) and loaded through the samples diameter between the plates of loading machines, which caused failure in the samples. (19)
