Enhancement in the Load-Carrying Capacity of Reinforced Concrete Corbels Strengthened with CFRP Strips under Monotonic or Repeated Loads

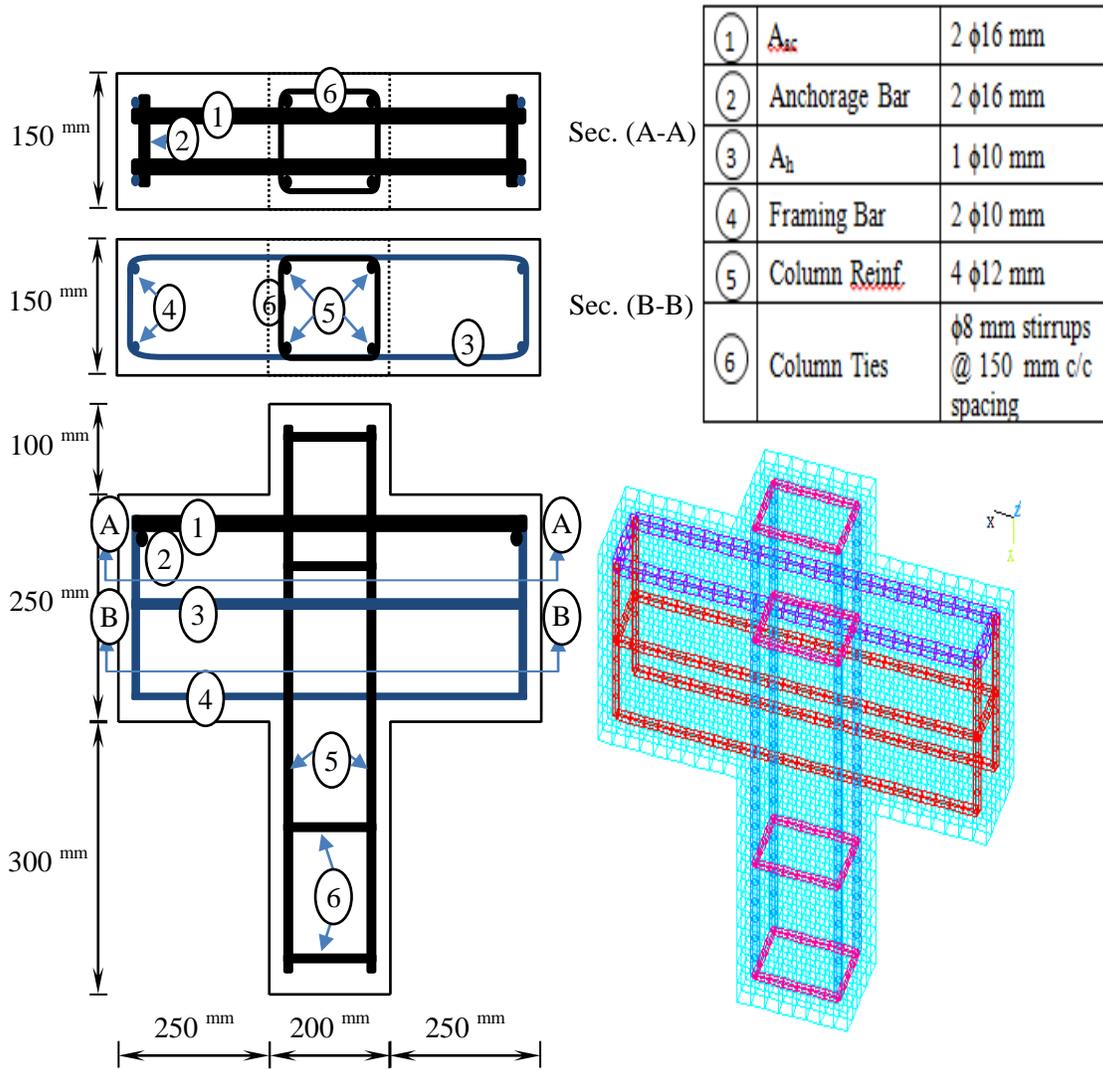
Figure 1 - Details of Research Specimens

The experimental program consisted of constructing and testing 20 normal weight reinforced concrete double corbels built monolithically with a short column, as shown in figure (1).

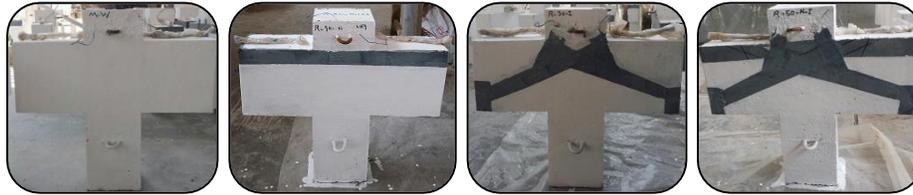
Figure 2 - Photos of Plain and 50-mm Strengthened Specimens

The CFRP strips were applied on the specimens in three orientations as follows:

- 1) Horizontal orientation performed by wrapping the fabric around the edges of the specimen with an overlap of 100mm at the end as means of anchorage.
- 2) Inclined orientation performed by applying the fabric at the center of the inclined strut path and perpendicular to it at both sides of the corbels; small strips were applied perpendicularly at the ends of the inclined strips as means of anchorage.
- 3) Mixed orientation performed by applying the horizontal orientation first and then the inclined one.

Photos of the plain and 50 mm strengthened specimens are illustrated in figure 2.

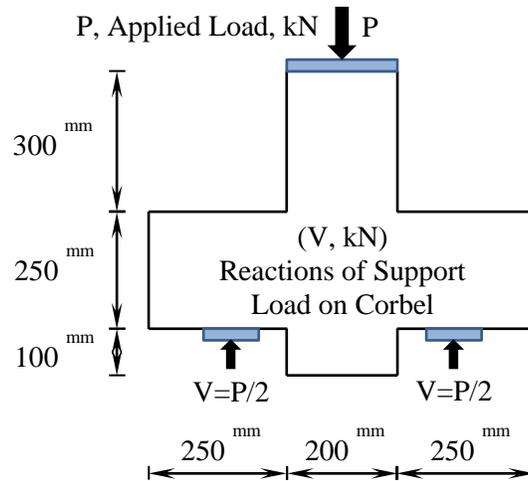
Figure 3 - Test Set Up, Inverted Position

The corbels were tested in an inverted position, as shown in figure 3; the vertical load, P, applied to the top end of the column, while the corbels were seated on two end supports. The reactions of the supports, V, represented the loads applied to the corbel. The support reaction was located at a distance of 100 mm from the face of the column, providing a shear span to depth ratio of, a_v/d , of 0.461.

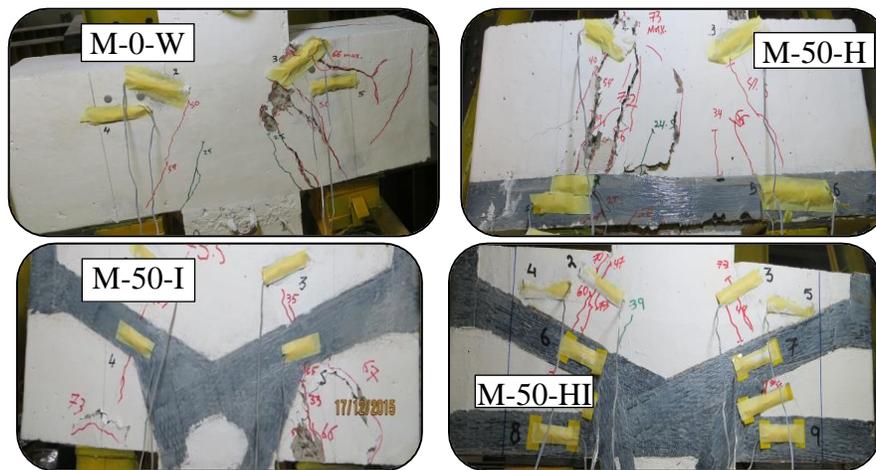
Figure 4 – The Crack pattern and Mode of Failure for Monotonically Loaded Specimen

All specimens tested under monotonic loading regime, behaved in an elastic manner at low load levels and were free from cracks at early stages of loading. As the load was increased, diagonal cracks were developed. The first crack was observed at regions close to the bottom corbel-column joint, in its inverted position, propagating along the corbel-column interface. At load levels close to

failure, the inclined cracks became wider and propagated towards the upper corbel-column joint. Further increase in the applied load caused the formation of other cracks until failure occurred. The mode of failure of all the specimens tested under monotonic loading regime was diagonal splitting failure, and the CFRP did not suffer of de bonding throughout the test as shown in figure 4. The effect of strengthening corbels with 50 mm of CFRP Strips in horizontal, inclined and mixed orientations on the cracking and failure loads are illustrated in table 2 and figure 5. Test results showed that the first crack appearance was delayed by this strengthening technique. The strengthening technique used helped in enhancing the load carrying capacity with about 11%, 15% and 27% for the horizontal, inclined and mixed orientations respectively, corresponding to an increase in the ultimate deflection of 16%, 18% and 22% respectively.

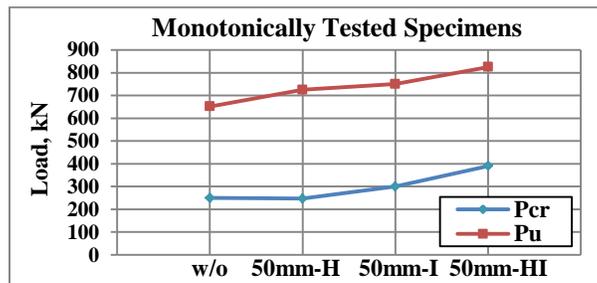
Figure 5 – Effect of Horizontal, Inclined and Mixed Orientation Strengthening

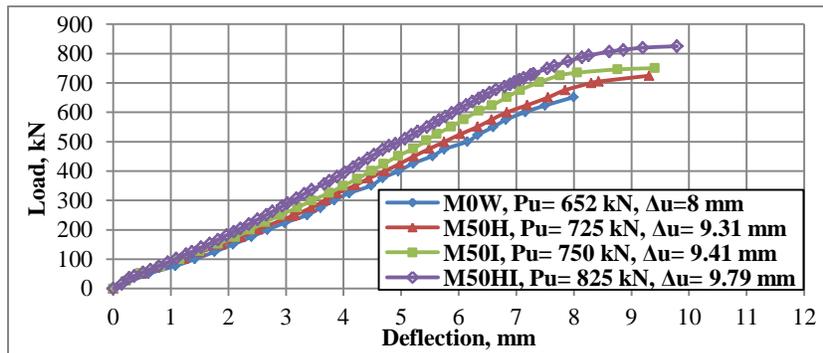
Figure 6 - The Load-Deflection Curves of the Monotonically Tested Specimens

The load-displacement responses for the monotonically tested specimens are shown in figure 6. Testing was terminated when failure occurred, the failure of the specimen was recognized either by the damage occurring or when the load could no longer be increased or start to decrease with the continue increase in deflection.

The deflection represents the movements of the loading jack, which correspond to the deflection at the center of the column supporting the double corbels. A data logger connected to the loading frame control system, was used to control and record the displacement and load applied to each specimen.

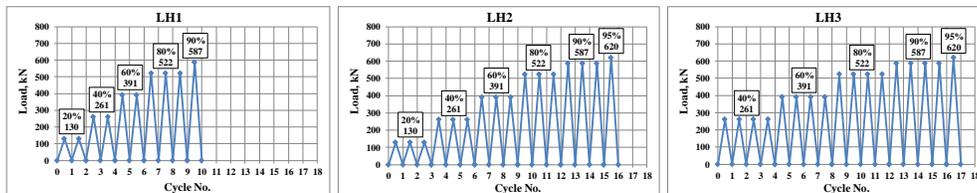
Figure. 7 – Non-Reversed Repeated Load History Schemes, LH1, LH2 and LH3

The sequence of the cycles followed a percentage of the failure load equal to 20%, 40%, 60%, 80%, 90% and 95%.

The loading history schemes are shown in figure 7. The details of the cycles, (C_i), of the three load histories are shown in table 3, where (i) refers to the cycle's number.

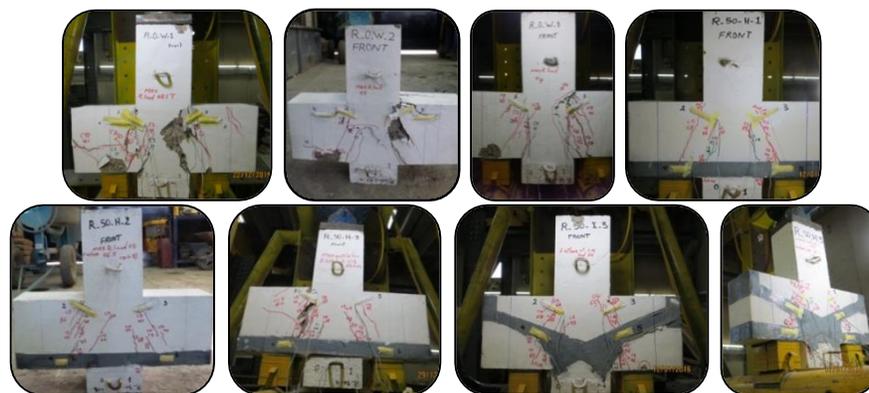
Figure 8 - The Crack pattern and Mode of Failure for the Non-Reversed Repeated Loaded Specimens

After the appearance of the first cracks, more new cracks were observed in the following consecutive cycles with the same altitude. No further cracks were observed during the unloading part of the cycles throughout all the tests. In the final cycles the cracks became wider and failure occurred in the ascending part of the cycle before reaching its peak. The cracks and the modes of failure for the non-strengthened and the 50-mm- strengthened specimens tested under non-reversed repeated loading regime are shown in figure 8.

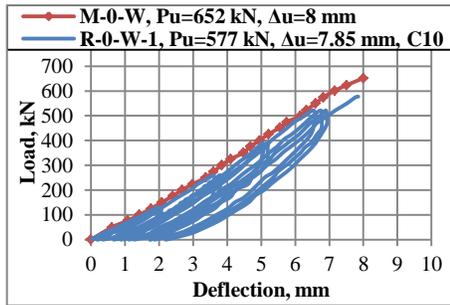
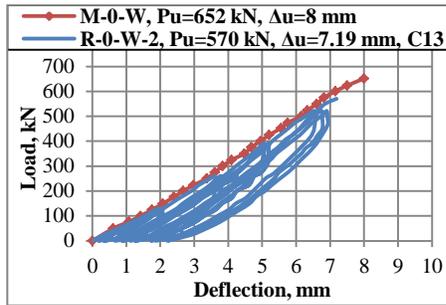
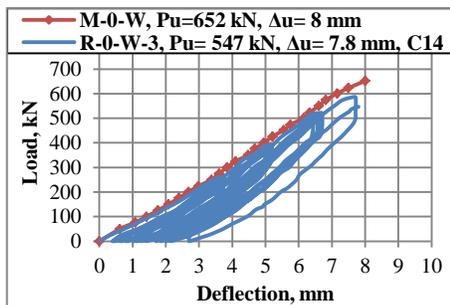
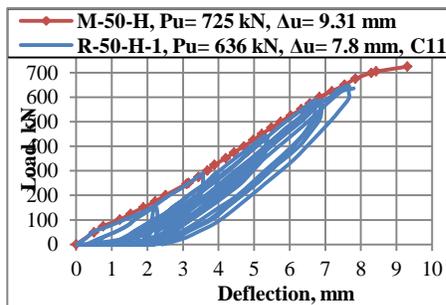
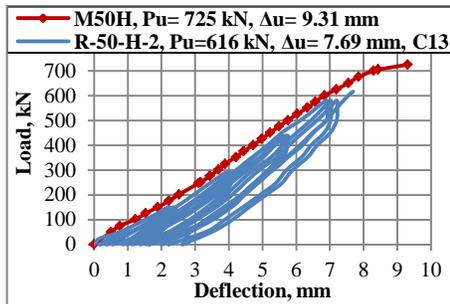
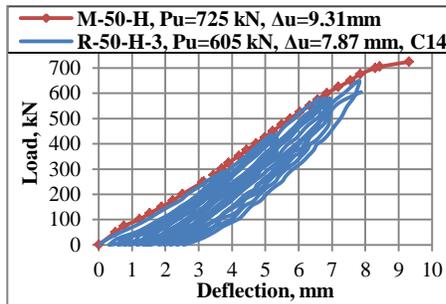
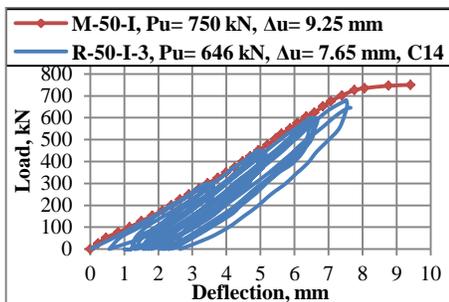
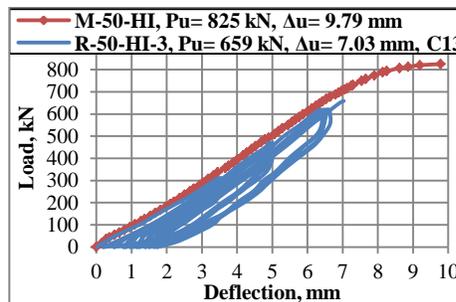
Figure 9 - L-D Curves of R-0-W-1

Figure 10 - L-D Curves of R-0-W-2

Figure 11 - L-D Curves of R-0-W-3

Figure 12 - L-D Curves of R-50-H-1

Figure 13 - L-D Curves of R-50-H-2

Figure 14 - L-D Curves of R-50-H-3

Figure 15 - L-D Curves of R-50-I-3

Figure 16 - L-D Curves of R-50-HI-3

The load-deflection curves showed that at early stages of loading the curves were initiated in a linear form with a constant slope. Soon after cracking the behavior changes and the load deflection response takes a nonlinear form with varying slopes, gradually, the slope decreases with consecutive cycles.

The load-displacement hysteresis loops for the fourteen specimens, tested under the three non-reversed repeated loading regimes selected in this study, show degradation in the load carrying capacity during the repeated cycles, due to the accumulation of cracks in the concrete.

Reinforced concrete corbels subjected to this type of loading always show a deflection increase through successive cycles. However, the consecutive increments of deflection decrease gradually with repeated loading.

The load applied at the first cycle produced a residual deflection; accumulation of this residual deflection increases through consecutive cycles. Cracking in concrete may be one of the causes for this residual deflection.

Generally, it was found that applying the non-reversed repeated loading regimes led to a decrease in the total deflection at failure when compared with specimens subjected to monotonic loading regime as shown in figures 9 through 16.

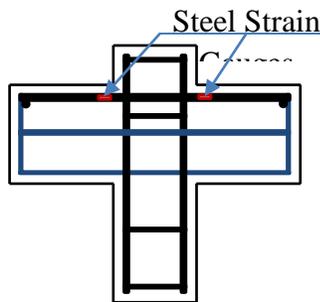
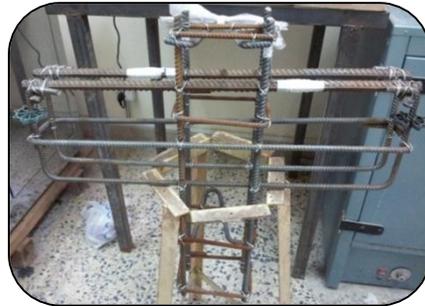
Figure 17 - Locations of Steel Strain Gauges

Strain gauges were installed on steel bars, at the location of maximum moment, one strain gauge on each bar in opposite directions, before the casting of the specimens, figure 17; and on the concrete surface, figure 18 and CFRP strips, figure 19, after casting and before testing, to record the strains in these materials during testing. The strain records were represented as Load-Strain curves between the load on the corbel, V , (which is equal to half the load applied on the column, $P/2$), and the strains recorded from strain gauges.

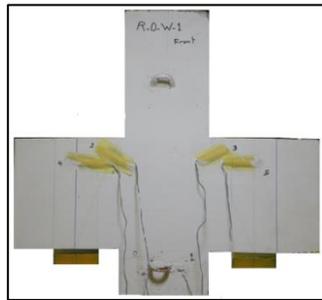
Figure. 18 - Locations of Strain Gauges Fixed on Concrete

The surface compressive strain in concrete was recorded by fixing the gauges on both sides of the front face of the corbels, within the compression side. The locations of these strain gauges were selected to be perpendicular to the expected line of failure, as shown in figure 18.

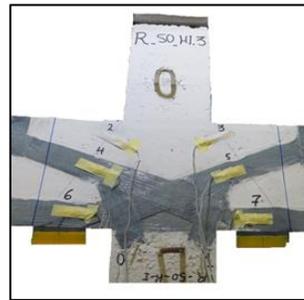
Figure. 19 - Locations of Strain Gauges Fixed on CFRP Strips

For the CFRP strips, strain gauges were mounted on both sides of the front face of the corbels, located at the center of the strip and in the direction of the fibers' orientation, to record the tensile strains in the CFRP during the test. The locations of the strain gauges are shown in figure 19.

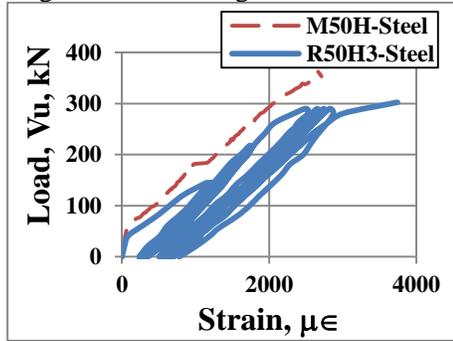
Fig. 20 - Comparison of Load-Strain Curves in Steel Reinf. for Specimen M-50-H and R-50-H-3

the release of the applied load, in the descending part of loading. Comparisons between monotonic and repeated load-strain curves in steel reinforcement and concrete for Specimen without strengthening are shown in figures 20 and 21.

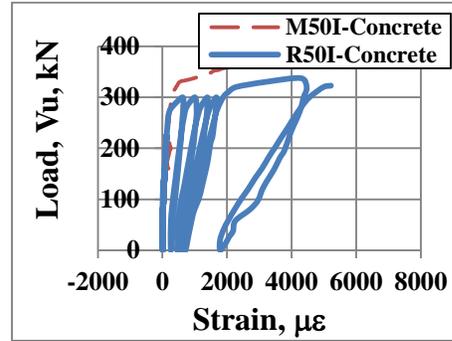
Fig. 21 - Comparison of Load-Strain Curves in Concrete for Specimen M-50-I and R-50-I-3

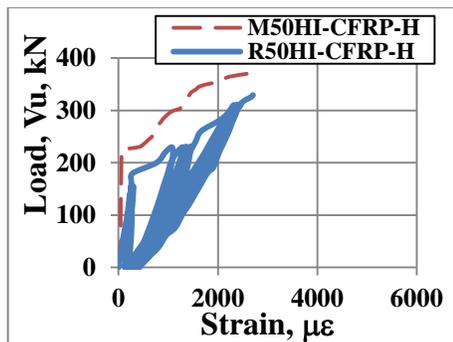
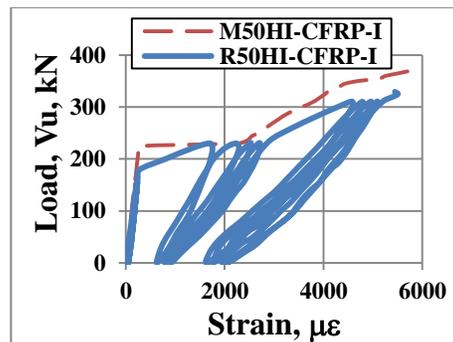
(a) Horizontal Strip

(b) Inclined Strip

Figure. 22 - Load-Tensile Strain Curves in CFRP for Specimen R-50-HI-3

The CFRP strips experienced small strains until the initiation of the cracks. Then the strains started to increase until failure occurred. The inclined strips exhibited a settled strain response up to failure. This shows the effectiveness of the inclined strengthening in limiting the width of inclined shear cracks, allowing the corbels with inclined strengthening technique to experience higher strains before failure, as shown in figure 22.
