## Strengthening of Continuous Reinforced Concrete Beams by Cfrp Laminates

### ABSTRACT

Experimental investigations of the behavior of reinforced concrete three-span continuous beams with 1200 mm length for each span, with cross-section 120 mm width and 180 mm depth strengthened by CFRP in flexure case of beams have been presented. The experimental program consisted of nine RC beams, which were strengthened at some locations with CFRP laminates and carefully designed to fail in flexure. The results show that the use of external CFRP laminate connected to the beams could enhance the ultimate flexural load capacity up to 102.88%.

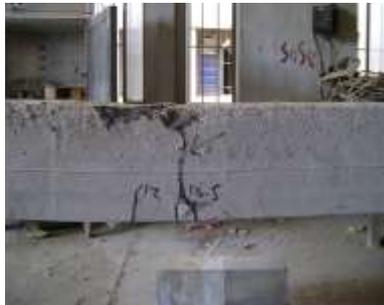
Figure (13) cracks pattern of beam (B1).

The cracks pattern of the unstrengthened reinforced concrete beam (control beam) B1 is shown in Figure (13). First crack was observed at an applied load of (25 kN) at center of left span. As the load was increased, the flexural cracks increased in number, width and depth. After the formation of first crack, a loss of stiffness occurred and the beam reached an ultimate load of (57.67 kN) at center of left span and exhibited a ductile behavior. Ductility of the beam was mainly due to the amount of reinforcement provided, which was larger than the minimum reinforcement.

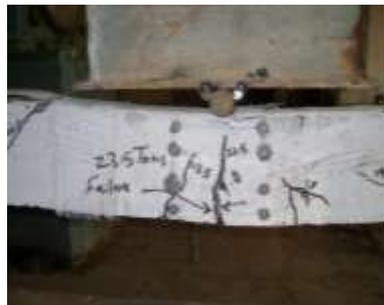
Figure (17) cracks pattern of beam (B3).

The beam failed due to yielding of the tension steel reinforcement and flexural cracks were observed in the beam throughout the right span length. Also debonding of CFRP laminates was shown at the right interior support as shown in Figure (17). The load-deflection curve for the beam specimen (B3) is shown in Figure (18).

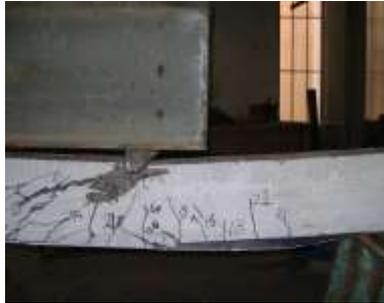
Figure (21) cracks pattern of beam (B5).

The beam failed due to debonding of CFRP laminates from the flexure-shear cracks zone with crashing in concrete under the applied load at center of left span as shown in Figure (21). The load-deflection curve for the beam specimen (B5) is shown in Figure (22).

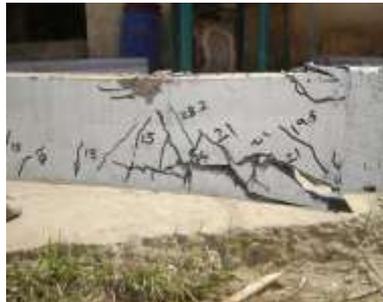
Figure (23) cracks pattern of beam (B6).

The beam failed due to concrete cover debonding plus CFRP laminates debonding from flexure-shear cracks zone at the left span as shown in Figure (23). The load-deflection curve for the beam specimen (B6) is shown in Figure (24).

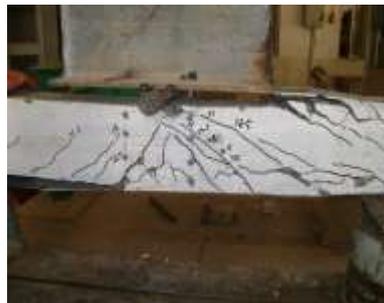
Figure (25) cracks pattern of beam (B7).

The beam failed due to debonding of top concrete over in the end of CFRP laminates near the support plus CFRP laminates debonding from flexure cracks zone as shown in Figure (25). The load-deflection curve for the beam specimen (B7) is shown in Figure (26).
