REPAIRING OF CONTINUOUS ONE-WAY REINFORCED CONCRETE SLABS BY CFRP COMPOSITES

Saif M. Aljbory¹ and Hayder H. Kamonna²

ABSTRACT

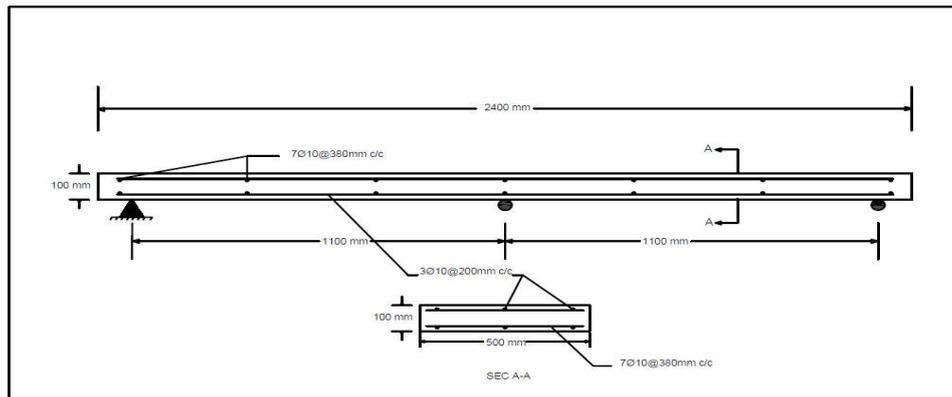
Fig.1. Details of typical slab

All slab consists of two equal spans with dimensions of 2200 mm in length, 500 mm in width, and 100 mm in height where the effective spans were 1100 mm. Three $\phi 10$ steel bars were placed at 200 mm c/c in both positive and negative moment regions and served as the main longitudinal reinforcement for each slab. In addition, the top and bottom secondary reinforcements were made of $\phi 10$ steel bars placed at 380 mm spacing along the length of each slab as shown in Fig.1.

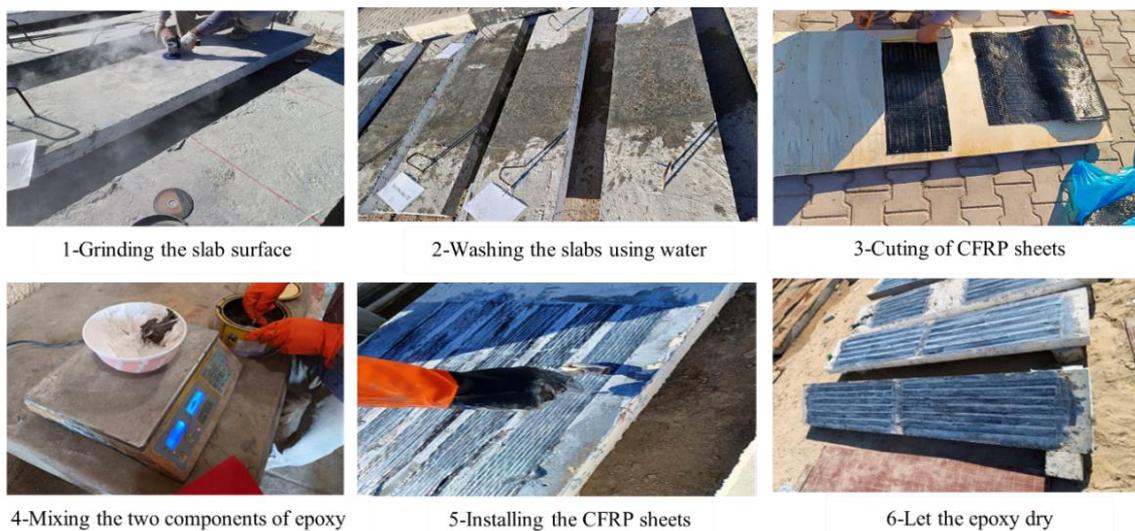
Fig. 2: Steps of repairing the RC slabs with CFRP sheets

1. As seen in [Fig. 2](#), there are a few steps to follow when adhering the sheets to the slabs:

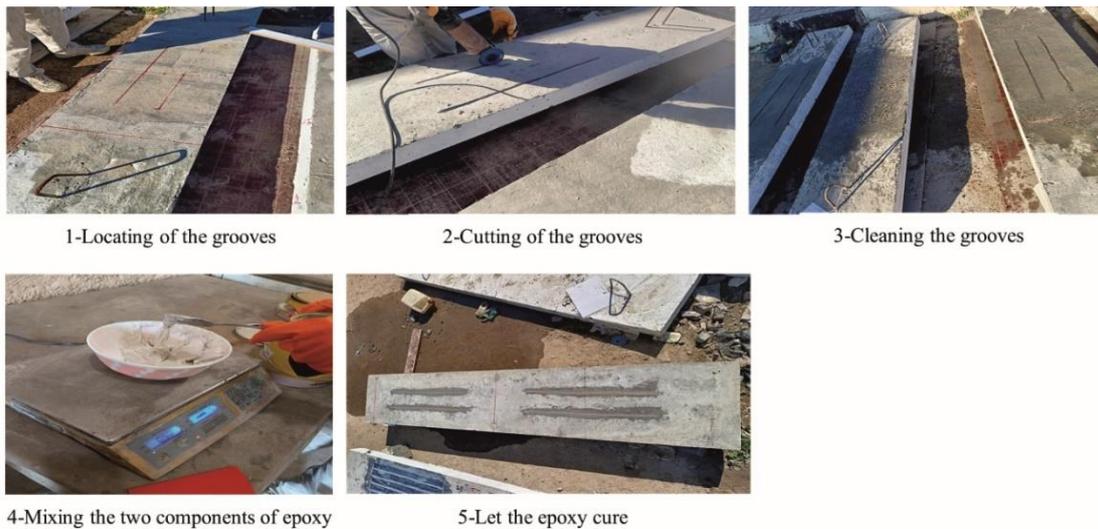
Fig. 3. Steps of repairing the RC slabs with NSM CFRP bars.

2. Fig. 3 indicates the steps for repairing RC slabs with CFRP bars

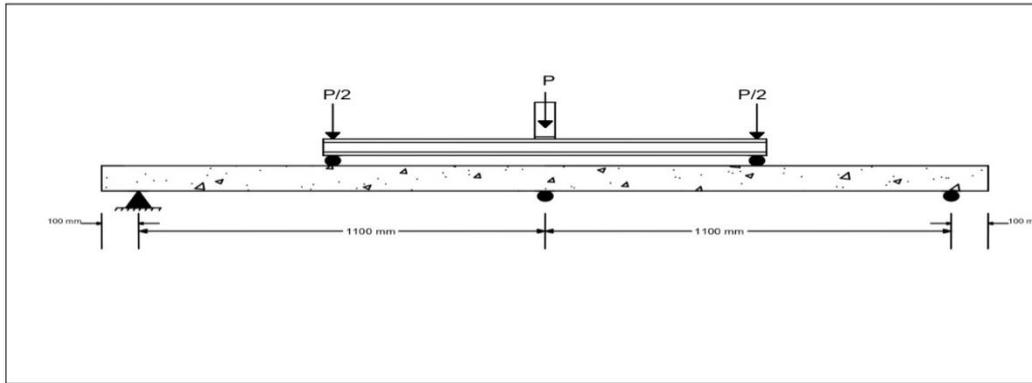
Fig. 4: Sketch for the location of supports and the applied loads

All Slabs were tested under a two-line load until failure. The slabs were continuous along three supports. The supports were positioned 100 mm away from the edges of the slabs resulting in clear spans of 1100 mm. Moreover, the load rate was 0.4 kN/s until the failure of the specimen, and the data of load and deflection were recorded using an LVDT. Additionally, the crack width was measured during the test. Fig. 4 illustrates the experimental test configuration while Fig. 5 displays the testing machine .

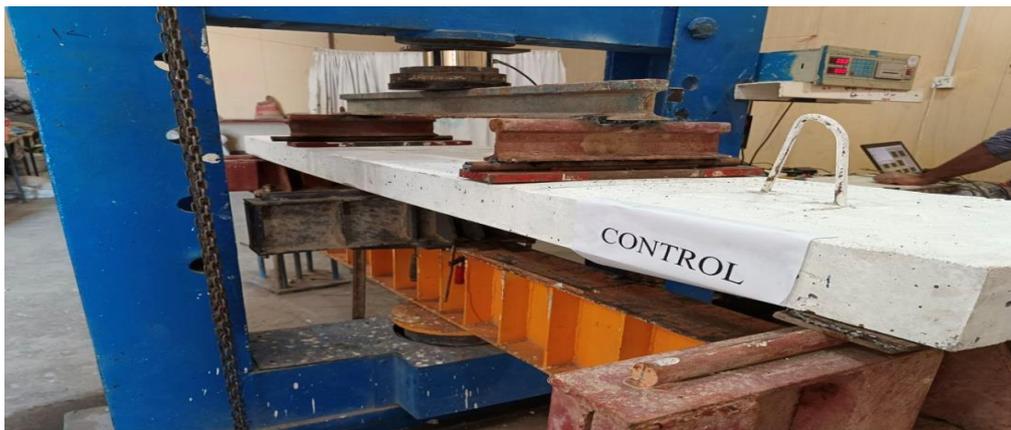
Fig. 5. Testing machine

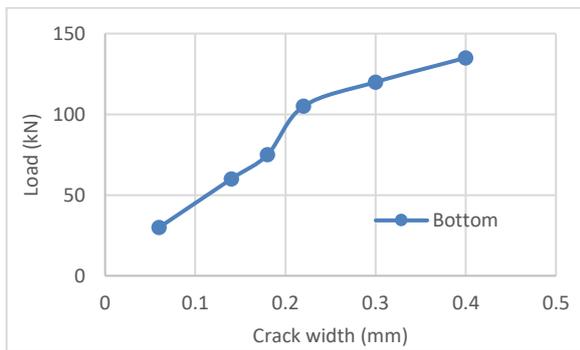
Fig.6. Crack width for positive region for control

Finally, the width of the first crack of the CS with respect to the applied load is illustrated in Fig.6. A linear path can be seen in the positive moment zone. However, when the applied load exceeds 108 kN, the crack begins to expand more and more until the slab fails. This ensured that the steel would yield at this value.

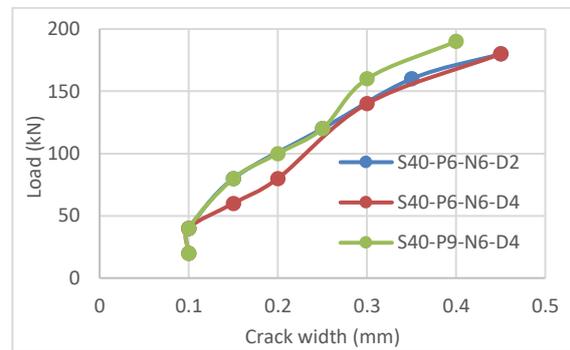
Fig.7. Crack width at negative moment region for slabs which changing their sheet length and spacing with preloading 40%

In the case of crack width, it can be observed from Fig. and Fig.8 that the cracks in the negative moment zone are wider than those in the positive moment zone because the negative moment is higher than the positive moment. Furthermore, convergent paths of the load-crack width can be observed in the negative cracks, because there was no change in the length of sheets in this region. While the curves in the positive cracks followed different paths. Additionally, when increasing the length of CFRP sheets the crack width reduced for all slabs.

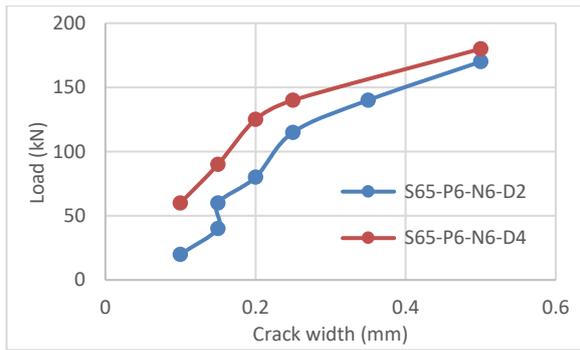
Fig. 7. Crack width at negative moment region for slabs which changing the spacing between the sheets that have 660 mm with preloading 65%

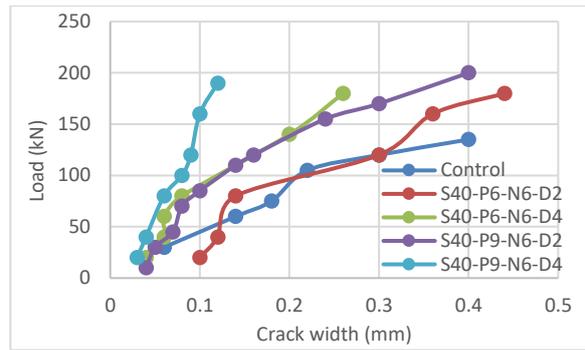
Fig.8. Crack width at positive moment region for slabs which changing their sheet length and spacing with preloading 40%

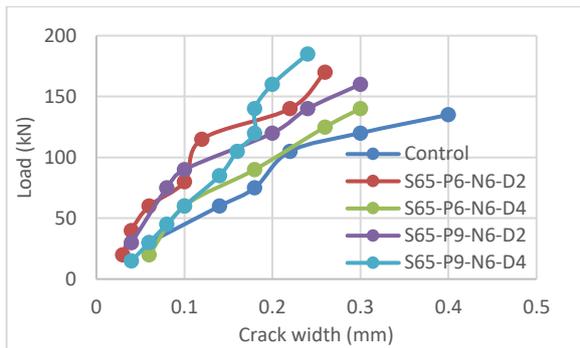
Fig. 9. Crack width at positive moment region for slabs which changing their sheet length and spacing with preloading 65%

Lastly, it can be seen in Fig. 9 that the repairing techniques tend to reduce crack width. Also, S65-P6-N6-D2 recorded a lower crack width than S65-P9-N6-D2 in the positive region due to the appearance of additional cracks in the concrete body. However, S65-P6-N6-D4 recorded a wider crack than S65-P9-N6-D2. This may be because S65-P6-N6-D4 has a higher ultimate load than S65-P9-N6-D2 resulting in wider crack width.

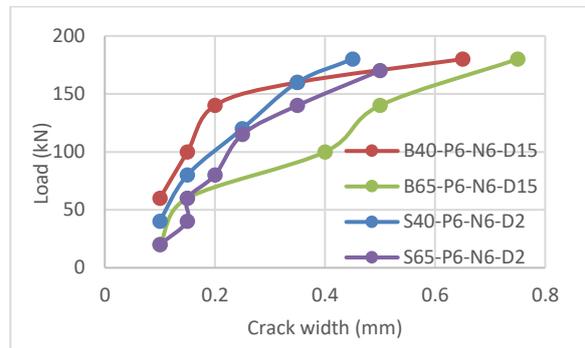
Fig. 10. Crack width at negative moment region for slabs that were strengthened with different methods (NSM and EB)

S65-P6-N6-D2 was strengthened with EB-CFRP sheets while B65-P6-N6-D15 was strengthened with NSM carbon bars. As seen in Fig.24, all the curves of the slabs have similar paths until the appearance of the first crack. After that, they took separate paths and recorded a decrease in deflection. Additionally, both techniques enhanced the ultimate load capacity by 65% for EB and 43.8% for NSM compared to CS. It can be observed that adopting the NSM method shows higher ductility than CFRP sheets by 11.43%, no change in initial stiffness, and less toughness by about 18.5% according to Table 9. In terms of crack width, the specimens that were strengthened with NSM carbon bars show a higher value of crack width compared to CFRP sheets in both regions as indicated in Fig. 10 and Fig.12.

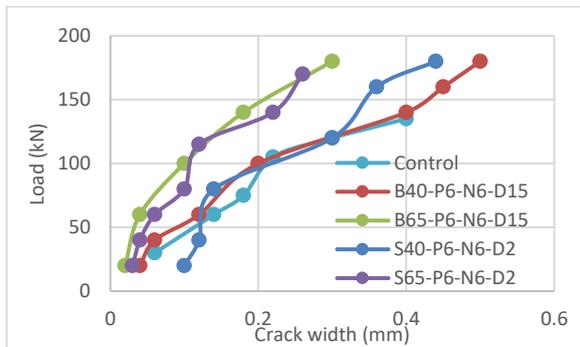
Fig.11. Crack width at positive moment region for slabs that were strengthened with different methods (NSM and EB)

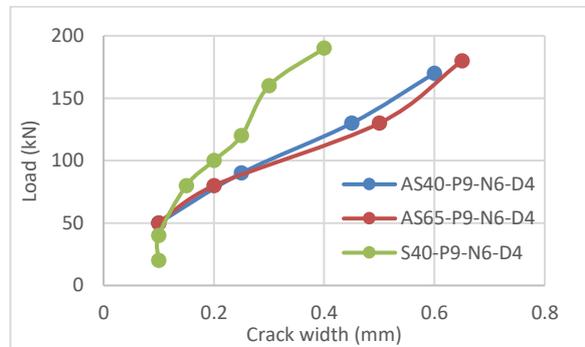
Fig. 12. Crack width at negative moment region for slabs that were anchored compared to CS and non-anchored slab

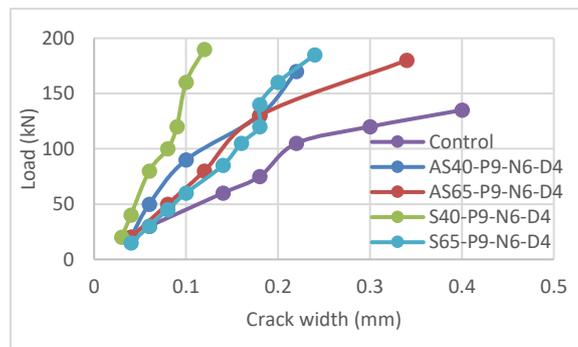
Fig. 13. Crack width at positive moment region for slabs that were anchored compared to CS and non-anchored slab

Finally, AS40-P9-N6-D4 has a wider crack than S40-P9-N6-D4 according. Finally, AS40-P9-N6-D4 has a wider crack than S40-P9-N6-D4 according to Figs.13 and 14 due to the development of an additional crack in the specimen.

24.8% compared to a non-anchored slab, with no change in initial stiffness and increased toughness according to Table 9. Additionally, wider cracks can be noticed in Figs. 13 and 14 for AS65-P9-N6-D4 compared to S65-P9-N6-D4.

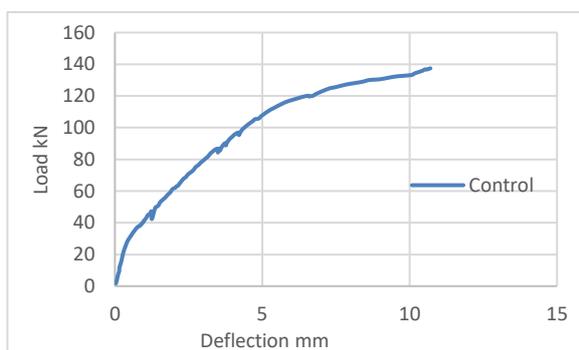
Fig.14. Load-deflection curve of CS specimen

The load-deflection curve for CS is shown in Fig.14. The failure was an ordinary flexural failure. The first loading stage, which ended with the first crack initiation at around 30 kN, shows linear behavior. In the second stage, cracks begin to appear in the concrete tension faces, but the steel bars are still within the elastic limit. This stage is usually referred to as the service stage. It can be recognized by a slight decrease in slab stiffness. The third zone is where the load value changes from 79% of its maximum capacity to the loading level at which the slab fails. This is called the ultimate load stage. A flat load-deflection curve might be obtained in this stage. The CS failed at load 137 kN according to Table 8. Moreover, it is clear from Table 9 that the control slab exhibited higher ductility, less stiffness, and less toughness than the other repaired slabs due to the absence of strengthening.

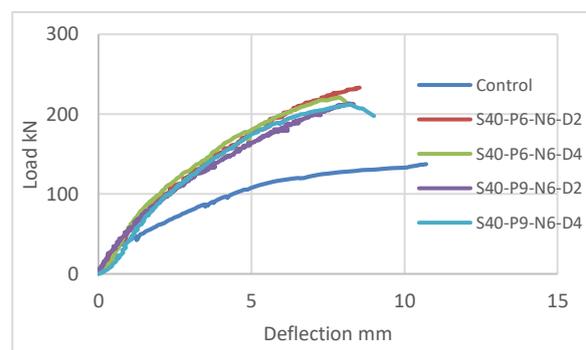
Fig.16. Load vs deflection curves for slabs which changing their sheet lengths with preloading 40%

Fig.16 represents the slabs that had a 40% damage ratio with changing their CFRP sheet length. It can be observed that the slabs with 0.9L did not achieve the highest ultimate load. This may be because when the length of the CFRP sheets is increased in the sagging region beyond the point of inflection, the extended sheets will enter the negative moment zone. Therefore, it does not effect on the compressive region of the middle span. Furthermore, it can be noticed from Table 9 that there is no effect on the ductility and no significant change in initial stiffness when increasing the length of CFRP sheets from 0.6L to 0.9L. This can be observed in Fig.16 at the early stage of loading. Additionally, all specimens that had a 40% damage ratio had higher toughness than the reference slab and S65-P9-N6-D2 had the highest value.

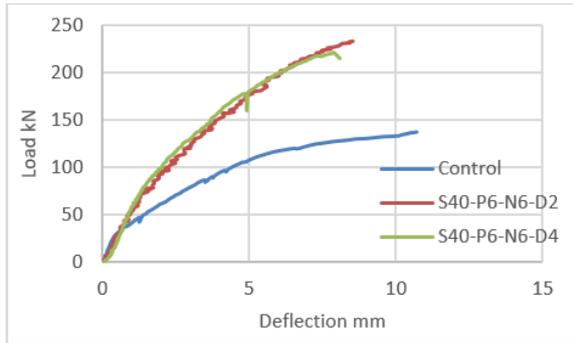
Fig.17. Load vs deflection curves for slabs which have 660 mm CFRP sheet length and different spacing with 40 % preloading ratio

As seen in Fig.17 and **Error! Reference source not found.**, low spacing (20 mm) between the sheets increases the ultimate load because the number of CFRP sheets is increased. However, more spacing achieved higher ductility and no change in initial stiffness according to **Table 9**. This can be noticed in load vs deflection curves in Fig.17 and **Error! Reference source not found.**. Moreover, according to **Table 9** S40-P6-N6-D2 and S40-P6-N6-D4 showed no significant change in toughness. Meanwhile, S40-P9-N6-D2 recorded lower toughness than S40-P9-N6-D4. It is important to note that S40-P9-N6-D2 failed to reach its maximum load capacity due to an accident in the laboratory. This may be the reason for these results. Furthermore, the width of the first crack decreases as the distance between the sheets increases as shown in Fig. and Fig. 7. The reason for this might be because the crack width increased as the applied load increased, at some point, the crack stopped expanding, while new cracks began to develop in other places in the concrete body.

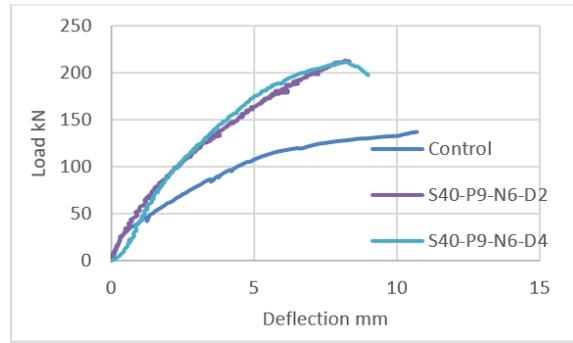
Fig.18. Load vs deflection curves for slabs which have 990 mm CFRP sheet length and different spacing with 40 % preloading ratio

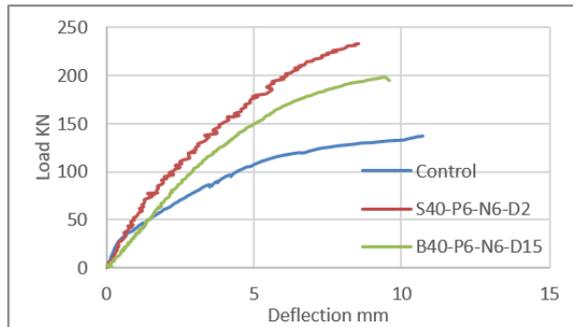
Fig.19. Load vs deflection curves for slabs that were repaired with different techniques and preloading 40%

To make the comparison between different strengthening methods (NSM and EB), two carbon bars with 6 mm diameter and 150 mm spacing were used in the middle of each span (positive and negative) as strengthening bars. The reason for using only two bars is to ensure that the cross-sectional area of the bar is similar to the cross-sectional area of the sheets. It can be observed from Fig.19 that there is a close path between the two slabs until 150 kN. Then, they followed different paths. S40-P6-N6-D2 shows better performance in terms of the ultimate load and reducing the deflection.

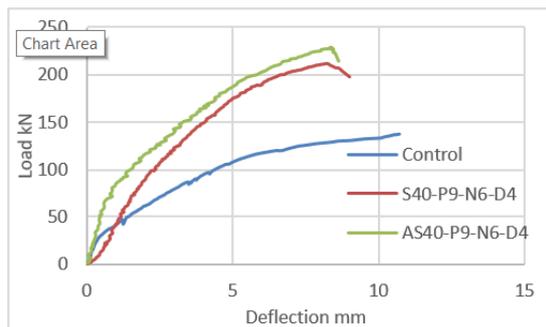
Fig.20. Load vs deflection curves for slab that were anchored compared to CS and non-anchored slab for a 40% preloading

Both S40-P9-N6-D4 and AS40-P9-N6-D4 in Fig.20 had a 40% damage ratio and were strengthened with the same configuration of CFRP sheets, except that AS40-P9-N6-D4 was anchored at the ends of each strengthening sheet to prevent debonding failure. It can be noticed that the slope of the curve (stiffness) starts to decrease at about 190 kN progressively due to the appearance of additional cracks in the concrete. Additionally, the primary finding was that the ultimate load capacity of the S40-P9-N6-D4 specimen increased by about 7% whereas the deflection was reduced by a little bit when adopting end anchors. Moreover, adopting end-anchors results in increasing the ductility, initial stiffness, and toughness by 7.19 %, 11.87%, and 6.93% according to

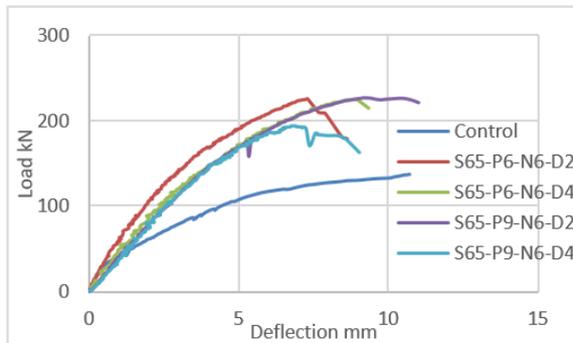
Fig.21. Load vs deflection curves for slabs which changing their sheet lengths with preloading 65%

As seen in Fig.21, S65-P6-N6-D2 and S65-P9-N6-D2 had the greatest ultimate capacity among the others, while S65-P9-N6-D4 had the lowest value. Also, it can be noticed that all slabs had convergent paths except S65-P6-N6-D2 which shows higher stiffens than the others. Moreover, it is easy to note that using longer sheets did not lead to any enhancement in the ultimate load capacity.

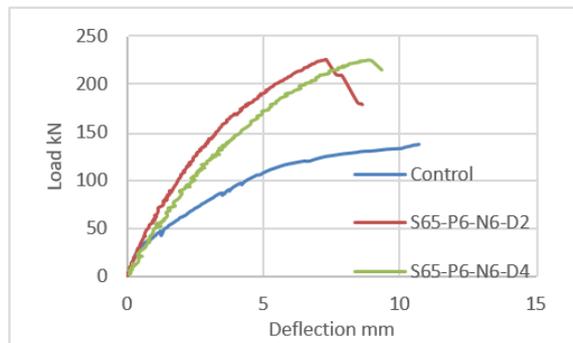
Fig.22. Load vs deflection curves for slabs which have 660 mm CFRP sheet length and different spacing with 65 % preloading ratio

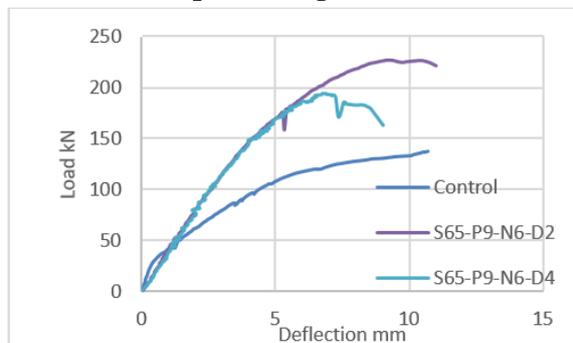
Fig.15. Load vs deflection curves for slabs which have 990 mm CFRP sheet length and different spacing with 65 % preloading ratio

Increasing the spacing between the sheets will decrease their number and consequently reduce the ultimate load. This can be seen in Fig. and Fig.15. Additionally, no change in ductility between S65-P6-N6-D2 and S65-P6-N6-D4 has been seen. But, S65-P9-N6-D2 shows higher ductility than S65-P9-N6-D4 by about 8.8%. Moreover, when the spacing was increased from 20 mm to 40 mm for specimen S65-P6-N6-D2, it was recorded less stiffness. However, there was no change in initial stiffness between S65-P9-N6-D2 and S65-P9-N6-D4 according to Table 9. In terms of toughness, S65-P9-N6-D2 recorded the highest value and it's significantly higher than S65-P9-N6-D4 by about 45%. However, there was no effect of spacing on toughness when compared between S65-P6-N6-D2 and S65-P6-N6-D4. According to Fig. 7 and Fig. 9, there was no significant change in crack width in the negative region. In the positive region S65-P6-N6-D2 specimen that has less spacing exhibits a smaller crack width compared to S65-P6-N6-D4. However, S65-P9-N6-D2 shows a higher crack width than S65-P9-N6-D4.

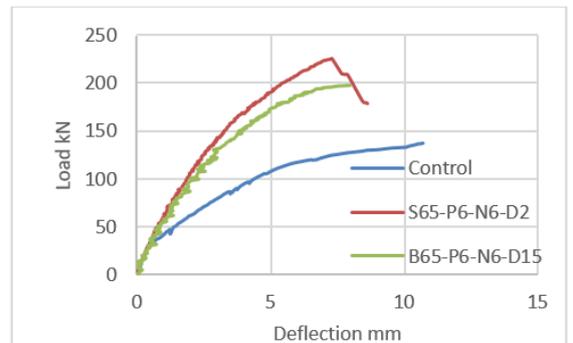
Fig.24. Load vs deflection curves for slabs that were repaired with different techniques and preloading 65%

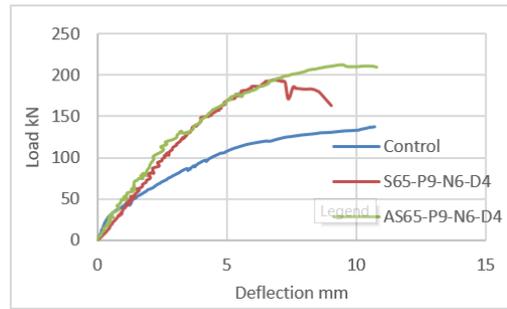
Fig.25. Load vs deflection curves for slab that were anchored compared to CS and non-anchored slab for a 65% preloading

The strengthening sheets were anchored at their ends by one layer of CFRP sheet with dimensions of (50 mm) in width and (700 mm) in length. For AS65-P9-N6-D4, end anchors were used on the top and bottom sides. When comparing S65-P9-N6-D4 and AS65-P9-N6-D4 in Fig. 25, it can be noticed that adding anchors to the slabs leads to an increase in the ultimate load capacity by about 9.27%. This may happen because of inducing the internal tensile force (catenary action) in CFRP sheets which means at a high stage of loading, the member stiffness may be increased or in other words when the deflection value becomes high. When cracks start to form and steel reinforcement begins to yield, additional cracks develop in the tension zone, relieving the concrete of stresses, and causing the sheet fibers to carry larger loads than the concrete. Adopting end-anchors in repairing slabs results in increase in the ductility by about
