# Investigation of Permanent Deformation in Iraqi Highways- Iraqi Expressway No.1 as a Case Study

The research in this domain is still limited and, most often, adopts laboratory approaches that tend to ignore field conditions. The present work studies rutting of the Expressway No.1 by combining numerous field aspects related to the existing pavement structure.

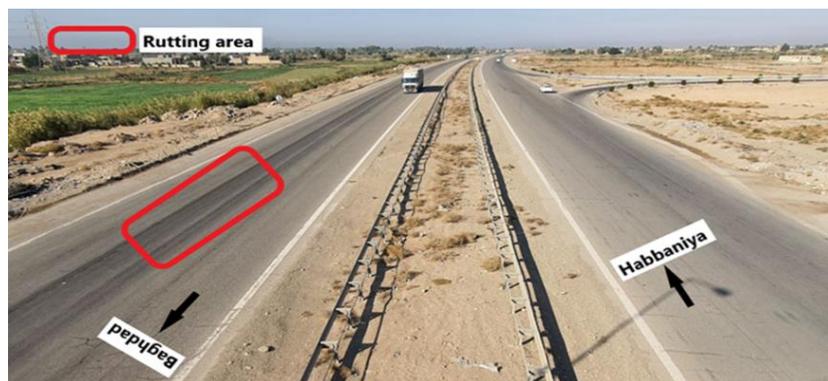
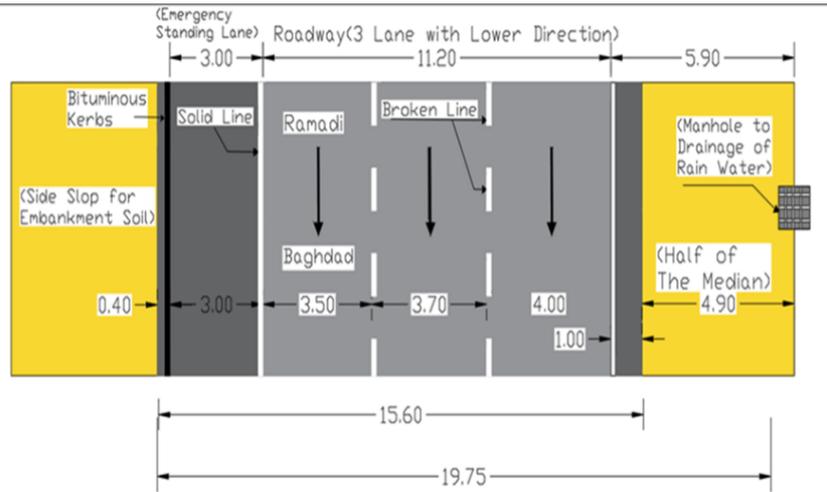
The study area of the current research lies within this section of the expressway (123 km). This section, constructed by Marubini Company- Japanese, was technically divided into R/9A (Baghdad West - Habbaniya), and R/9B (Habbaniya - Ramadi - the intersection of Hit). Each direction of the expressway consists of three lanes as well as a fourth lane for emergency stops. A median strip separates the opposing traffic (IENO CDR PF C: R/9AB, 1976, & IENO CS PT C: R/9AB, 1976), as shown in Figure 2(a) and (b).

Fig. 2 Continued: (a) Express No.1 of part R9/A and R9/B (b) Half section.

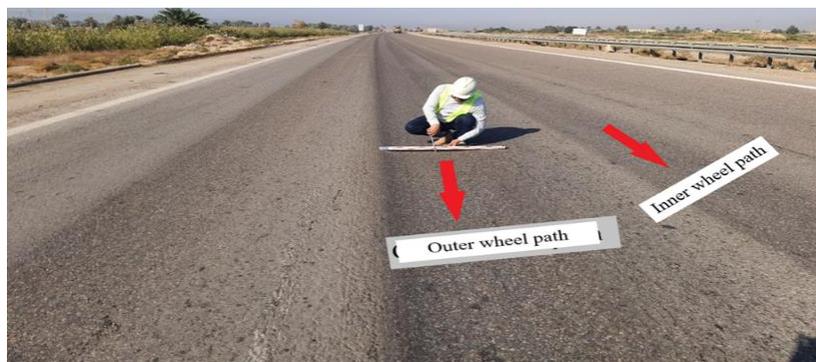
The permanent deformation is a superficial depression in the wheel paths, as shown in Figure 3. The visual field survey of the permanent deformation of the road was carried out in two ways (investigating the depth and density of rutting). Generally, most of the asphalt pavement maintenance processes are related to rutting (Du et al, 2018).

Fig. 3 Measurement of rut depth in the inner and outer wheel tracks of Express No.1 for Station 46+500 in Part R9/A.

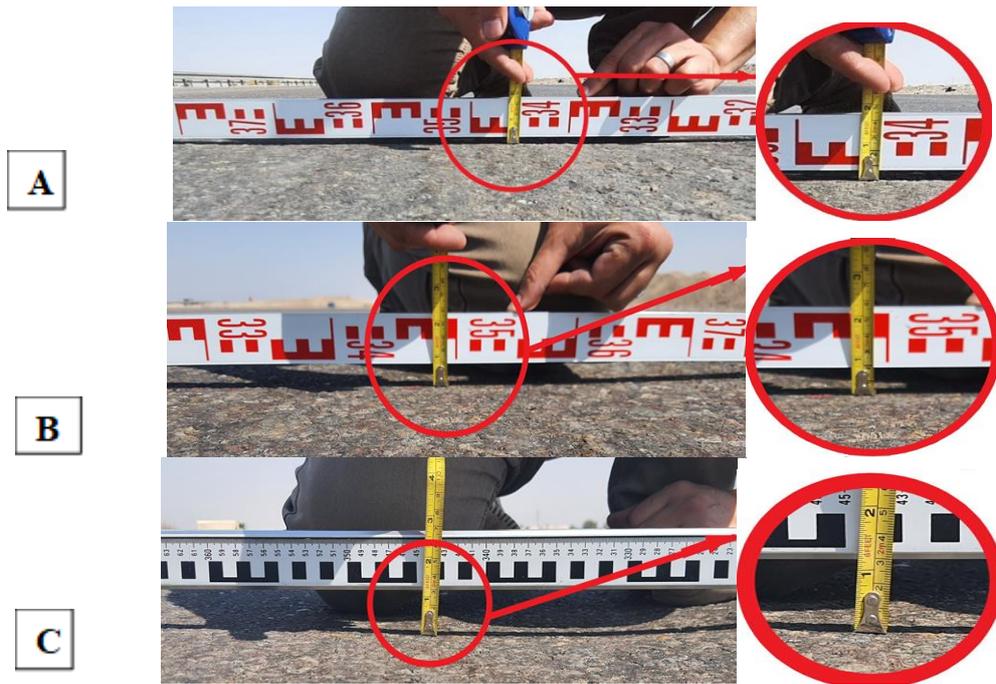
Many highway agencies and researchers have suggested that pavement rutting could lead to vehicle hydroplaning and loss of skid resistance. Most highway agencies classify rut severity based on engineering judgment or field experience. As illustrated in Table 3 (Fwa, & Ong, 2012). previously, there are limits on rut depth thresholds used by different highway agencies in the severity level classification of ruts for pavement maintenance management. Highway Pavement Condition Index (PCI) thresholds will be taken to classify the rutting levels for the study area, as in Table 3 No. 1. For the study area, the severity of rutting was classified into three levels; low, medium, and high as presented in Figure 4 (A, B, and C respectively).

**Fig. 4 Severity level measurement: (A) Low for Section 1, (B) Medium for Section 3, (C) High for Section 2.**

The field survey of Expressway No. 1 for part R/9 was centered on identifying and classifying ruts based on their severity, see Section 3.1. The study area was surveyed in the following order; see Figure 4 (A, B, and C):

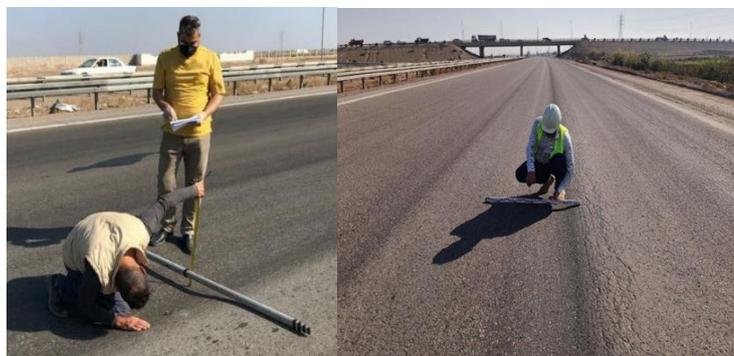
The Straight edge method is the most accurate and widely used method by agencies and researchers (Yeganeh1 et al, 2019; Kannemeyer, 1996; Mallela & Wang, 2006; McGhee, 2004; & Wang, 2005). It has been used in this work for rut depth measurement. According to (ASTM-E1703 M , 2010), before taking measurements and collecting data, the pavement surface was cleaned, provided that the pavement surface is free of any obstruction that affects the measurements, for example, potholes or loose debris. Then, a straight metal straightedge with a length of 1.83 meters (6 feet) was used. The straightedge is placed transversely over each path of the wheel in which the rutting occurred; the maximum vertical distance from the bottom of the straight edge to the top surface of the pavement is measured with a gauge and is considered as the rut depth. According to this method, the intensity level of the three stations was determined, as shown in Figure 3, 4 and 5.

**Fig. 5 Measuring the rutted level of the three sections using Short Straight Edge Method.**
