Impact of Elevated Temperatures on the Mechanical Properties of GFRP Bars in RC One-Way Slab: A Review

Akeel A. Jias¹ and Abdul Qader Nihad Noori²

^{1,2} Department of Civil Engineering, College of Engineering, Mustansiriyah University, 10064 Baghdad, Iraq

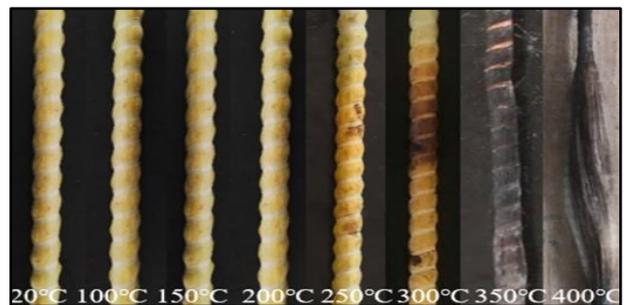
Figure 3. GFRP bars after exposure to elevated temperature [26]

GFRP bars when heated, rods darken, as shown in Figure 3. and at 400°C the resin fully decomposes. The tensile strength of GFRP rods was not significantly affected at temperatures below 100°C, but it decreased with increasing temperatures above 100°C, as shown in Figure 4. However, after cooling, the tensile strength of the GFRP bars was 4-56% higher than under high-temperature conditions due to partial recovery of the resin from its rubbery state. The modulus of elasticity is less impacted than tensile strength and shows minimal change at temperatures below 400°C, as the fibers primarily influence it. At temperatures below 150°C, the final strains of the GFRP bars under and after exposure to high temperatures were similar. However, at temperatures above 150°C, strain values increased due to partial recovery of the resin [26].

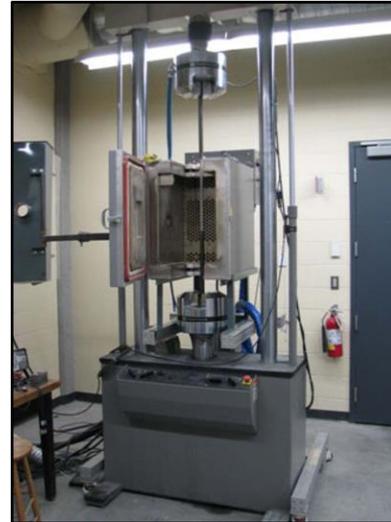
Figure 5. Tensile test at the heated chamber [27]

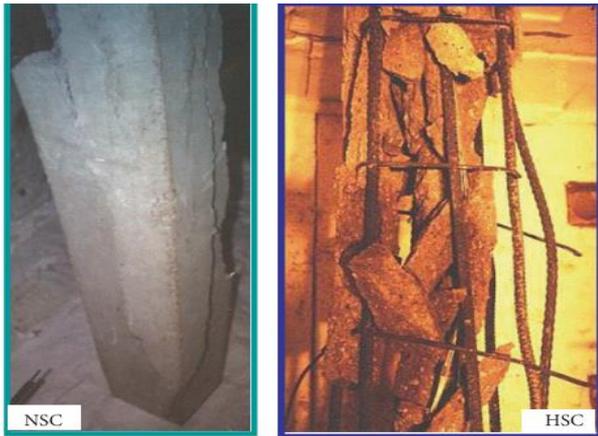
Figure 11. Spalling in NSC and HSC columns under fire conditions

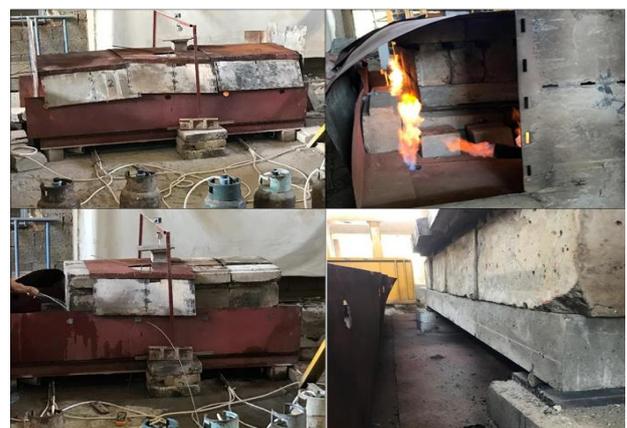
Figure 12. Details of specimens and the fire

process [43]

Abdullah and Al-Khazraji (2019) [43] conducted an experimental investigation on six high-strength laced reinforced concrete one-way slabs exposed to fire flames as shown in Figure 12. The slabs, each with a compressive strength of approximately 60 MPa, were subjected to fire at 500°C for two hours and then cooled suddenly by spraying water. The study aimed to evaluate the effect of laced steel reinforcement ratios (0.0021, 0.0040, and 0.0060) on the slabs' performance after fire exposure. The slabs were tested under a four-point bending test to examine their residual bending strength, deflection, and failure modes. The results revealed that the fire-exposed slabs showed a decrease in residual bending strength. The residual bending strength for slabs with laced ratios of 0.0021, 0.0040, and 0.0060 were 72.56%, 70.54%, and 70.82%, respectively. In contrast, the deflection increased by 11.34%, 14.67%, and 17.22% for the corresponding slabs compared to non-burned specimens. The increase in deflection and reduction in load capacity were attributed to the loss of concrete compressive strength and the weakening of the bond between the concrete and reinforcement. However, the presence of laced reinforcement helped maintain some structural capacity after fire exposure, showing the importance of this reinforcement in fire-prone applications. The study suggests that further research is needed on optimizing laced reinforcement ratios for better fire resistance, as well as exploring alternative materials and retrofitting methods to enhance fire resistance.

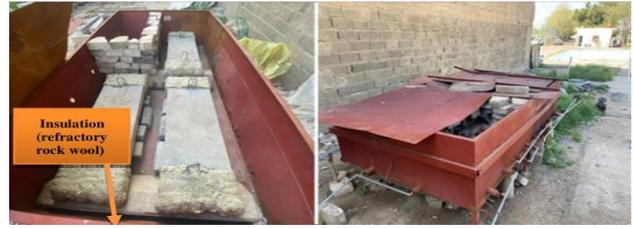
Figure 14. Specimens test (a) setup of furnace and specimens, (b) test setup [45]

Rasheed and Mohammed (2024) [45] studied the structural behavior of concrete one-way slabs reinforced with mixed steel and GFRP bars under fire exposure. The slabs, measuring 1500×540×120 mm, were subjected to fire at 500°C for 1 hour as shown in Figure 14, followed by rapid cooling. GFRP replacement ratios of 0%, 20%, and 40% were tested to assess their impact on the slabs' load capacity, failure modes, deflection behavior, and toughness. The results revealed that slabs with 20% GFRP replacement showed a slight increase in load capacity (2.62%) and toughness (18.30%), while those with 40% GFRP replacement exhibited decreases in both load capacity (3.13%) and toughness (28.16%). The failure mode shifted from flexural failure in the 0% and 20% GFRP slabs to shear failure in the 40% GFRP slab. Cracks formed predominantly in the middle of the slabs, with shear cracks appearing in the 40% replacement slab. The study found that centrally located GFRP reinforcement improved fire resistance compared to reinforcement placed near the ends. The authors suggested further research into optimal GFRP placement and long-term performance under repeated fire exposure to enhance fire-resistant concrete design.
