# Al-Rafidain Journal of Engineering Sciences

## Experimental Investigation on the Ultimate Strength of Corroded Composite Concrete Beams Strengthened with NSM GFRP Bars

This study examined the impact of corrosion on the ultimate strength of composite concrete beams and assessed the effectiveness of Glass Fiber Reinforced Polymer (GFRP) bars applied using the Near-Surface Mounted (NSM) technique. Five composite beams were cast and tested, each comprising a self-compacting concrete (SCC) web and a normal-strength concrete (NC) slab connected by vertical steel links. The primary variables were corrosion level and the location of GFRP strengthening. One specimen was used as a control, while the remaining four were exposed to either partial corrosion (50 mm into the slab) or full-depth corrosion across the entire cross-section. GFRP bars were applied through the NSM technique at two positions: within the slab region and in the tensile zone of the beam. Experimental results showed that corrosion significantly reduced load-carrying capacity, especially in fully corroded specimens, which failed earlier. However, NSM-GFRP bars enhanced the structural execution of corroded beams. Strength

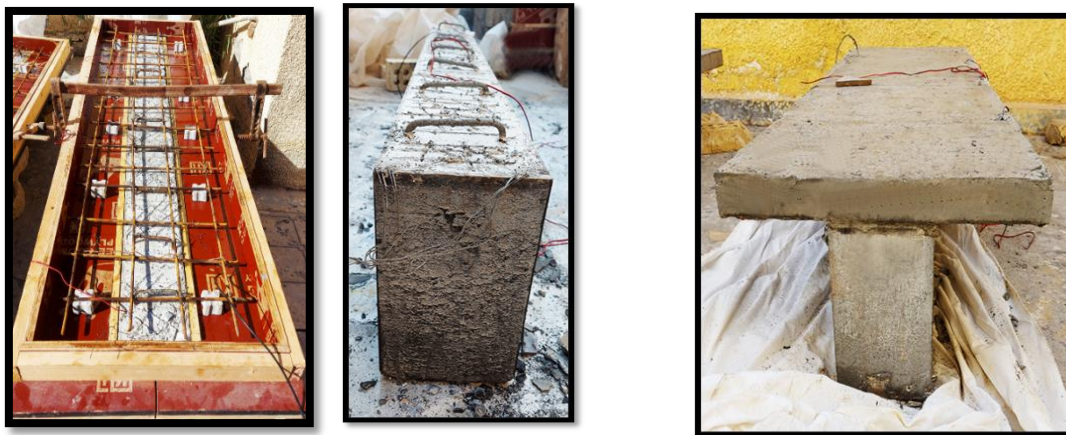
**Figure 4** Beam Specimens Cast

on-site casting of composite beam specimens and control samples (cylinders, cubes, and prisms) for evaluating the mechanical properties of the hardened concrete. Steel cages for the beams and reinforcement layers for the deck slabs were carefully assembled and positioned prior to casting. The concrete components were mixed according to the specified mix design, transported, and placed into molds. Following casting, all specimens were demolded after initial setting and cured in water for 28 days to enhance hydration and minimize moisture loss, ensuring optimal long-term strength. The composite beams were cast in two stages: first, the lower section (web) was poured and cured; after several days, the upper section (slab) was cast, completing the composite configuration. This sequential casting approach is illustrated in Figure 4

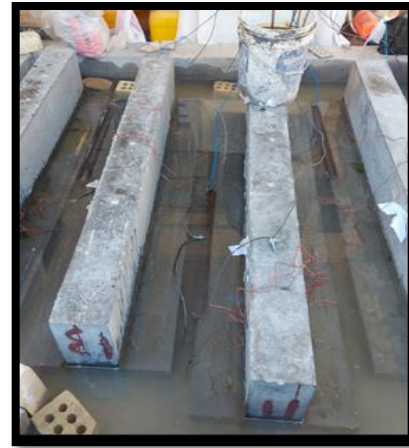
Figure 6 Phases of the corrosion process for first-level specimens

An electrochemical method is used to expedite the degradation of both longitudinal and transverse reinforcement in composite beams, which indirectly facilitates the deterioration of the two concretes used (NC) and (SCC). Two levels of corrosion were administered to the tested composite beams. The first phase entails revealing the upper section of the beam (flange), which encompasses the deck slab level, characterized by a thickness of just (50 mm). The subsequent phase is subjecting the

whole beam to corrosion at a height of (300 mm). A consistent corrosion rate was established for both levels, resulting in an estimated (30%) reduction in the mass of the steel bars utilized to fabricate the tested beam specimens for this study. Three concrete containers (tanks) were used to do the accelerated (artificial) corrosion process. The dimension of the first tank was (2m x 2mm), the second tank was (2.2m x 1.4m), and the third tank was (2.6m x 1.8m). Four samples were allocated to the first tank, and two samples were designated for the second tank to initiate the corrosion process at the upper section (flange) of the tested composite beams, leading

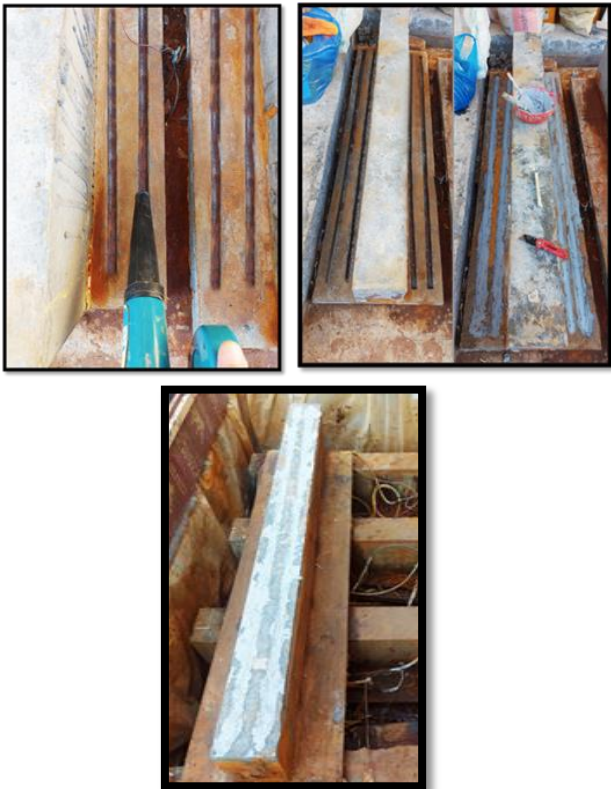
**Figure 8** Implementing the NSM technology on corroded beams

their structural performance. A critical aspect of using FRP materials for strengthening is ensuring proper adhesion between the FRP and the concrete substrate. To achieve this, the beam surfaces were thoroughly prepared: grooves formed during casting were carefully cleaned using a soft brush, and residual dust was removed with an air blower. A high-performance epoxy adhesive, Sikadur-31 CF, was used to bond the GFRP bars. The epoxy's two components (A and B) were mixed at the manufacturer's recommended weight ratio of 1:2. The mixed epoxy was applied into the grooves, followed by the placement of the GFRP bars. The grooves were then sealed with an additional epoxy layer, as illustrated in Figure 7. The assembly was left to cure for 10 days in accordance with the manufacturer's guidelines.

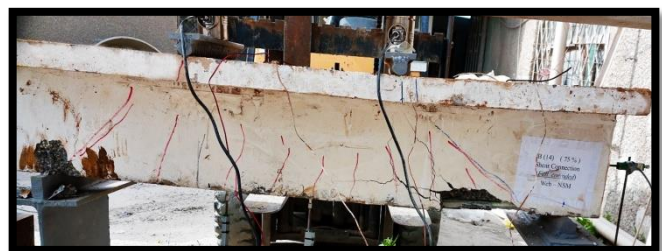
**Figure 10** Beam specimen's test

failure, Figure 9. To observe the progression of cracks, the beam specimens were coated (painted) with white color paint. Consequently, the fissures were apparent during the experimental test of the beam specimens. Two linear variable differential transformers (LVDTs) were positioned on the bottom face of the tested beams for bending testing; the first one was fixed at the mid-point of the tested beam, and the other was fixed under the location of one of the two-point loading. The beam specimens were tested using an electric hydraulic machine with a maximum capability of (500 kN). Loads were incrementally applied to the tested beams until the failure threshold was attained. All measured and observed deflections for each beam specimen were documented with a data logger. Marks were applied to the cracks that emerged during the test utilizing coloring pens, and the width of the cracks for each model was quantified using a digital microscope, as illustrated in Figure 10.

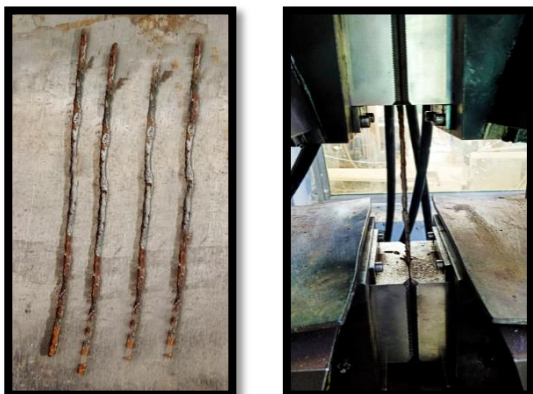
**Figure 12** Corroded and non-corroded steel bars tensile test

reinforcing steel bars (longitudinal and lateral), particularly concerning the shear connections of the composite beams, Figure 11. Various samples of corroded reinforcing steel bars were collected for laboratory analysis, Figure 12; the bars were cleaned by removing rust and mortar residue around their surfaces by brushing. The test findings of the corroded steel bars were juxtaposed with those of the non-corroded steel bars, and the extent of loss in the reinforcement steel attributable to corrosion was quantified in Table 3.
