## ASSESSMENT OF ROCKFALL HAZARDS ON MIRAWA – MAWARAN MAIN ROAD, KURDISTAN REGION, N IRAQ

Key words: RHRS, Rockfall hazard, Slope stability, Mirawa, Iraq

### ABSTRACT

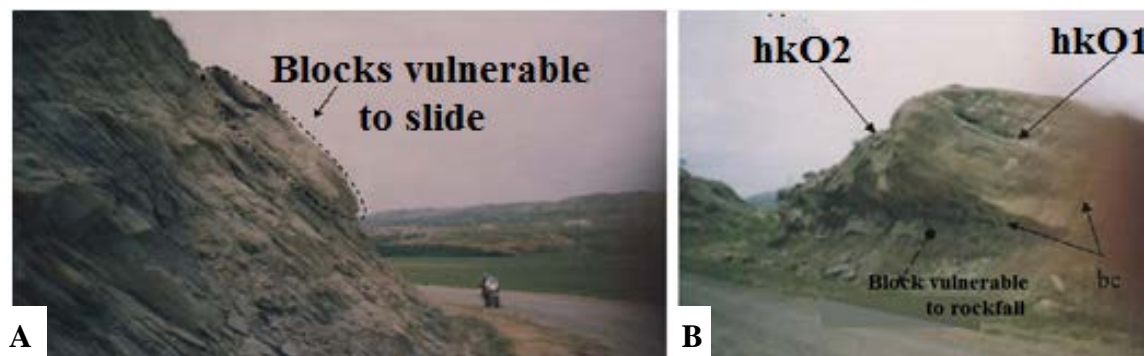
Fig.3: Side views of sites 11 (A) and 14 (B); showing the blocks vulnerable to rockfall on Mirawa road

sandstone beds have taken place, after the removal of the underlying supports by either differential erosion of the claystone or by the road cut works. Most of the rock failures are defined as plane sliding, especially in the sites 6, 14, 18 and 20; as demonstrated in Figs. (3 and 4) and wedge sliding in sites 10, 11 and 22; as shown in Figs. (5 and 6).

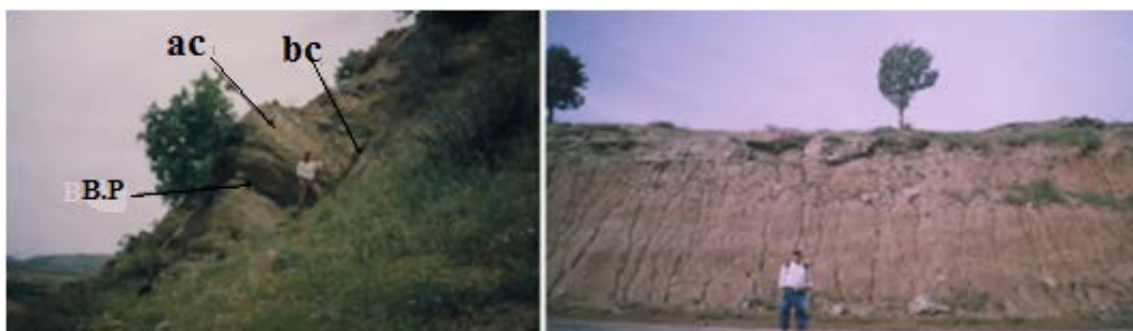
Fig.4: Side and frontal views of sites 18 and 20 respectively, of potential plane sliding

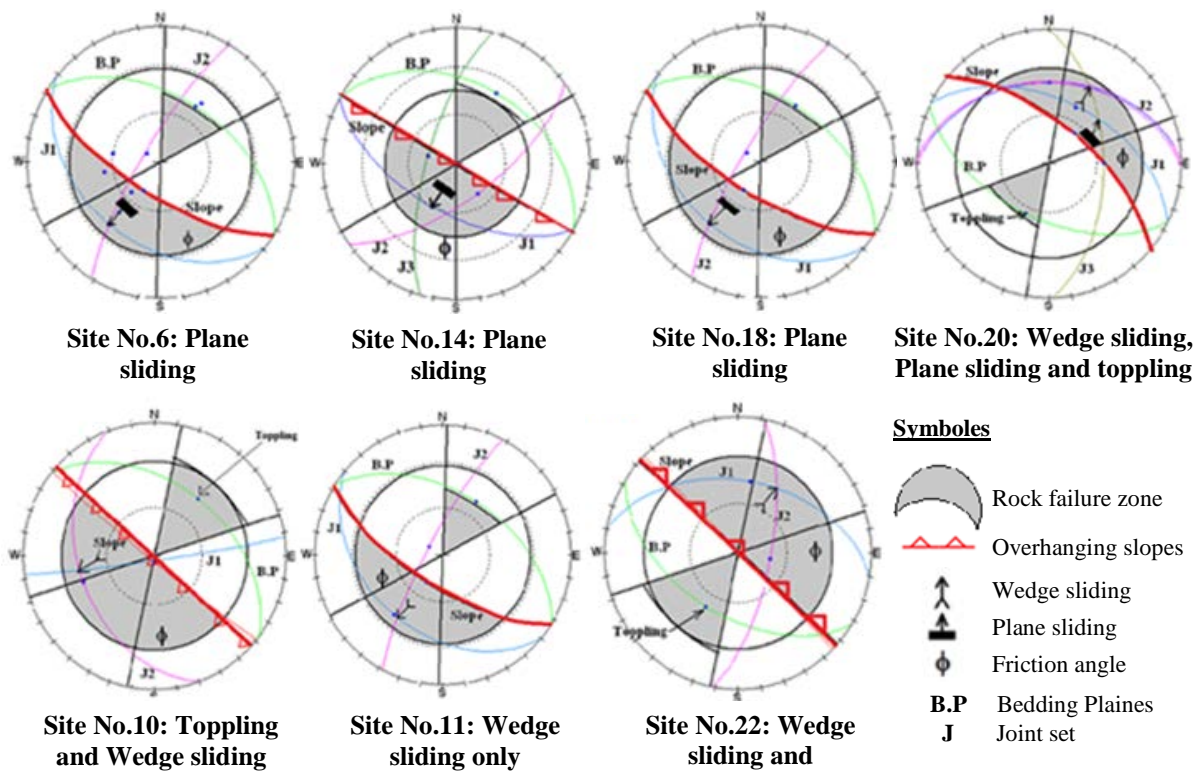
Fig.7: Stereographic projection of rock failure types of the studied road cuts

The studied rock slopes are kinematically analyzed and represented by the stereographic projection in Fig. (7), which shows the potential plane sliding that has taken place along the slopes of sites 6, 14 and 18. The slopes of sites 10, 20 and 22 have the probability to wedge sliding, in addition to toppling, while along the slope of site No.11 only wedge sliding is probable.
