ASSESSMENT OF ROCK SLOPES STABILITY USING STEREOGRAPHIC PROJECTION ALONG WADI SHORSHIRIN IN ZURBATIYA REGION/ EAST OF IRAQ

Anwar Dh. Jasim^{1*}, Amera I. Hussain¹, and Ali Kh. Al-Shwaily²

ABSTRACT

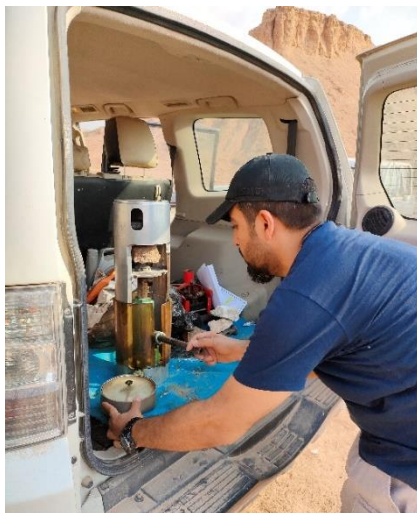
Figure 2: Point load testing for the selected rock samples in the field.

The strength of the rocks was estimated in the field by hammering with the field geological hammer, then selecting rock samples that are representative of some rock units to conduct a point load testing and obtain the unconfined compressive strength values indirectly. This test was conducted on samples with lump shapes using the apparatus: Portable Point-Load tester which was borrowed from the Central laboratories of the Iraqi Geological Survey (Figure 2). From the following equation, we can derive the values of the point loading coefficient (I_s):

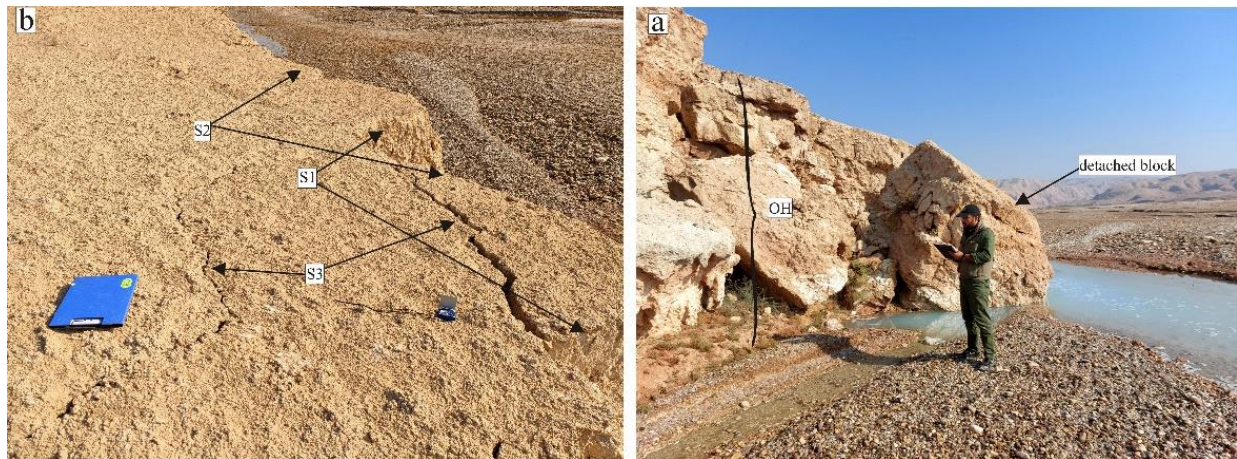
Figure 6: **a)** Side view showing slope and size of the detached block, **b)** view showing the three sets of joints.

spacing ranges to (0.5 m). Rockfall and secondary toppling were occurring in this station, the rock mass of gypsum detaching because of differential weathering of marl mudstone under gypsum layers and the existence of joints. The size of the failed blocks of gypsum rock mass reaches up to (1.8 m³), (Figure 6a). More falling is likely to occur in the future due to the continuous growth of the releasing fractures at the top of the slope of this station, so the slope is unstable because of the existing joints shown in (Figure 6b).
