Post Fire Performance Of Thin-Walled Carbon Steel Single Shear Bolted Connections

ABSTRACT

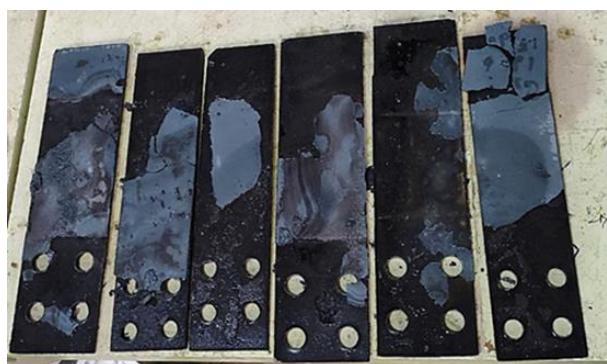
Figure 2. Specimens after heating and cooling

prepared with the required dimensions and bolt holes then placed in the furnace for heating to 1000°C for 120 min. Then, specimens were immersed in water for cooling purposes. A thick pulling plate with dimensions of 185×300×16 mm was used for pulling the specimens during the test. The specimens were connected to a thick pulling plate (185×300×16 mm) by four M14 bolts. Two strain gages were used (first one fixed next to the bolt along the end distance and the other one to the side of the bolt) (Fig. 3). Linear Variable Differential

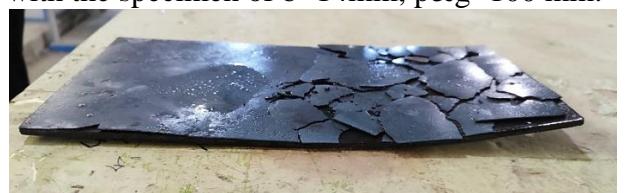
Figure 5. Peeling surface layers and deformation (bending) of large specimen

It was found that peeling surface layers of all specimens after heating and cooling can be considered as 18% decreasing in thickness of the specimens and this must be taken into consideration in the redesign of steel structure after it has been exposed to fire (Fig. 5). The type of failure for eight specimens was net section fracture failure, some of them shows curling displacement. While the ninth specimen was failed by end distance fracture failure and without curling displacement. This difference of failure types happens due to the difference of the specimens' dimensions and parameters like end, edge distances and bolt spacing. Accordingly, the failure tracks the shortest

- Physical changes can occur after exposing to high temperatures (1000°C) and cooling with water:
 - The curvature of specimens because of the high and fast cooling and the curvature amount was noted to be higher as the specimen surface area was larger.
 - All specimens showed reduction of thickness by about (18%), and the other dimensions did not seem to be greatly affected.

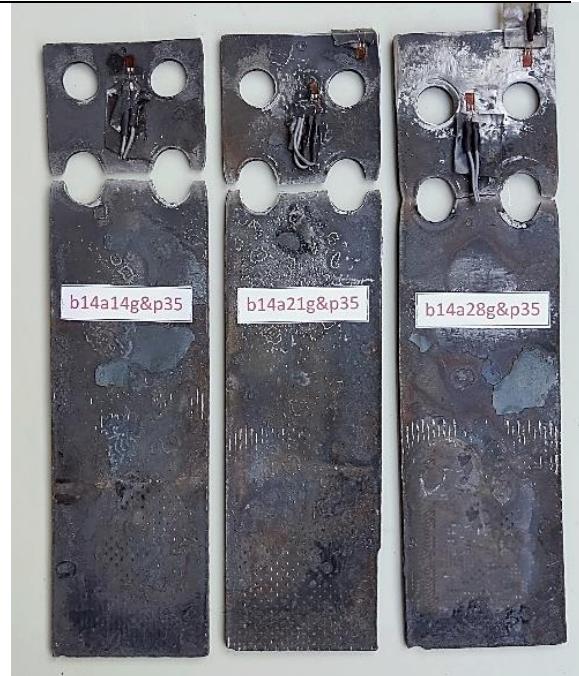
**Figure 6.** Specimens with (b=14 mm, g&p=35 mm)

The specimens with edge distance 14 mm and bolt spacing 35 mm, (b14a14g&p35, b14a21g&p35, b14a28g&p35) failed by net section fracture (Fig. 6). These specimens showed increasing of the ultimate load when their end distances increase, they show enhancement in ductility when the end distance was increased (Fig. 7). Also, they had no curling displacements only longitudinal displacements. This is likely due to the small dimensions of the specimens, which means a faster failure path for net tensile fracture to occur. (Fig. 8).

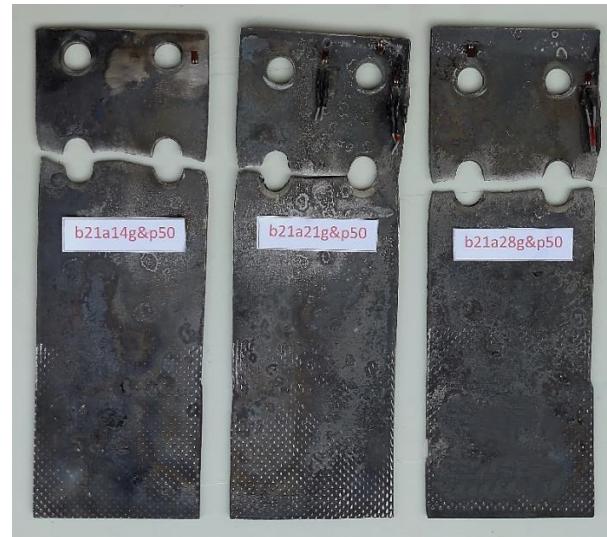
Figure 9. Specimens with (b=21 mm, g&p=50 mm)

Specimens of edge distance 21 mm and bolt spacing 50, (b21a14g&p50, b21a21g&p50, b21a28g&p50) the type of failure was also net section fracture failure (Fig. 19). The ultimate load was higher in the specimen that had the end distance 21mm (b21a21g&p50) but its ductility was the lowest (Fig. 10). The curling

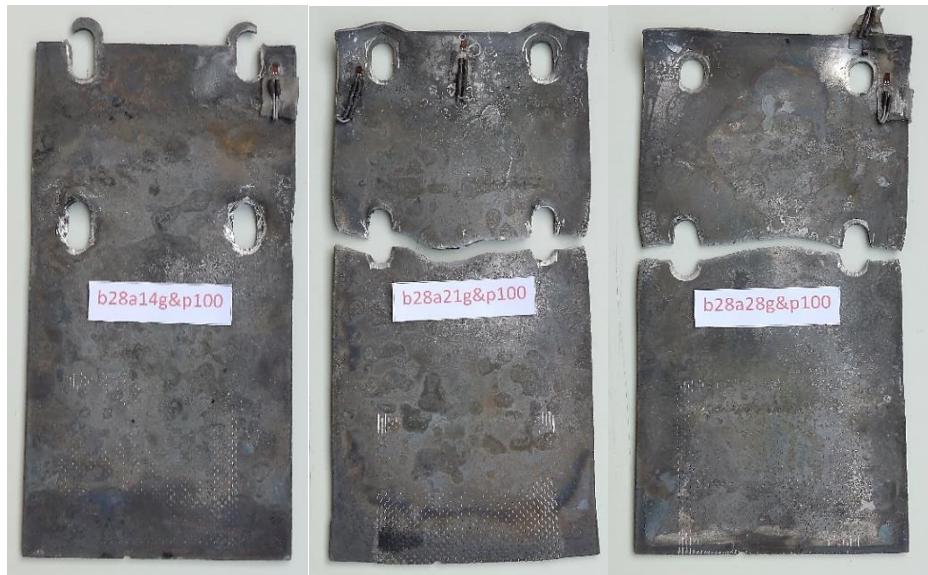
Figure 12. Specimens with ($b=28\text{mm}$, $g\&p=100\text{mm}$)

For the specimens with edge distance 28 mm and bolt spacing 100 mm, (b28a14g&p100, b28a21g&p100, b28a28g&p100) the type of failure was net section fracture for specimens (b28a21g&p100, b28a28g&p100), while the specimen with end distance 14mm (b28a14g&p100) was failed by bending fracture along the end distance and without curling displacement (Fig.12). It is possible that this type of failure occurred due to the small end distance compared to edge distance and the spacing between bolts. The higher value of ultimate load was with the specimen (b28a21g&p100), and it has the highest ductility (Fig.13). However curling displacement appeared in the specimens with the highest end distance (21,28 mm) (Fig.14). Also, with these specimens and as a result of the long net tensile fractur failure path, if compared with the rest of the specimens, it was a reason for the appearance of curling displacement. As for the specimen, which had a very small end distance (14mm), it provided a very fast failure path due to this small distance, so it failed bending fracture along the end distance.
