Applying Ni-WC as a Composite Coating Combines both Protective and Repair Functions by Thermal Spray for HPTB Applications

Coating,
Repair,
High pressure turbine blades,
Flame thermal spray,
Taguchi

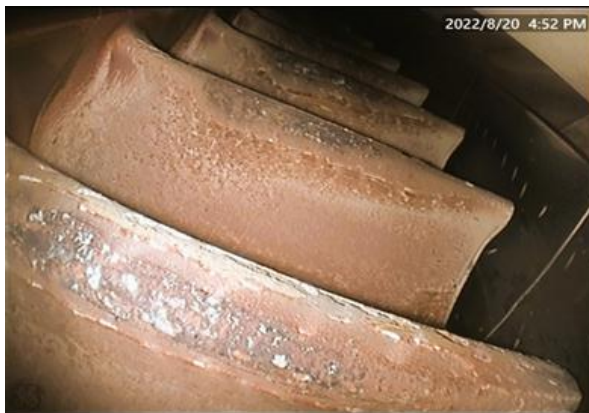
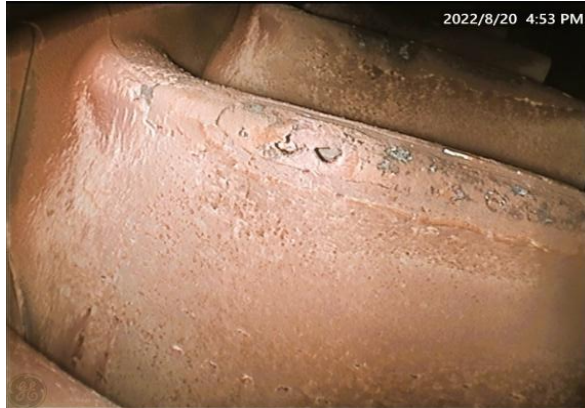
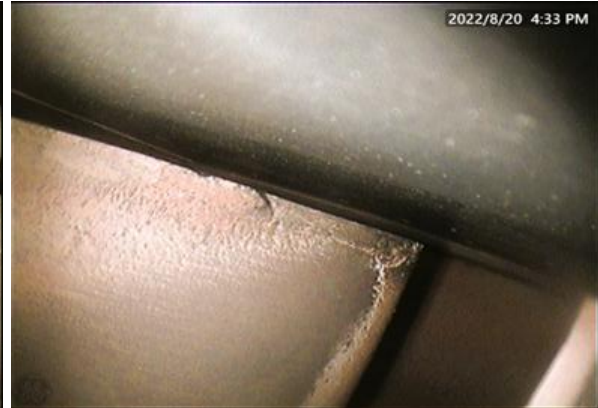
HPTB of the CFM56-72B engine

Oxidation/LE

Crack/LE

Burn through/LE

Missing material/Tip

Figure 1: Defects of HPTB.

Damage to the parts that operate at high temperatures exceeding 1000 °C is a common issue, particularly in gas turbine engines. In these engines, thermo-mechanical stresses occur in the rotor blades of the high-pressure turbine blades (HPTB) unit due to the combination of high pressure and high temperatures. Damage occurs at the leading edges (LE) or trailing edges (TE) or the blade tips during service [1, 2]. The causes of turbine blade damage can be categorised into three main factors: operational, environmental, and impact-related. Operational factors include extreme temperatures, high pressures, and hard landings. Environmental factors may involve hot or polluted intake air. Impact-related damage can result from foreign object damage (FOD), such as dust and organic materials like birds, as well as engine debris, referred to as known object damage (KOD). **Fig. 1** illustrates the most common defects identified during HPT inspections using a borescope [3].

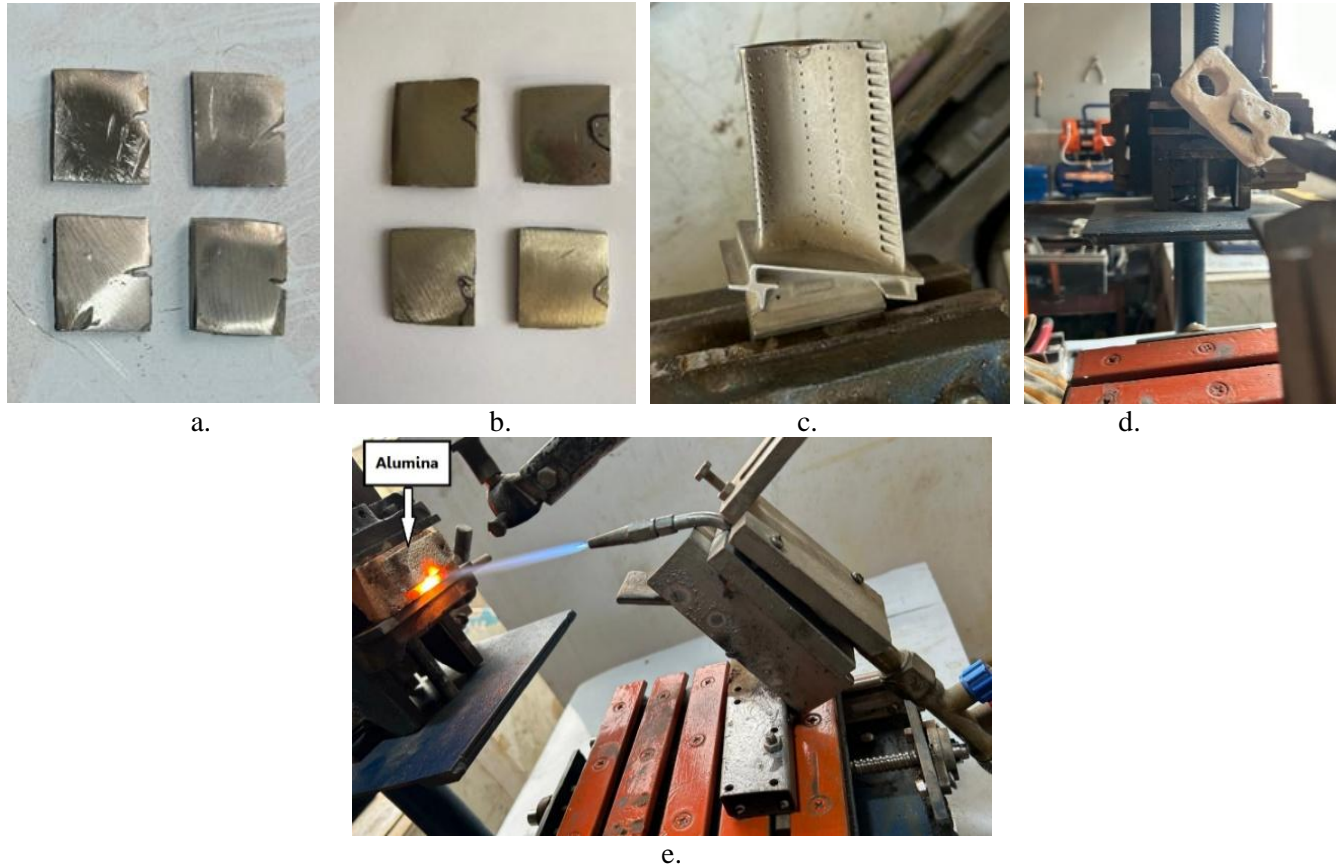
Figure 6: a) samples before repair, b) samples after repair, c) HPTB after repair, d) protective shield Alumina, e) using the FTTHS technique for repair.

The FTTHS process was used to repair a turbine blade that had a tip crack. To facilitate this process, an artificial crack less than 0.05 cm was created in four samples measuring $(2 \times 2 \times 0.04)$ cm, designed to mimic the shape of the blade tip. To repair the HPTB, the crack area at the blade tip was first cleaned. Following this, two layers of coating were applied using FTTHS along with the optimal parameters. A spray nozzle with a diameter of 0.5 mm was used to concentrate the coating materials in a narrow area. To protect the remaining parts of the turbine blade during the spraying process, a piece of alumina was employed as a shield, as illustrated in **Fig. 6**.

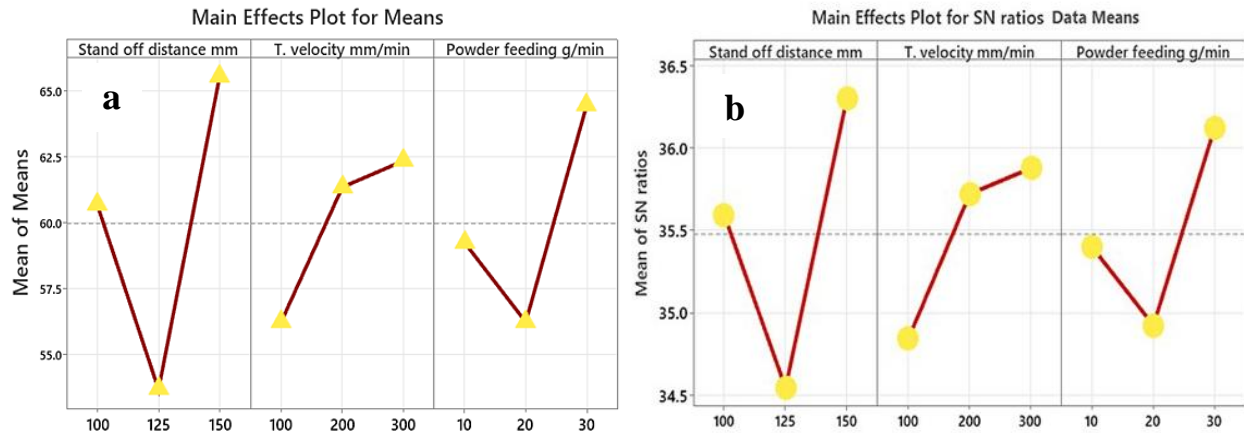
Figure 7: Diffusion main effect plot for: a) means and b) S/N.

To determine which parameters, require control to achieve coating with good properties, a response table of means and signal-to-noise ratio (S/N) was utilised. The parameter with the largest difference in delta value, defined as the difference between the highest average S/N and the lowest average S/N for each parameter, exerts the most significant influence on the response. The results indicate that SOD (A) had the highest effect and delta value, making it the parameter with the greatest influence on coating spread (ranked 1st). In contrast, TV (B) had the least influence among the other parameters (ranked 3rd), as shown in **Tables 4** and **5**. Based on these results, **Fig. 7** shows the mean and S/N plots generated using Minitab software.

From **Fig. 7**, the diffusion depth increased over 10 μm when the SOD was raised from 125 mm to 150 mm. Additionally, an increase in the FR from 20 g/min to 30 g/min resulted in an improvement of about 8 μm in diffusion depth. Furthermore, the diffusion depth also increased over 6 μm when the TV was increased from 100 mm/min to 300 mm/min. So, the optimal coating conditions were achieved by selecting the following parameters: A3 (SOD = 150 mm), B3 (TV = 300 mm/min), and C3 (FR = 30 g/min), as appear in **Table 6**.
