# Failure Characteristics Of Boiler Pipes In Al-Emsaeb Electric Power Plants

Sami Ibrahim Jafar

*Department of production eng. & metallurgy, University of technology, Baghdad*

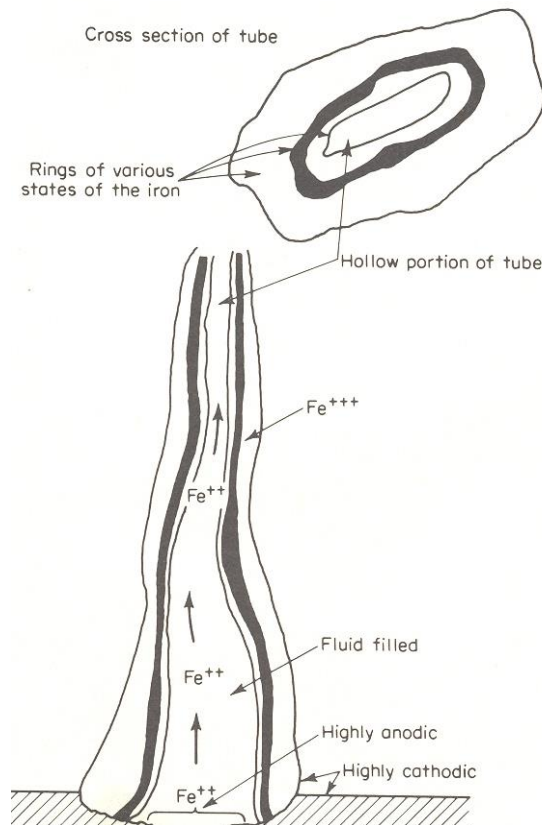
Fig.7 indicates that iron hydroxide forms due to interaction between the OH produced by the cathodic reaction and the corrosion product. This is further oxidized by the dissolved oxygen in the solution to  $\text{Fe}(\text{OH})_3$ ,  $\text{Fe}_3\text{O}_4$ ,  $\text{Fe}_2\text{O}_3$ , and other oxides. This { rust } rims grows in the form of a tube as shown in Fig.7.

**Fig.7** Corrosion tube growth mechanism { Fontana & Greene,1987).
