## SLOPE STABILITY ASSESSMENT WITHIN AND AROUND THE RESERVOIR OF THE PROPOSED BASARA DAM, SULAIMANIYAH, NE IRAQ

Ghafor A. Hamasur<sup>1</sup>

Received: 08/ 12/ 2011, Accepted: 28/ 04/ 2013

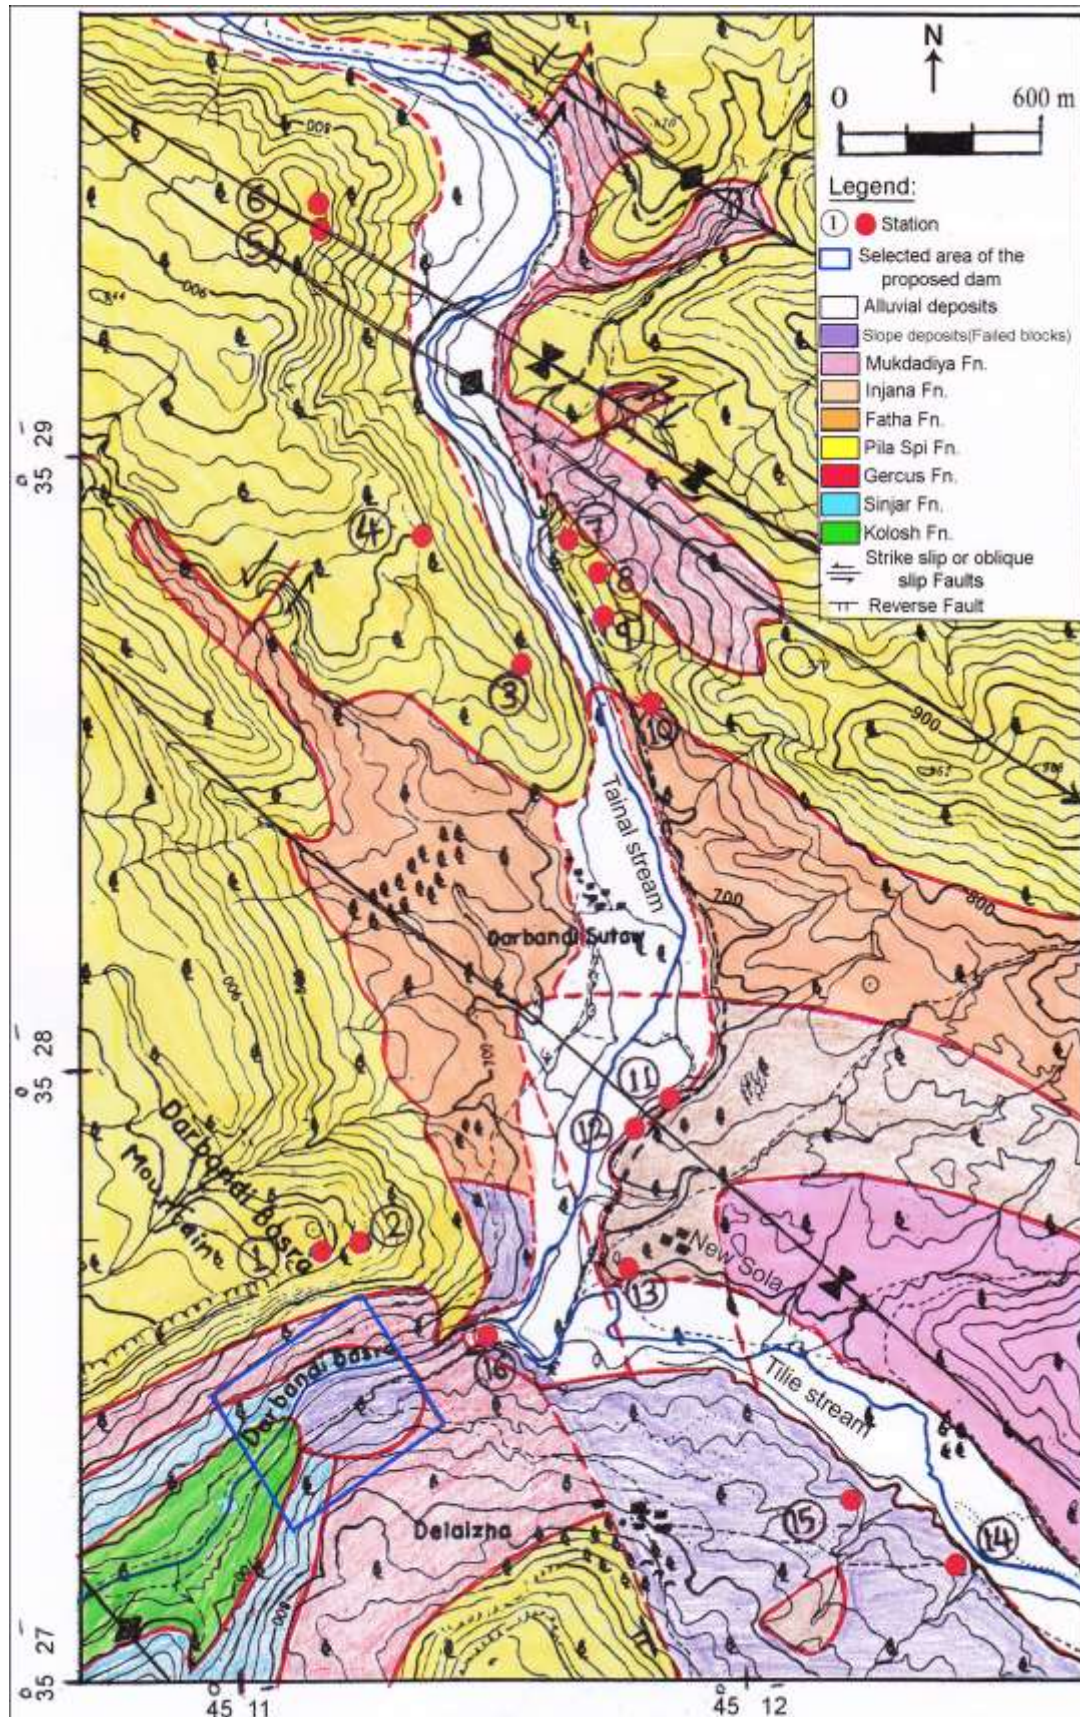
In this study, 14 stations in rock slopes (Stations No. 1, 2, 3, 4, 5, 6, 7, 8, 9, 10, 11, 12, 13 and 15) were selected; within and in the vicinity of the reservoir area. Moreover, 2 stations (Stations No. 14 and 16) in the soil and talus sediments were selected (Fig.2). The possibility of landslide occurrence within the 14 mentioned rock slopes was evaluated; by using the Landslide Possibility Index (LPI) system (Bejerman, 1994), who evaluated rock slopes stability of 2831 m of road, near Los Molinos dam (Cordoba, Argentina) (Bejerman, 1998). This system uses rating, which establishes the failure possibility and to indicate the need for a detailed study. Further study was carried out for those stations, which need a detailed study to determine the type of failure using Hoek and Bray (1981) method.

Fig.2: Geological map shows locations of the studied assessed slopes (stations with serial numbers) (Modified from Hamasur, 2009)
