Control of Corrosion of Copper-Alloy Condenser Tubes by Chemical Treatment

ABSTRACT

The present work deals with the study of the factors that affect the corrosion resistance and heat transfer resistance of treated condenser tubes by surface filming with ferrous sulfate solution. The reduction of corrosion rate on the filmed surfaces was determined under dynamic conditions using weight loss method. The variation of the corrosion rate at different exposure time and different fluid velocities of the filming solution were studied throughout the laboratory corrosion system. While the effect of surface filming on depression of heat transfer process in term of increasing the heat transfers resistance was studied throughout the laboratory thermal system. The results indicated that the filming solution reduced the corrosion rate of copper alloy to 52.7%, but the heat transfer resistance increased from 12.88 to $18.73 \times 10^{-4} \text{ m}^2 \text{ K/W}$. Moreover, the metallurgical investigation clearly revealed the feature and nature of the film formed on the metal surface.

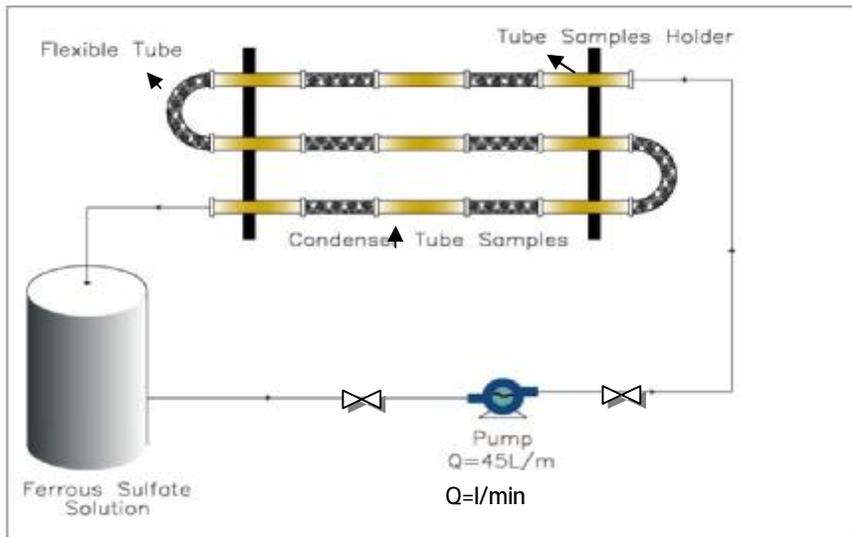
Figure (1) Ferrous sulfate treatment system.

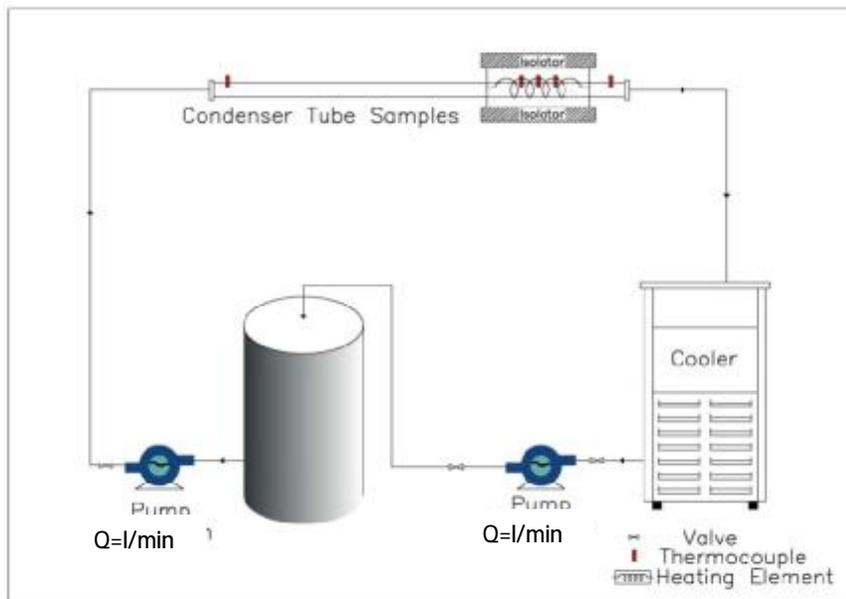
Figure (2) Thermal measurements System.

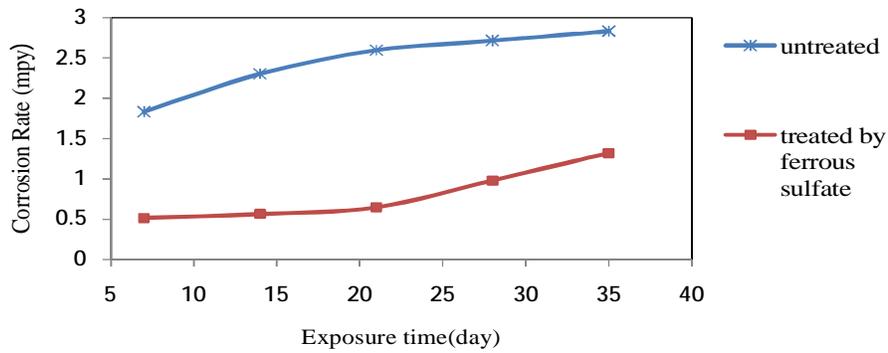
Figure (3) Variation of corrosion rate with time for treated and untreated brass with ferrous sulfate and filtered water (pH 7.6) respectively, velocity 1.6 m/s, at 25°C.

Effect of exposure time on corrosion rate

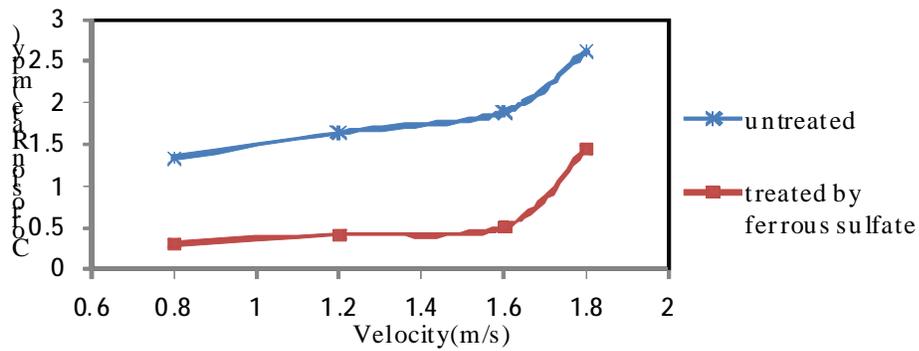
Figure (4) Variation of corrosion rate with velocity of treated and untreated brass with ferrous sulfate and filtered water (pH 7.6) respectively for 7 days, at 27°C.

Effect of velocity on corrosion rate

increased to 1.8 m/s the corrosion rate accordingly increased to 1.443mpy, where the film of ferrous sulfate seemed to be affected by recirculation velocity i.e. high velocity led to destruction of the protective film [10]. It was found that the efficiency of ferrous sulfate film in reduction the corrosion rate at maximum velocity used was 52.7%.

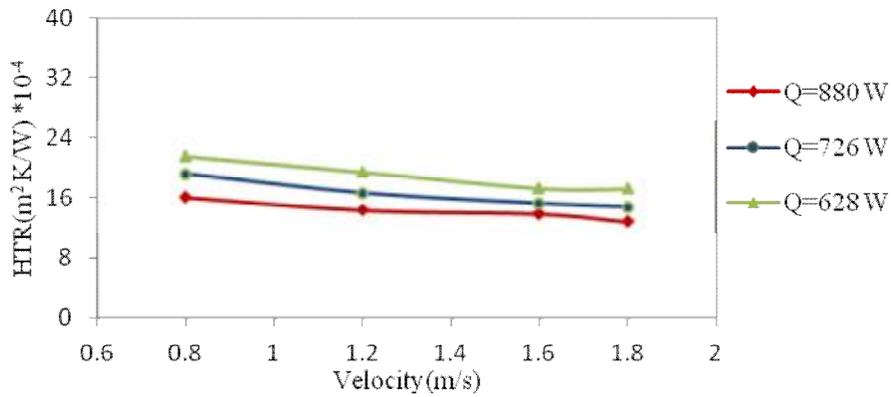
Figure (5) Variation of heat transfer resistance with velocity for untreated brass tubes at different applied heat, at 30°C.

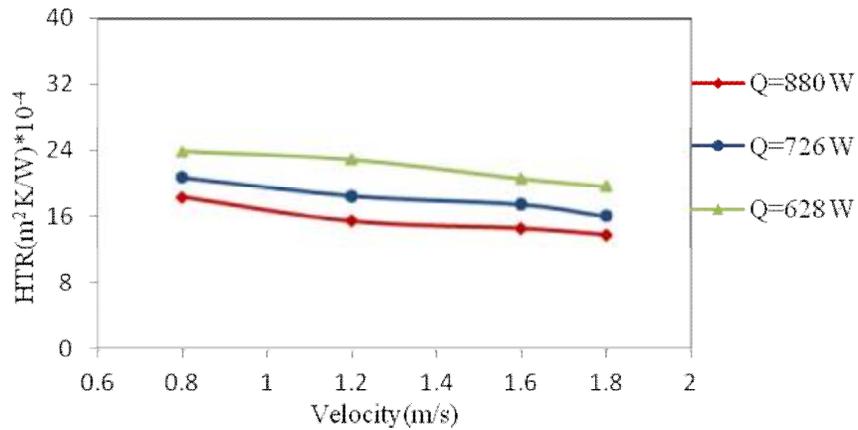
Figure (6) Variation of heat transfer resistance with velocity for treated brass with ferrous sulfate at different applied heat, at 30°C.

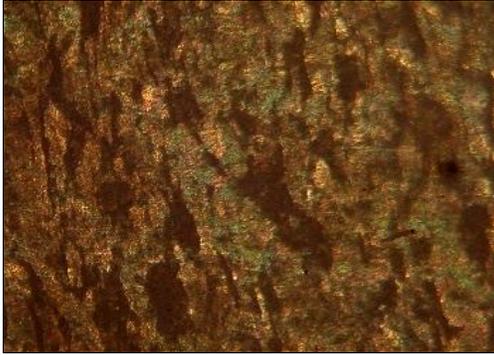
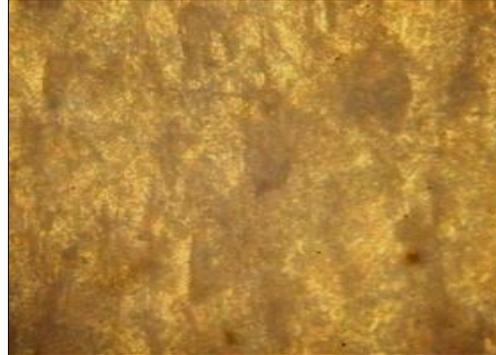
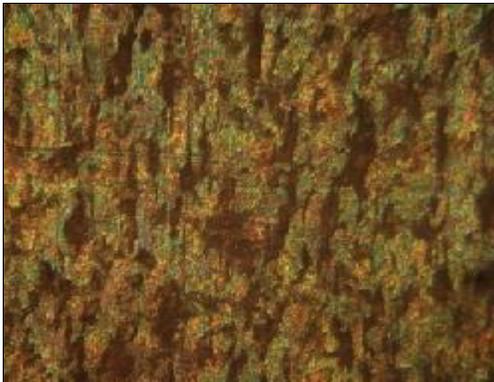
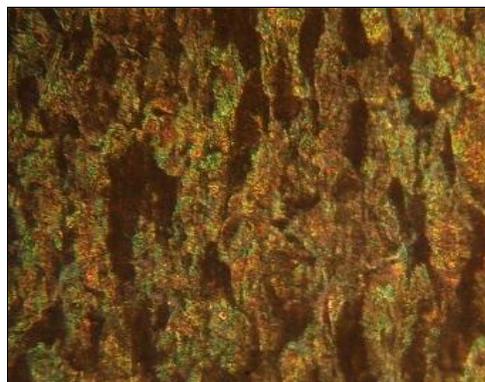
(a) As received specimen

(b) 8 Days immersion

(c) 12Daysimmersion

**Figure (7) Surface feature of as-received specimens with and without
Immersion in filtered water, 200X.**

It was observed that the oxidation profile of as-received specimens showed dark brown color resulted from originally black oxidation CuO mixed with red cuprous oxide Cu_2O and green corrosion product of copper carbonate CuCO_3 . While polished specimens showed corrosion of brass with red cuprous oxide Cu_2O and green copper carbonate CuCO_3 . Apparently prolonged immersion time increased the amount of the corrosion product on metal surface.

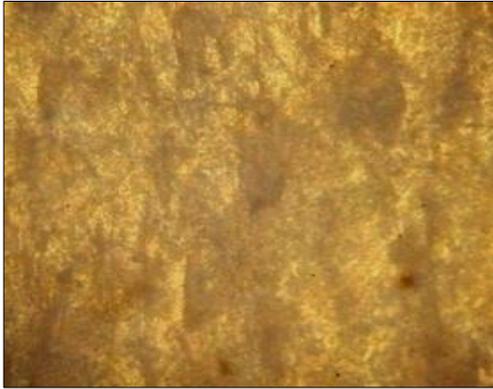
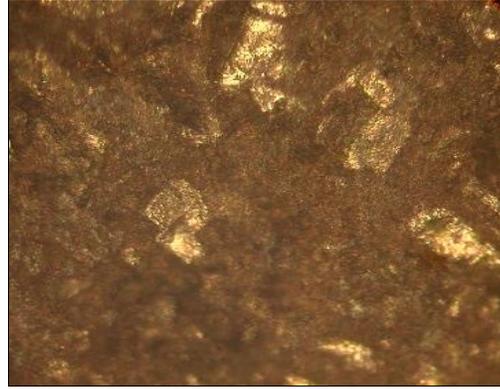
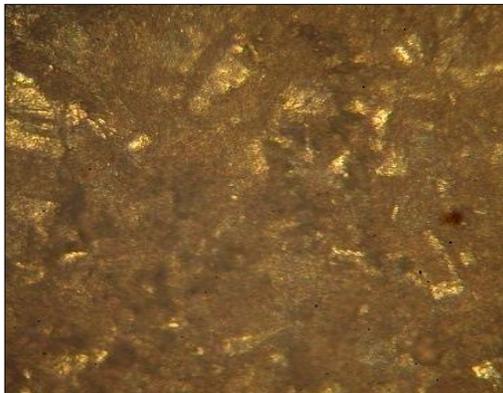
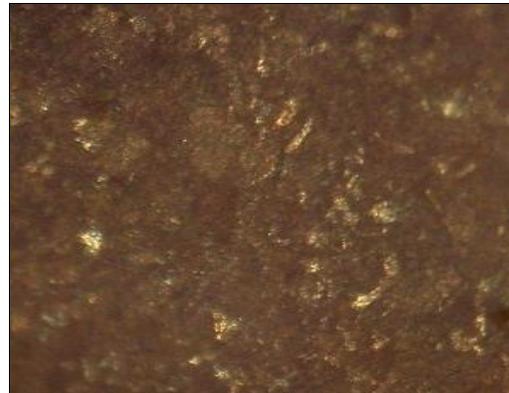
(a) As received specimen

(b) 4 Days immersion

(c) 8 Days immersion

(d) 12 Days immersion

**Figure (8) Surface feature of as-received specimens with
and without immersion in ferrous sulfate solution, 200X.**

The same microstructure profile was observed in each polished and as-received specimens, the only difference was in color darkness. The polished specimen showed red brown color refer to ferric hydroxide formed by ferrous sulfate, while as-received specimen showed dark-brown mixed with black coloration of originally present oxidation products.

The treatment of as-received specimens were more practically accepted, because it represent the actual situation observed in power plant, as the condenser tubes internally treated with ferrous sulfate.

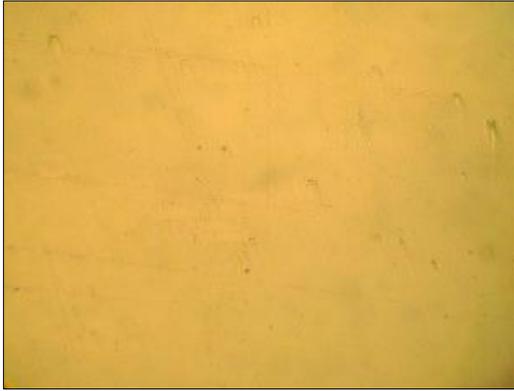
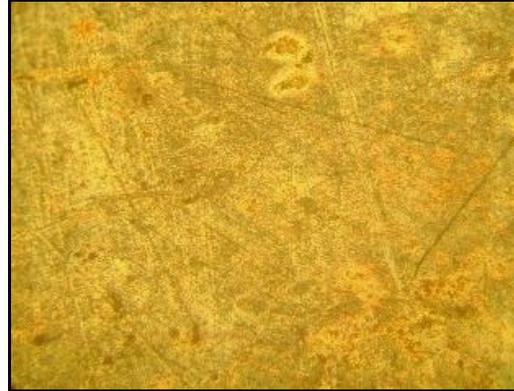
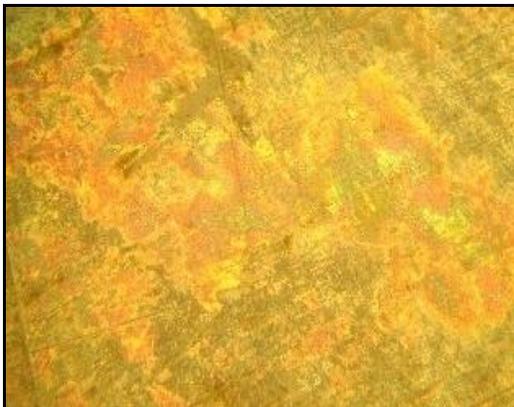
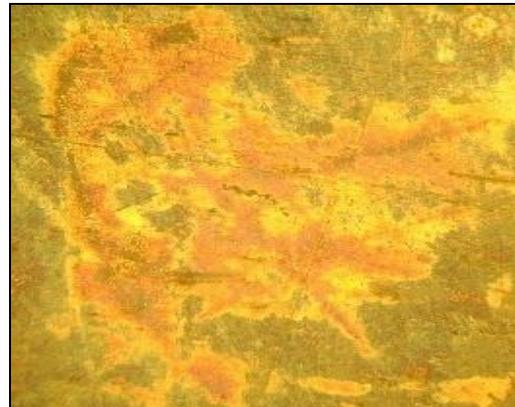
(a) Polished specimen

(b) 4 Days immersion

(c) 8 Days immersion

(d) 12 Days immersion

**Figure (9) Surface feature of polished specimens with and
Without immersion in filtered water, 200X.**

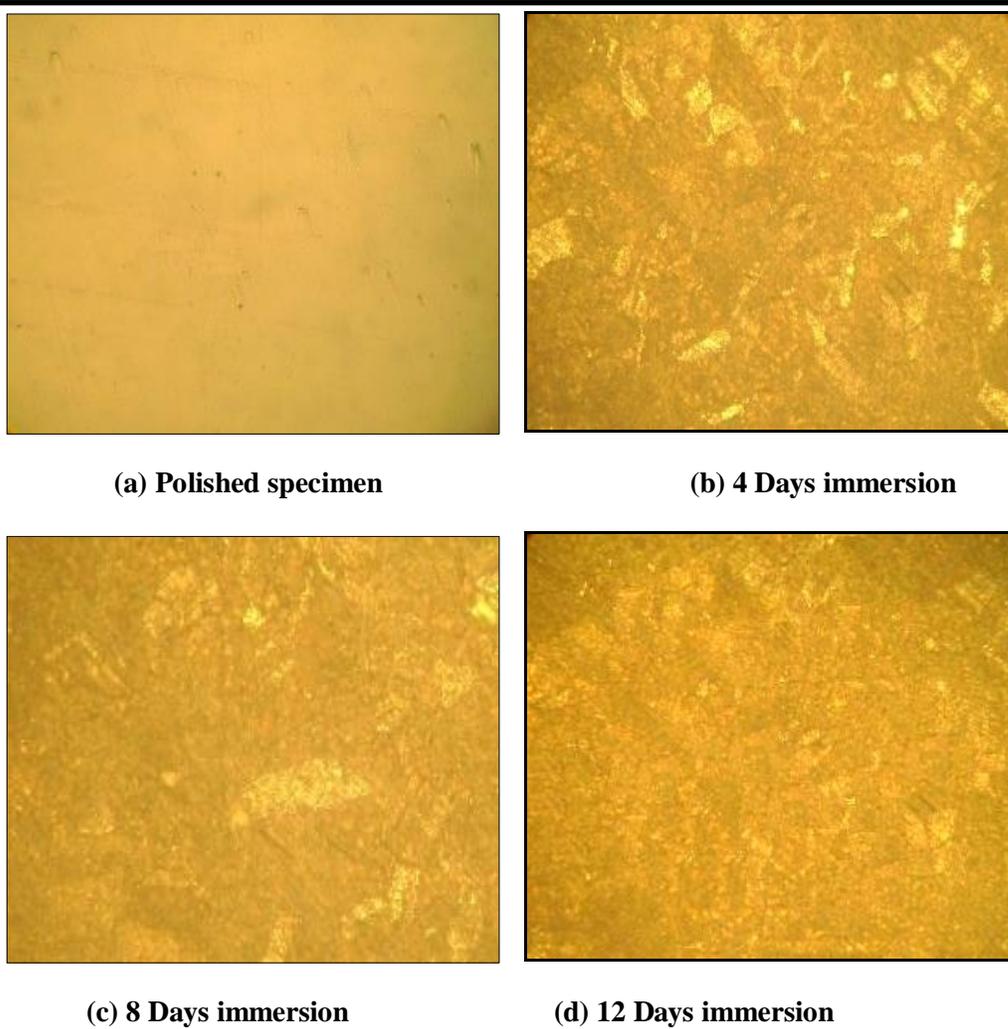
**Figure (10) Surface feature of polished specimens with and
Without immersion in ferrous sulfate solution, 200X.**

The polished metal specimens immersed in ferrous sulfate for a period of 4, 8 & 12 days are shown in Figure (10)b,c,d, apparently ferrous sulfate act as etching solution; α brass grains were visible associated with the presence of twinning [12]. Ferric film (brown) shielded the metal microstructure partially, which revealed evidence to ferrous sulfate film formation. Prolonged immersion time of 8 & 12 in ferrous sulfate solution showed film thickening see Figure (10) c,d.
