Retrofitting of SCC Deep Beams With Circular Openings Using CFRP

Nabeel A. Al-Bayati^a, Dhiyaa H. Mohammed^b, Nawfal A. Abdul Jabbar^{c*}

How to cite this article: N. A. Al-Bayati, D. H., Mohammed, and N. A. Abdul Jabbar, "Retrofitting of SCC Deep Beams With Circular Openings Using CFRP" Engineering and Technology Journal, Vol. 39, No. 07, pp. 1092-1104, 2021.

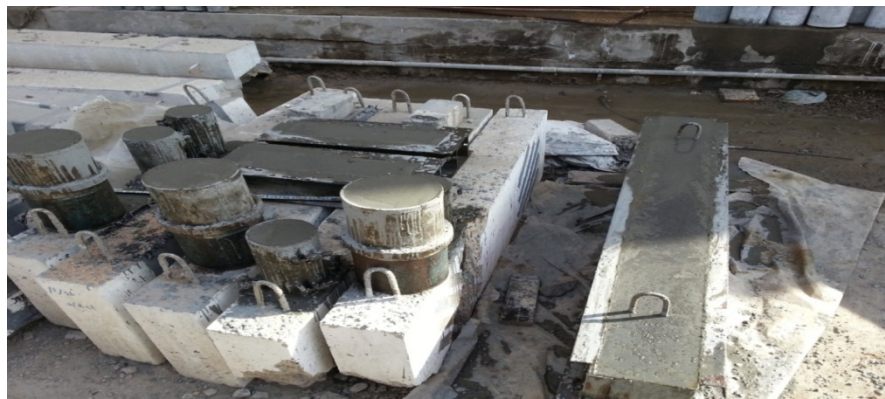
Plate 1: Deep beam specimens and control specimens after finished casting process

The remaining quantity of fresh SCC was used for casting the control samples. Two standard prisms of 100×100×400mm, three standard cylinders of 150×300mm, and three standard cylinders of 100×200mm are also cast without any vibration and covering them with nylon sheet to prevent or reduce water evaporation, as shown in Plate 1. After 24-48 hours all the molds of the control samples and the beam were opened. The control samples was cured for 28 days in water tanks while the deep beam specimens were cured by covering with canvas sheet and spraying the water on the canvas sheet twice a day for 56 days.

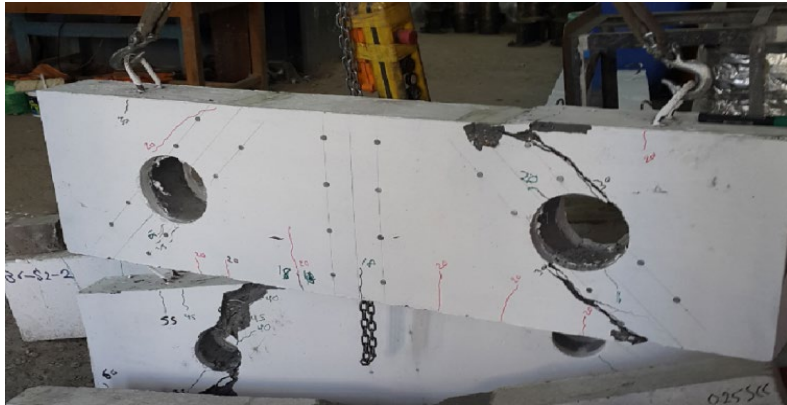
Plate 2: Failure mode and cracks patterns for B1-Control

The control deep beam specimen (B1-Control) was tested to failure without retrofitting. In general, no cracks were noticed in the early stages of loading. The first shear crack was observed at a

load of 160 kN with vertical mid-span deflection of 3.65 mm. The first flexural cracks were observed at a load of 180 kN with mid-span deflection of 3.9 mm. The beam failure was at the load 330 kN with mid-span deflection 6.3 mm. Failure mode of the beam was diagonal splitting failure as shown in Plate 2.

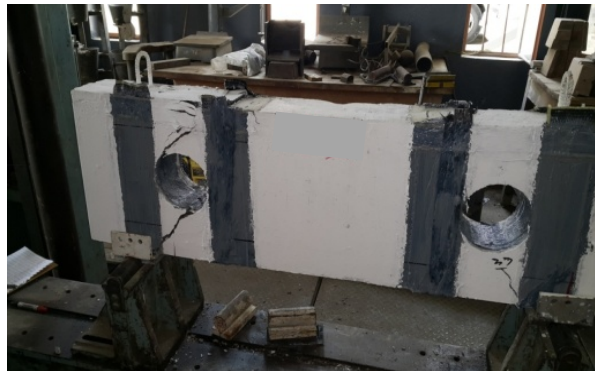
Plate 3: Failure mode and cracks patterns for B1-R-V

The first retrofitted beam B1-R-V was bonded by two vertical strips (U-shape) on the both sides of the circular openings. The width of strips was 100 mm. The first shear cracks and the first flexural cracks were observed at a load of 160 kN with vertical mid-span deflection of 3.5 mm. These cracks propagate and increase in number, width, and length with each further increase of the load. The beam failure was at the load 390 kN with vertical mid-span deflection 6.7mm. The improvement in load capacity was 18.2% compared with ultimate failure load of the control beam. Failure mode of the beam was diagonal splitting failure as shown in Plate 3.

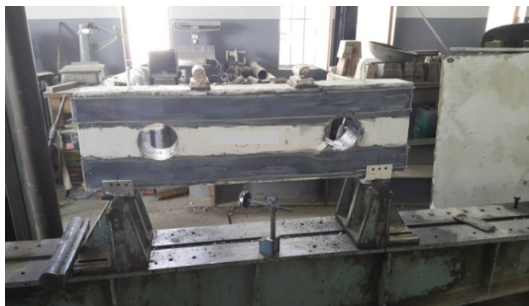
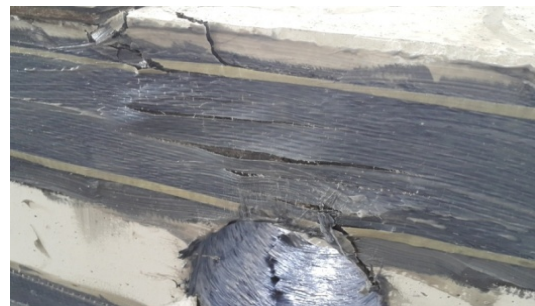
Plate 4: Failure mode and tearing of CFRP strip for B2-R-H

The second retrofitted beam B2-R-H was bonded by two horizontal strips from top and down sides of the circular openings. The width of strips was 100 mm. The first shear cracks were observed at a load of 160 kN with vertical mid-span deflection of 3.4 mm. The first flexural cracks were observed at a load of 180 kN with mid-span deflection of 3.7 mm. The beam failure was at the load 420 kN with vertical mid-span deflection 6.8mm. The improvement in load capacity was 27.27%

compared with ultimate failure load of the control beam. Failure mode of the beam was diagonal splitting failure as shown in Plate 4.

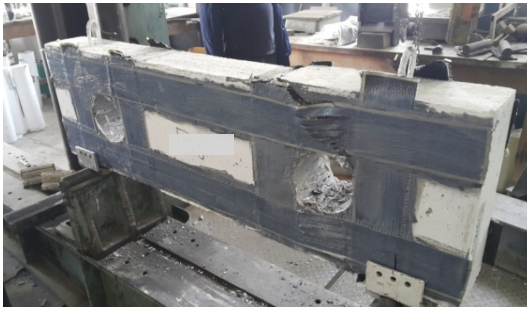
Plate 5: Failure mode and tearing of CFRP strip for B3-R-VH

The third retrofitted beam B3-R-VH was bonded by two vertical strips (U-shape) on the both sides of the circular openings in addition to two horizontal strips from top and down sides of the circular openings. The width of strips was 100 mm. The first shear cracks were observed at load 140 kN with vertical mid-span deflection of 3.45 mm. The first flexural cracks were observed at a load of 160 kN with mid-span deflection of 3.8mm. The beam failure was at the load 420 kN with vertical mid-span deflection 6.7mm. The improvement in load capacity was 27.27% compared with ultimate failure load of the control beam. Failure mode of the beam was diagonal splitting failure as shown in Plate 5.

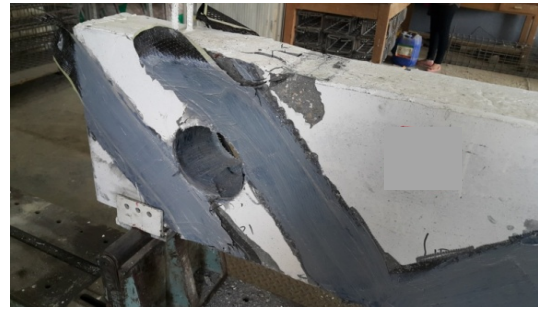
Plate 6: Failure mode and tearing of CFRP strip for B4-R-I

The fourth retrofitted beam B4-R-I was bonded by two inclined carbon fiber (CFRP) strips orthogonal on the load path which linking the load point and support point. The width of strips was 100 mm. The first shear cracks were observed at a load of 140 kN with vertical mid-span deflection of 3.25 mm. The first flexural cracks were observed at a load of 160 kN with mid-span deflection of 3.55mm. The beam failure was at the load 420kN with vertical mid-span deflection 6.6mm. The improvement in load capacity was 27.27% compared with ultimate failure load of the control beam. Failure mode of the beam was diagonal splitting failure as shown in Plate 6.

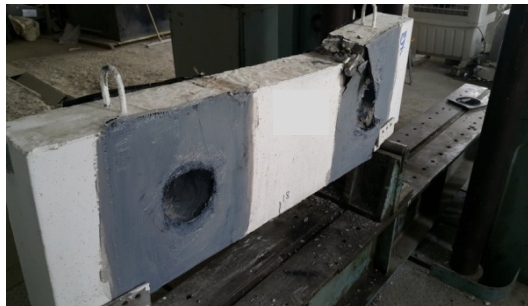
Plate 7: Failure mode and tearing of CFRP strip for B5-R-SS

The fifth retrofitted beam B5-R-SS was covered the shear span zone except the opening area by CFRP sheet. The width of the sheet was 350 mm. The first shear cracks and the first flexural cracks were observed at a load of 160 kN with vertical mid-span deflection of 3.45 mm. The beam failure was at the load of 390 kN with vertical mid-span deflection 6.45mm. The improvement in load capacity was 18.2% compared with ultimate failure load of the control beam. Failure mode of the beam was diagonal splitting failure as shown in Plate 7.

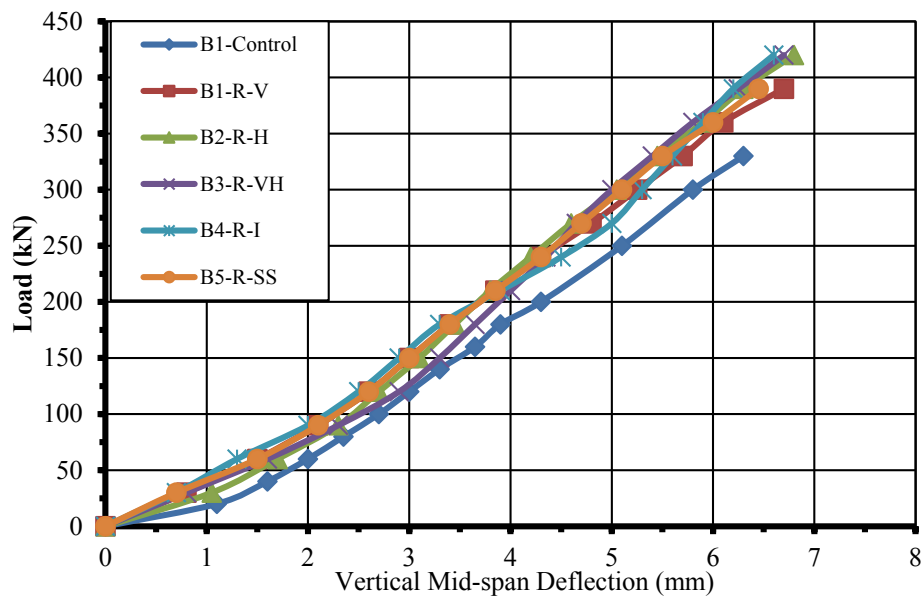
Figure 3: Load- mid-span deflection relationships for deep beams after retrofitting

- 5) Figure 3 shows the load-mid-span deflection relationships for the deep beams after retrofitting process. The curves show a clear convergence in the beams performance
